INSPECTION REPORT:

PROPERTY ADDRESS: 757 Atkins Road
Fuquay Varina, NC 27526

DATE OF INSPECTION: November 17, 2022

NORTH CAROLINA SEPTIC INSPECTIONS

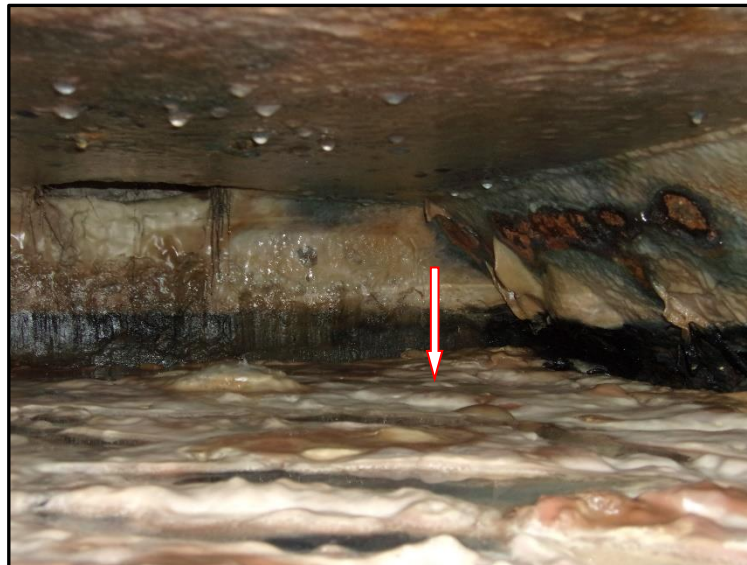
- 1). Considering the current depth of mixed solids, sludge, and the thickness of surface scum, in addition to non-biodegradable materials, it is recommended that septic tank be pumped and cleaned. **FYI: To prevent a backup of sewage resulting in an interruption in service, periodic removal, and cleaning of the effluent strainer is also recommended. NC Septic System Rules and Regulation suggest that septic tanks be pumped on a 3 to 5 year rotation, or sooner, if necessary.**

Inlet Primary Chamber Scum and Non-Biodegradable Materials:

- 1). The combined depth of surface scum, mixed solids, and sludge does not equal the 25 to 30 percent of the liquid holding capacity necessary for pumping, however, because of the non-biodegradable materials, in addition to the thickness of primary chamber surface scum, consideration should be given to **pumping** the tank at this time. FYI: To prevent a backup of sewage resulting in an interruption in service, periodic removal, and cleaning of effluent strainer is also recommended (see page 9 for additional information and pictures).

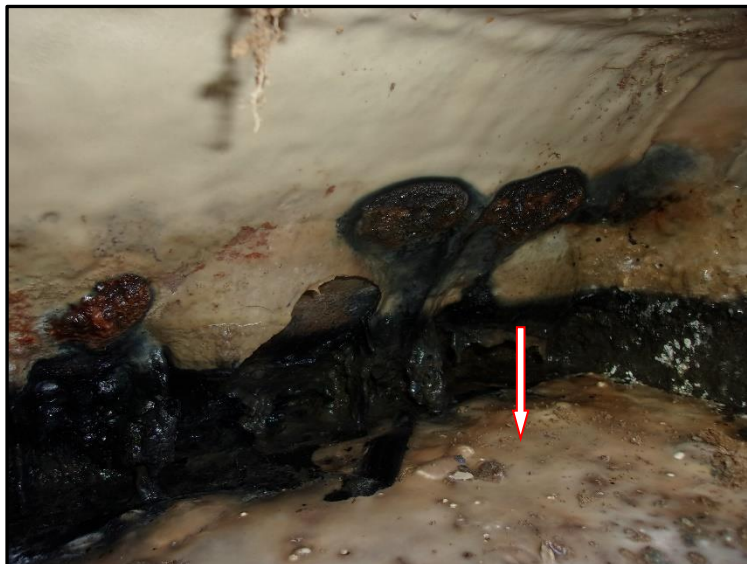
Secondary Chamber (Scum):

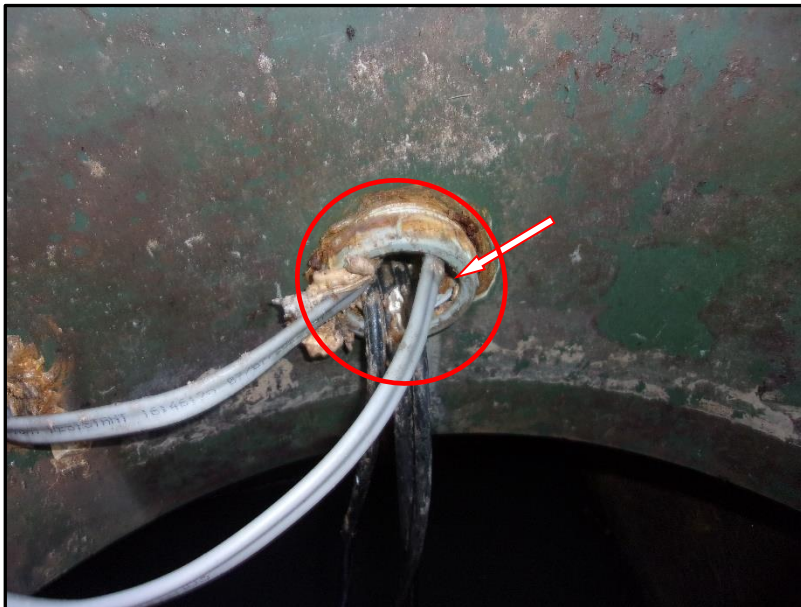
Existing Conduit:

- 2). To prevent the infiltration of moisture and insects, it is recommended that Service Provide reseal around the effluent pump and highwater alarm float wires located in pump tank riser well (see page 10 for additional information and pictures).

- 2). To prevent the infiltration of moisture and insects, it is recommended that plumber's putty or the appropriate sealant be installed in electrical conduit located in pump tank riser well.

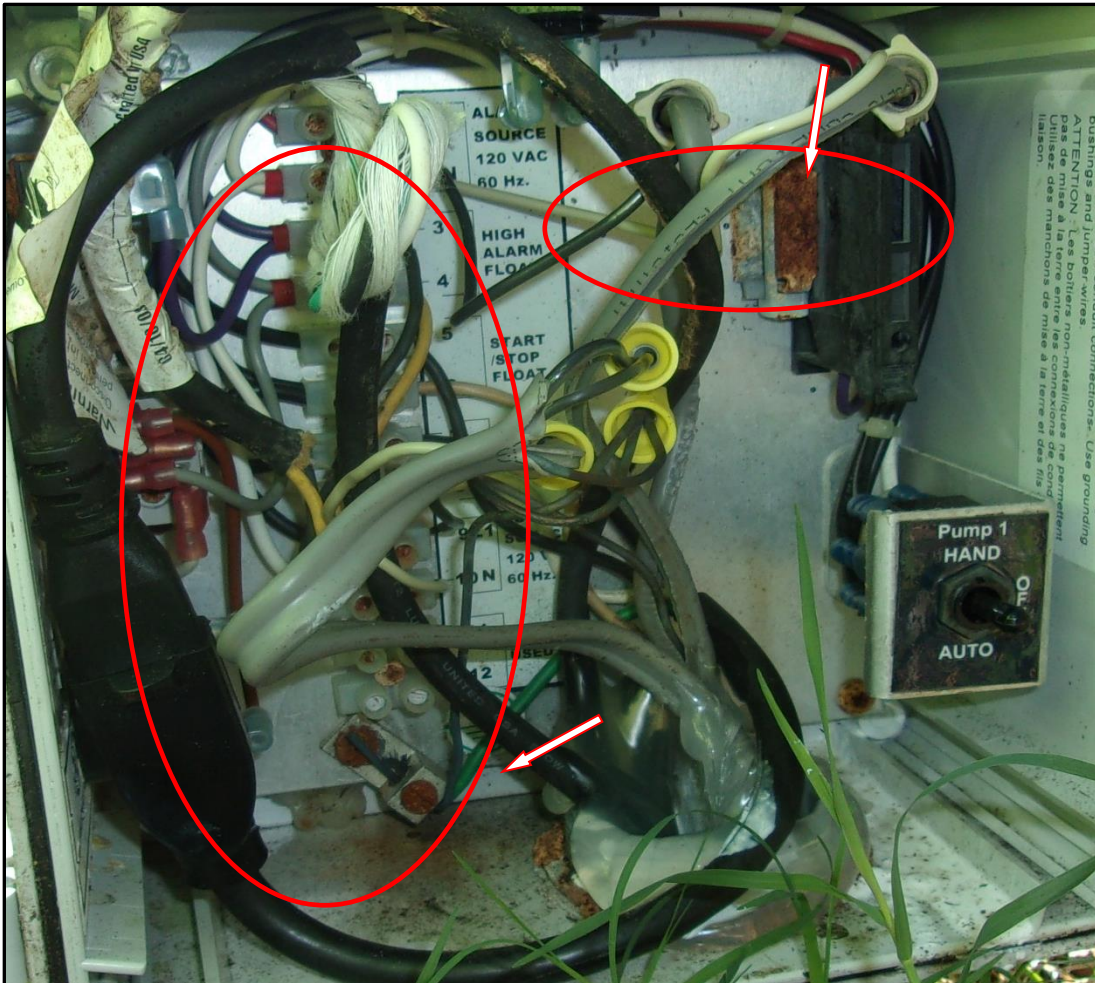
- 3). Electrical contacts in pump tank control panel box have rust and corrosion. To prevent possible electrical short, cleaning the terminals is recommended (see page 11 for additional information and pictures).

- 3). Electrical contacts in pump tank control panel box have rust and corrosion. To prevent possible electrical short, cleaning the terminals is recommended.

Pump Tank Control Panel Box:

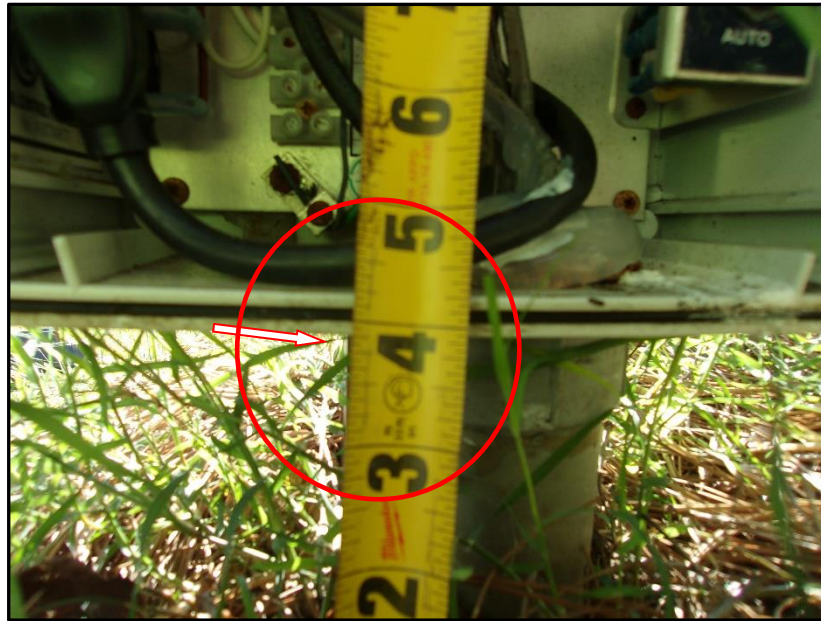
- 4). Pump tank Electrical control panel box should be a minimum of 12 inches above grade. In extreme rain events water possibly could reach levels of infiltration around base of box. FYI: The lesser height is not unusual when landscaping and backfill have been added around the tanks (see page 12 for additional information and pictures).

- 4). Pump tank Electrical Control Panel Box should be raised to a minimum of 12 inches above grade to prevent infiltration of surface water. In extreme rain events water possibly could reach levels of infiltration around base of box.

Existing Panel Box:

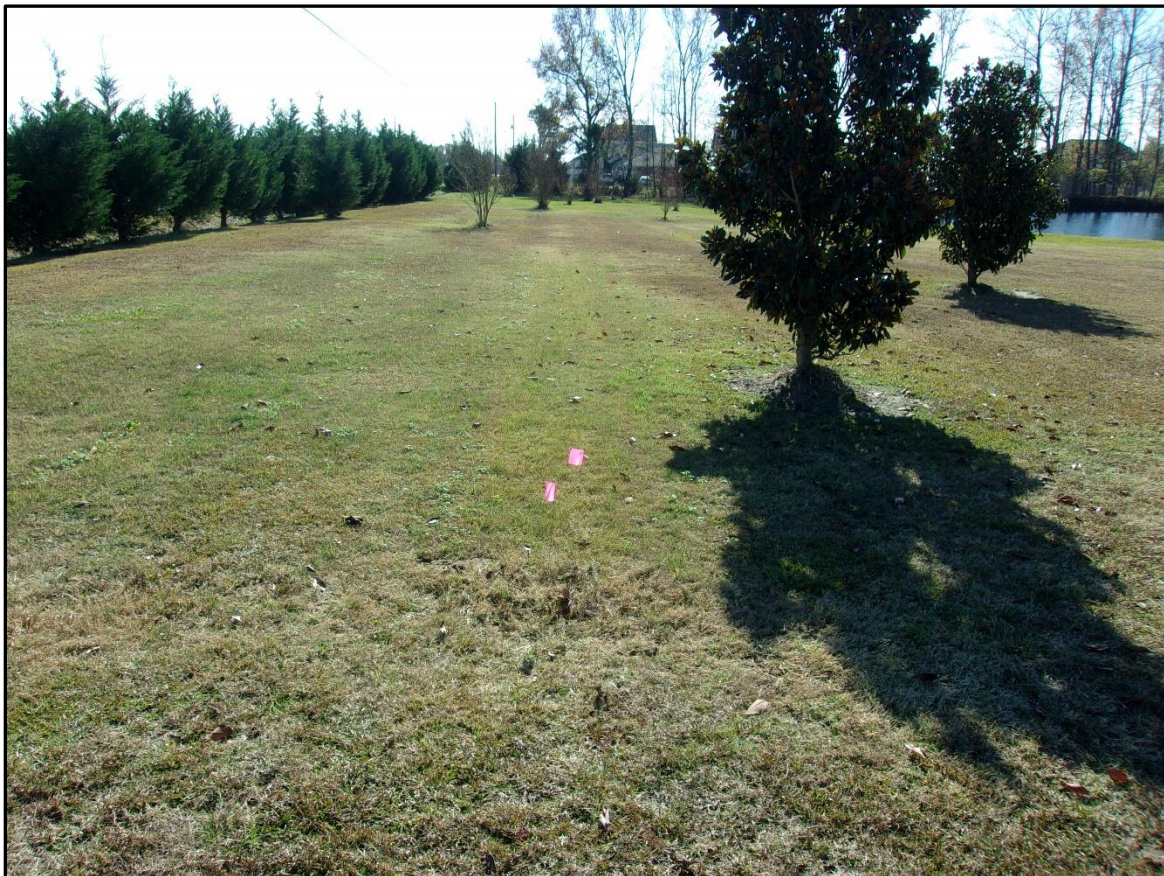
Nitrification field was located, and a visual inspection was performed. Nitrification field consists of two (2) lines, each approximately 150 feet in length. Probing confirmed the depth, however, the exact length or the configuration of nitrification lines was not confirmed. **Septic systems are subterranean, therefore, without exposing the actual nitrification lines and the soil absorption area beneath the lines it is impossible to make an accurate assessment of their overall condition.** Caution should be observed not to disturb the soil in and around the nitrification field and the adjoining designated repair area. It is always recommended to properly maintain the vegetation growth over nitrification areas. Planting appropriate vegetation over the leaching field is key to allowing a septic system to properly treat household wastewater and ensure the safety of your family and the environment. **FYI: All permanent structures should be a minimum of 5 feet from any or all portions of a septic system. In addition, it is important to avoid equipment or vehicular traffic over the nitrification area.**

Nitrification Area (Diagram of lines may not be exact):

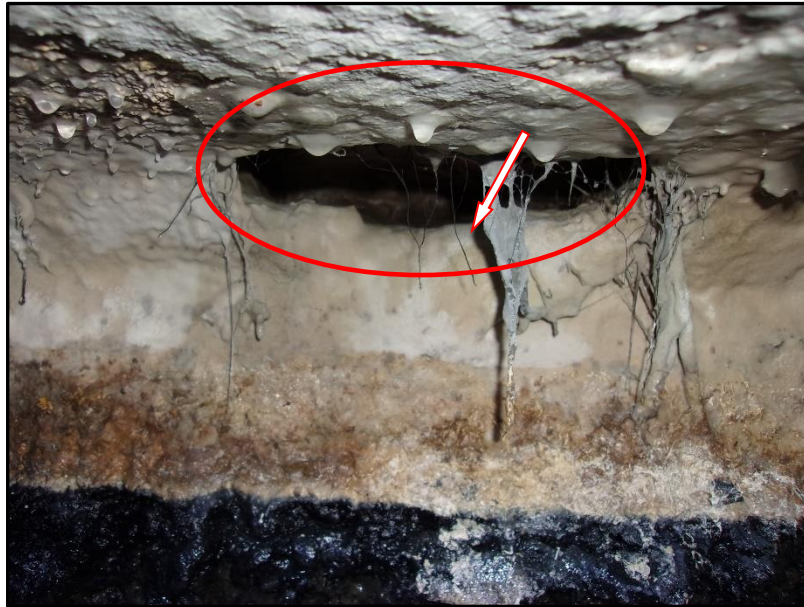
The following pictures suggest that this system, on occasions, has experienced a backup of sewage. This normally is the results of a **power outage or a clogged strainer** in outlet secondary chamber. To prevent an interruption in service, it is recommended that the effluent strainer be periodically removed and cleaned, when soiled.

Solids and Scum on Interior Dividing Baffle Wall Vent:

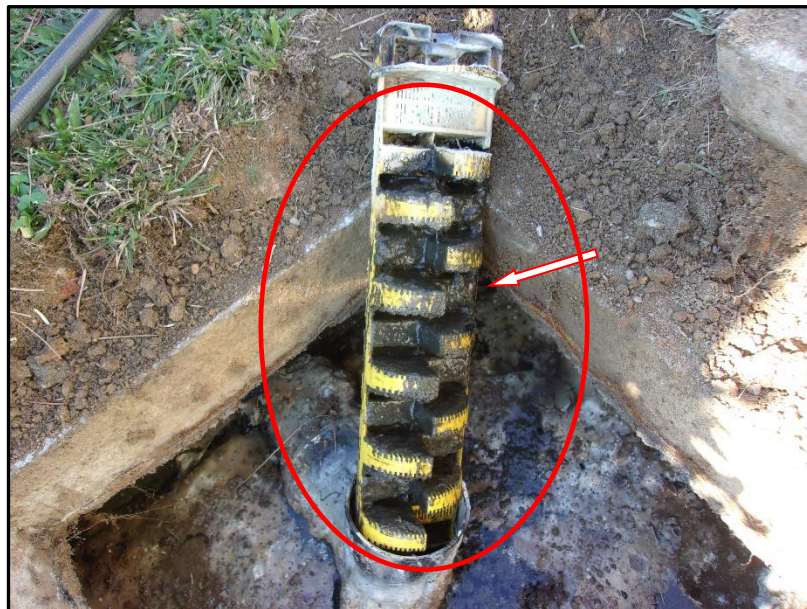
Soiled Effluent Strainer:

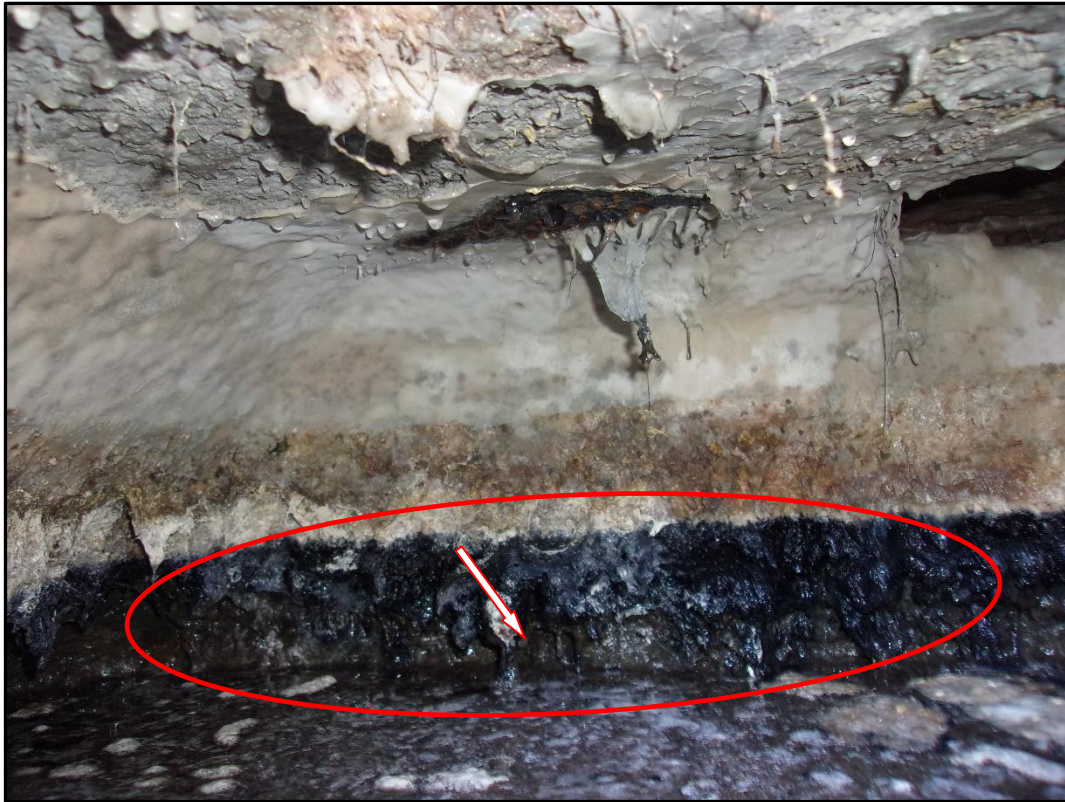
Corrosion and concrete etching was present at the static water line, in addition to areas of the sidewalls. This is a normal progression in concrete tanks. Periodic inspections are recommended, if etching is determined to be accelerating or advancing, a repair by “skim coating” this area may become necessary.

Age Related Concrete Etching and Sidewall Corrosion:

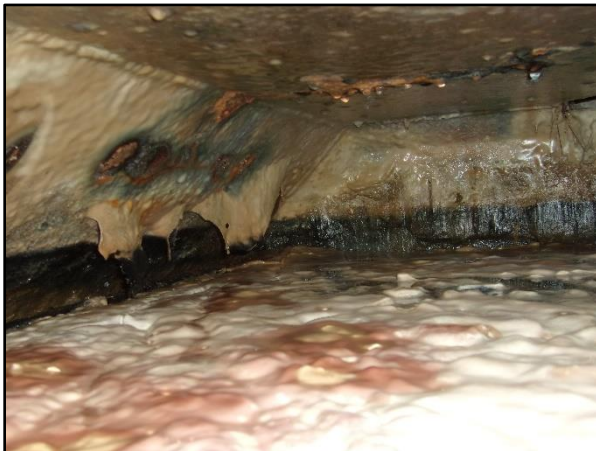
Primary Chamber (Scum):

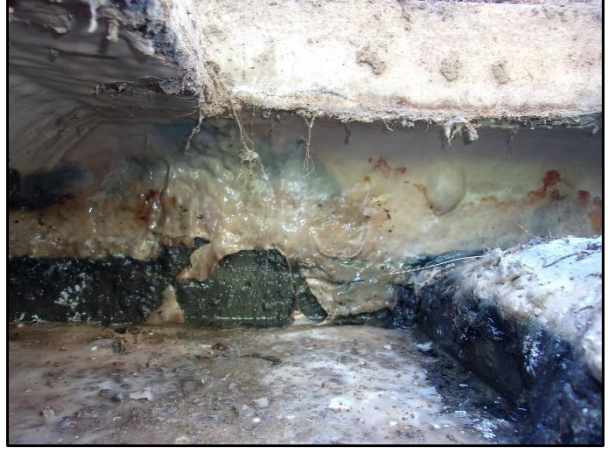
Secondary Chamber (Scum):

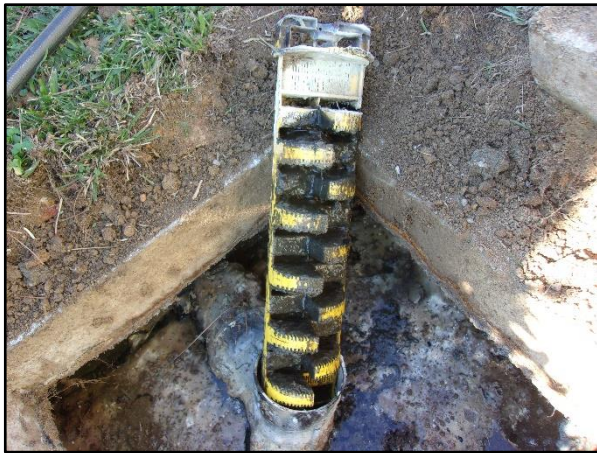
Soiled Effluent Strainer:
