Onsite Wastewater System Inspection

7722 NC Hwy 27 West

11/29/2022, 09:45 AM

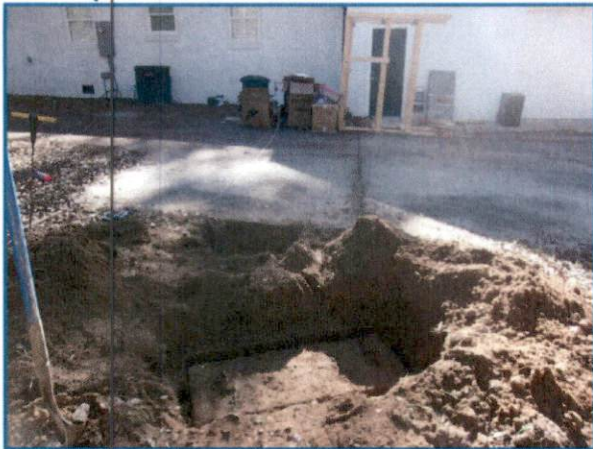
P3. Septic Tank Location

The septic tank is a single compartment tank without a baffle wall. Therefore the top of the tank consists of individual slabs that also serve as access points for cleaning. The inlet slab of the septic tank was measured to be approximately twenty-eight feet straight out from the rear crawl space door, and is approximately thirteen inches deep. Since the concrete driveway pad was poured over top of this end of the septic tank, I inspected the tank from the outlet end. I was able to capture some images of the interior of the inlet side, and I did not observe any large cracks, or signs of excessive corrosion, and the inlet pipe appeared to be sufficient. The septic tank was pumped out within the last few weeks, so it was only half full of wastewater, and no measurable solids were present. Water was flowed inside the house, and I did not observe wastewater enter the tank in an amount comparable to that which was running inside. There was a slight trickle of water entering the tank, however. To further investigate this issue, I went underneath the house, and listened to the water travel through the plumbing. I traced all the plumbing pipes to a common point where they transition into a single cast iron drain. This was the only drain leaving the house that I could see, and all the plumbing pipes come together at this point. Based on the location of this cast iron pipe, it is clear that it drains towards the septic tank that was being inspected. After flowing water in all the fixtures inside the house, I went back underneath the house, and immediately began seeing an excessive

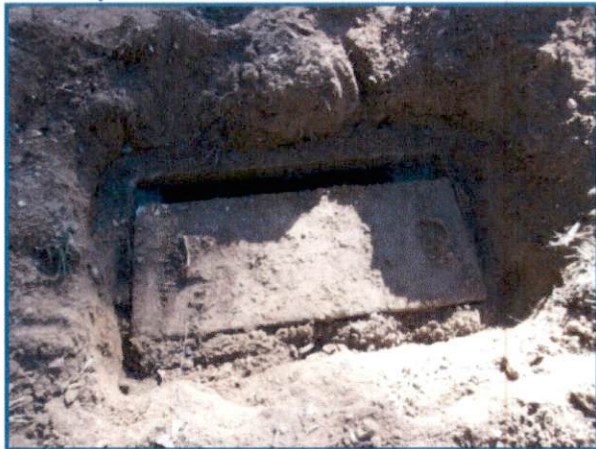
P4. Septic Tank Outlet Slab

The outlet compartment access to the septic tank was measured to be thirty-six feet straight out from the rear crawl space door. The outlet compartment slab was found to be fourteen inches deep, in good condition, and properly seated to the top of the septic tank. There was a terracotta outlet sanitary tee present on the outlet of the septic tank that was in good condition. Upon inspection of the interior of the outlet compartment I did not observe any large cracks or excessive corrosion to the concrete above the water level. Lastly, I ran water directly into the outlet tee with a hose pipe and I observed the water flow properly into the distribution box.

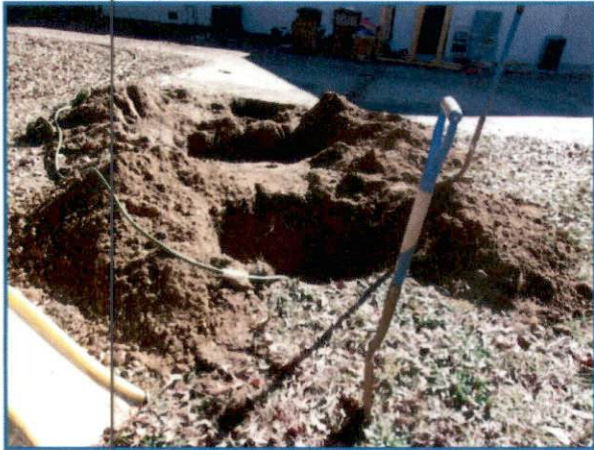
P11. Distribution Box Location

The distribution box was located and this component measured five feet straight out from the outlet of the septic tank. The distribution box and distribution box lid were both found to be structurally sound with no signs of damage or excessive corrosion. While water was flowing into the outlet of the septic tank I confirmed that the effluent enters the distribution box appropriately. I also confirmed that the effluent is being distributed equally into each of the two outlet pipes. I continued flowing water for an additional forty-five minutes, and the water flowed, equally, into each of the lines the entire time.
