3RD PARTY INSPECTION FORM

Residential Single-Family Project: (Y) N	Commercial Project: Y (N)	
Code Enforcement Project No:	Permit No: BRES2304-0039	
Project Name: 3305 US-401 South Lillington, NC 27546	Owner:	
Project Address: 3305 US-401 South Lillington, NC 27546	Suite No:	
Date Inspected: 8/4/2023	Contractor Name:	
Component Inspected: Footing Excavation	n & Bearing Soils

Reference: Engineering Services

TE&D Project No.: DRB2101-0152-C

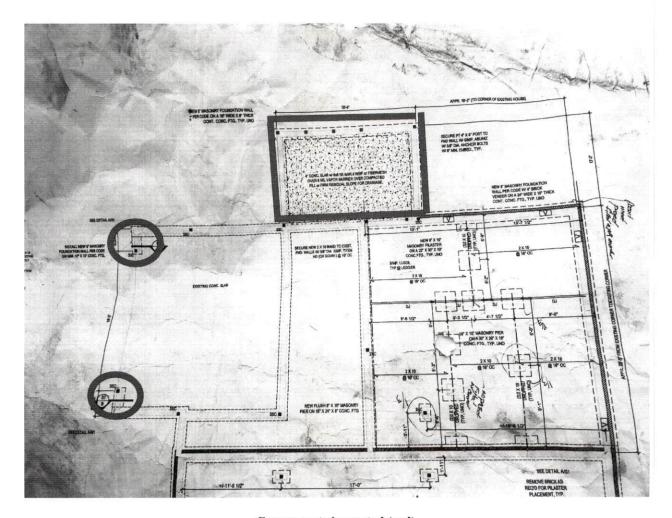
Components inspected (red)
