23 March 2023

Re: Crawlspace Inspection - 2624 Raynor McLamb Road Linden, NC 28356

Jenkins Consulting Engineers, PA

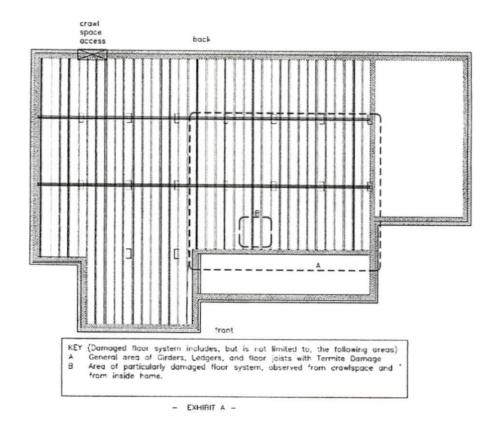
On March 8, 2023 Jenkins Consulting Engineers (JCE) observed the crawlspace at the subject location. Upon initial investigation, the area under the house has experienced extensive damage from termites. The portion of the house that was inspected (at the request of the owner) is shown in Exhibit A (Detail A). It is possible that the termite issue may have precluded a water issue. There was evidence of moisture under the house – visible water droplets under the plastic moisture barrier.

The girders in the area near the front porch (as shown on the exhibit above) have sever termite damage, along with the ledger strips on those girders. There are several joists that have termite and/or water damage. There appears to be water damage on much of the subflooring in this area as well.

We propose replacing all of the damaged members and subflooring from above. The members are brittle and cannot be anchored to in a "sistered" fashion, so it is recommended to remove and replace, like for like. The entire home should be evaluated for members that are damaged, and replaced accordingly. The sheathing in these areas should be replaced if damaged.

It is also recommended that the moisture issue be resolved at this time as well. Adding a dehumidifier will help. Any existing mold or mildew should be abated as well.

JCE recommends complete abatement of the mold before beginning work. The mold will continue to spread and will eat away at the old members as well as the new members to be installed as a part of this scope of work. It is also important for the moisture to be addressed with dehumidifiers, pumps, encapsulation, French drains, or whatever methods determined by the contractor and homeowner.
