June 8, 2023

Project No. 23-1757

Re: Structural Observation — 403 West I Street, Erwin, NC 28339

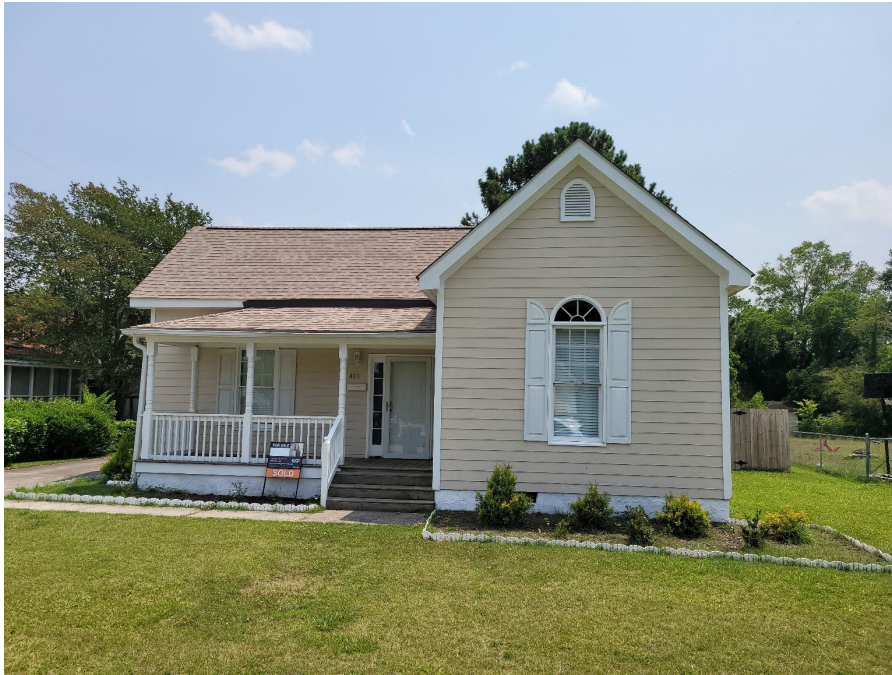
*Picture 1 – 403 West I St.
Erwin, NC 28339*

At your request, on June 8, 2023 we performed a visual structural inspection and review photographic evidence of a reframed section of the first floor by *Tarheel Basement Systems* at the Erwin residence noted above. The structure is a conventionally framed, detached, single family residence with raised first floor framing over a pier/curtain wall foundation system (*see picture 1*).

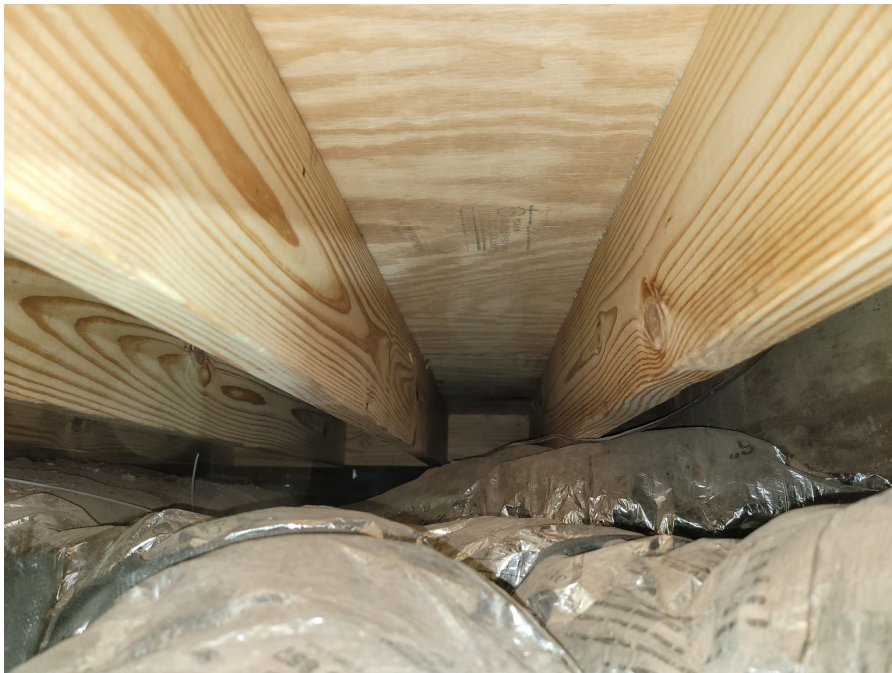
- A section of the first floor framing towards the middle of the right side of the home was noted to have been reframed using 2x8 joists at 12” o.c. spacing. The new floor joists were fastened to 2x8 ledger boards using face hangers. The ledger boards had been secured to the existing girder and rim beam using Structural wood screws (*see pictures 2-4 for examples*).

Picture 2 – Example of new floor joists and subfloor

Upon completion of our observations, we consider all completed structural repairs to have been performed in a good and workmanlike manner in accordance with the intent of applicable provisions of the 2018 edition of the *North Carolina Residential Building Code*.

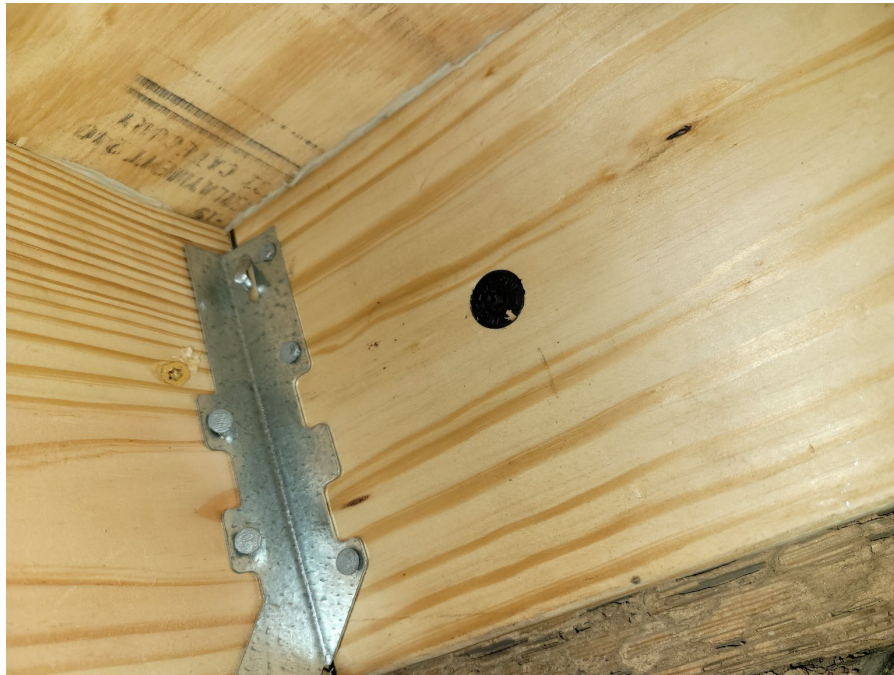
Picture 3 – Example of joist hangers and structural wood screws

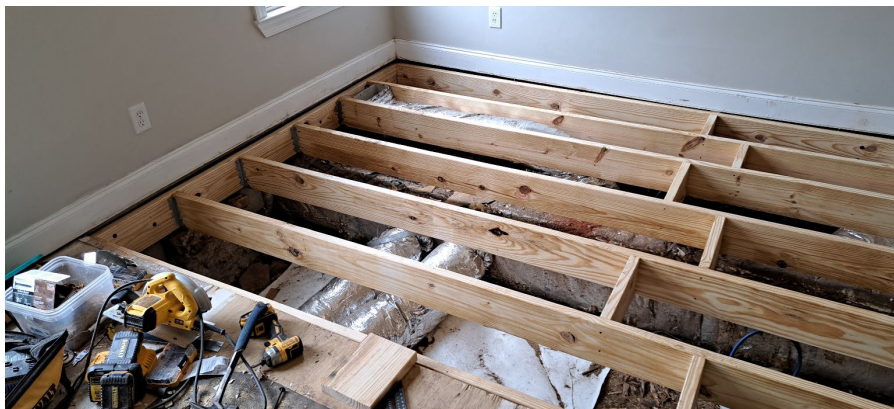
Picture 4 – Photographic evidence repair in progress
