W. Harrison Welch, PE  
Stonewall Structural Engineering, PLLC  
4800 Falls of Neuse Rd. #120  
Raleigh, NC 27609  
(919)407-8663

Re: Structural Observation — 342 Lambert Lane, Fuquay-Varina, NC 27526

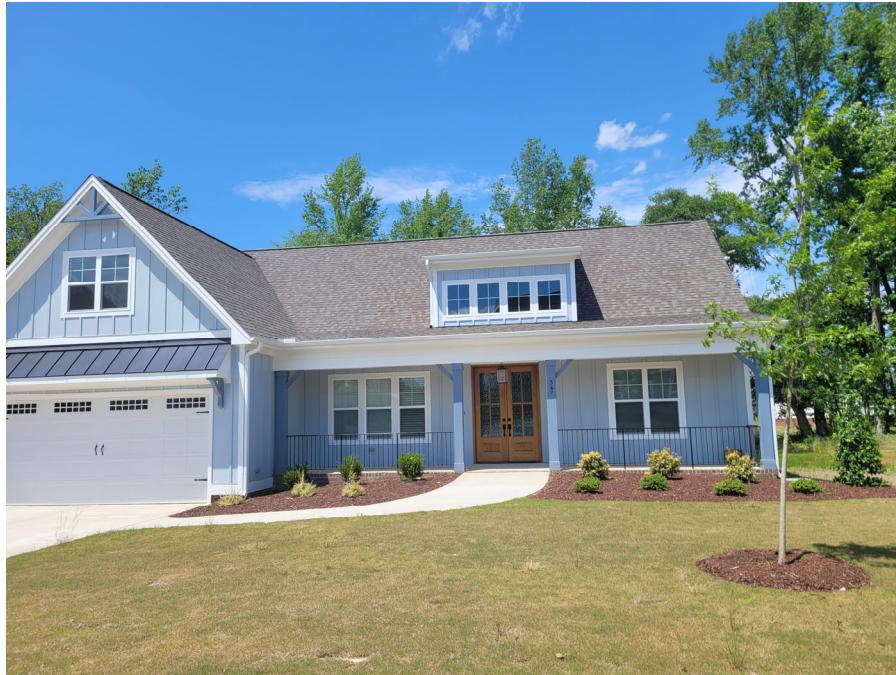
At your request, on May 9, 2023 we performed a visual structural observation of uneven floors at the Fuquay-Varina residence noted above. The structure is a conventionally framed, detached, single family residence with raised first floor framing over a pier/girder foundation system with perimeter masonry foundation walls (*see picture 1*).

*Picture 1 – 342 Lambert Lane  
Fuquay-Varina, NC 27526*

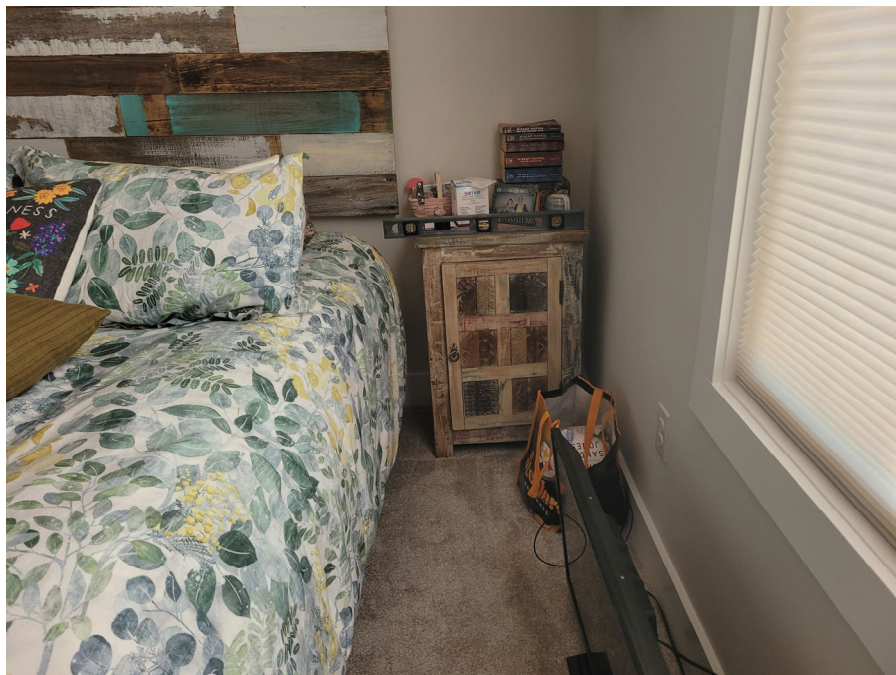
- Uneven floors were noted in the primary bedroom and bathroom on the left side of the home. Additionally, furniture in the primary bedroom was noted to be visibly leaning (*see picture 2 for example*).

- Measurement by laser level indicated the girder beneath the left wall of the primary bedroom was down as much as approximately  $\frac{1}{4}$ " relative to the girder under the right wall of the bedroom.

- Per Section 2.2 of the structural warranty for the home (provided by the client), the builder of the home is responsible for correcting uneven floors which exceeded  $\frac{1}{4}$ " within a 32" increment.

*Picture 2 – Example of leaning furniture*

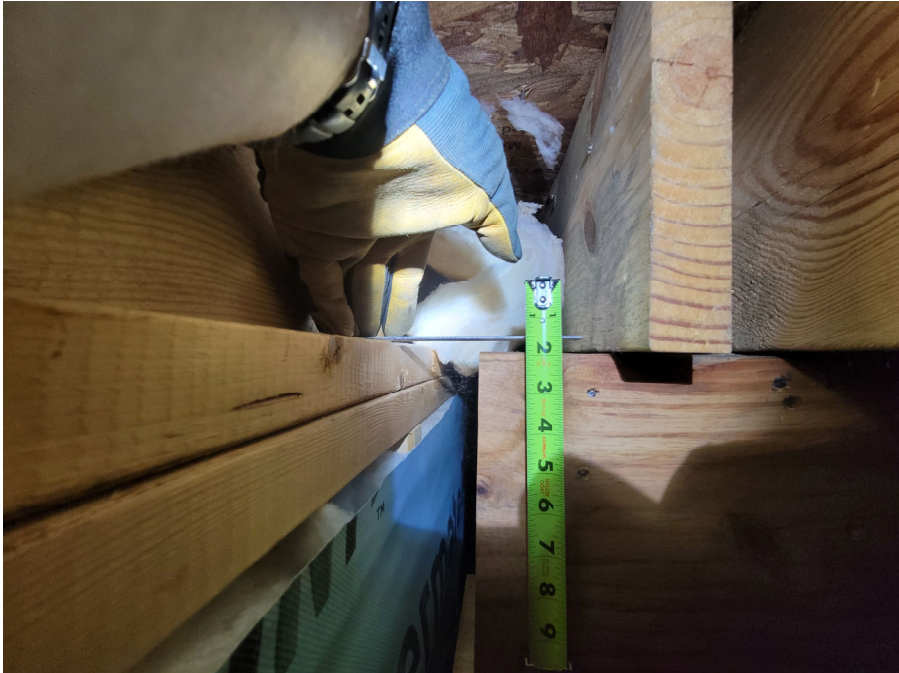
- Investigation from within the crawlspace revealed that the back end of the girders beneath the left and right walls of the primary bedroom were set low to the perimeter sill plate by as much as approximately  $\frac{1}{2}$ " and floor joists were out of contact over the girder (*see pictures 3-4 for examples*).

- The above noted uneven floors have been the result of a combination of the interior framing and foundation elements being built low relative to the perimeter foundation, potentially inadequate handling of building materials during construction, and out of level construction of the perimeter foundation.

*Picture 3 – Example of girder set low to the perimeter sill plate*

- To correct the low girders, raise the girders over masonry piers and shim using full width and full length treated shim material to the tops of piers. Girders should be raised at the ends such that the top of the girder is level to the top of the perimeter sill plate.

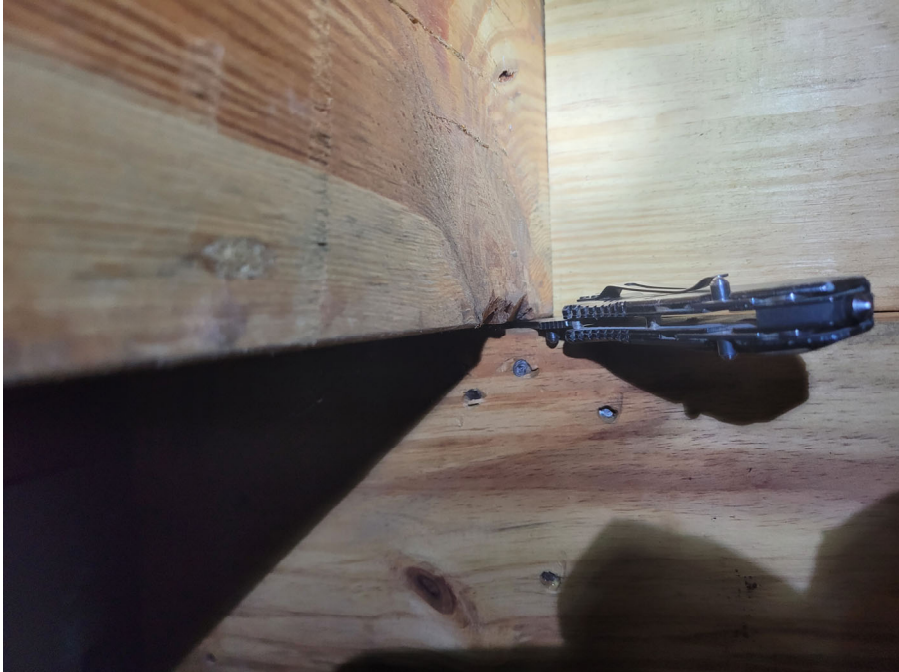
*Picture 4 – Example of joist out of contact with the girder below*

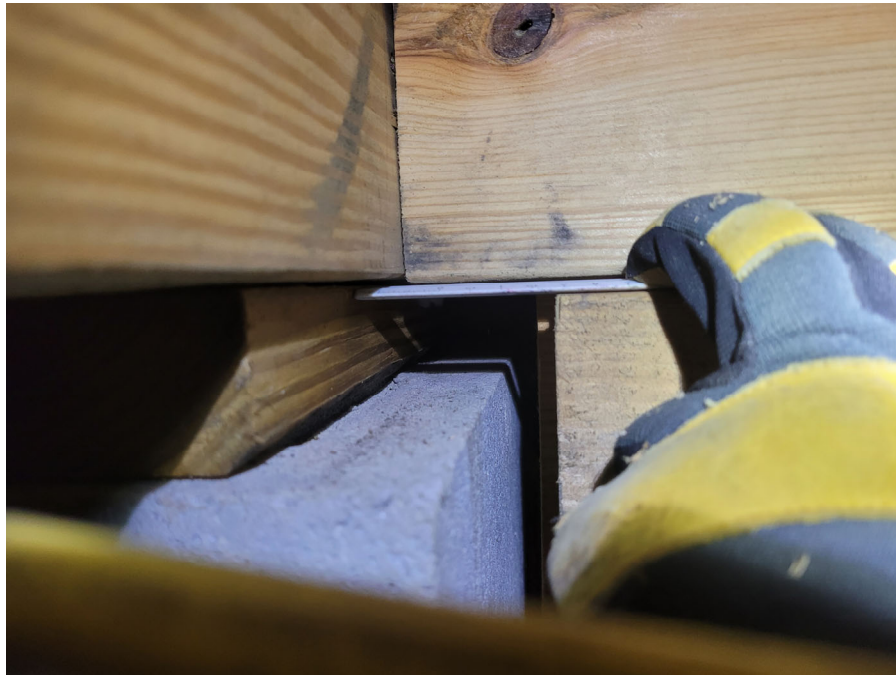
- Uneven floors were noted in the laundry room.
  - Investigation from within the crawlspace revealed that the front end of the girder beneath the right wall of the laundry room was set low to the perimeter sill plate (*see picture 5*).

*Picture 5 – Example of girder set low to perimeter sill plate*

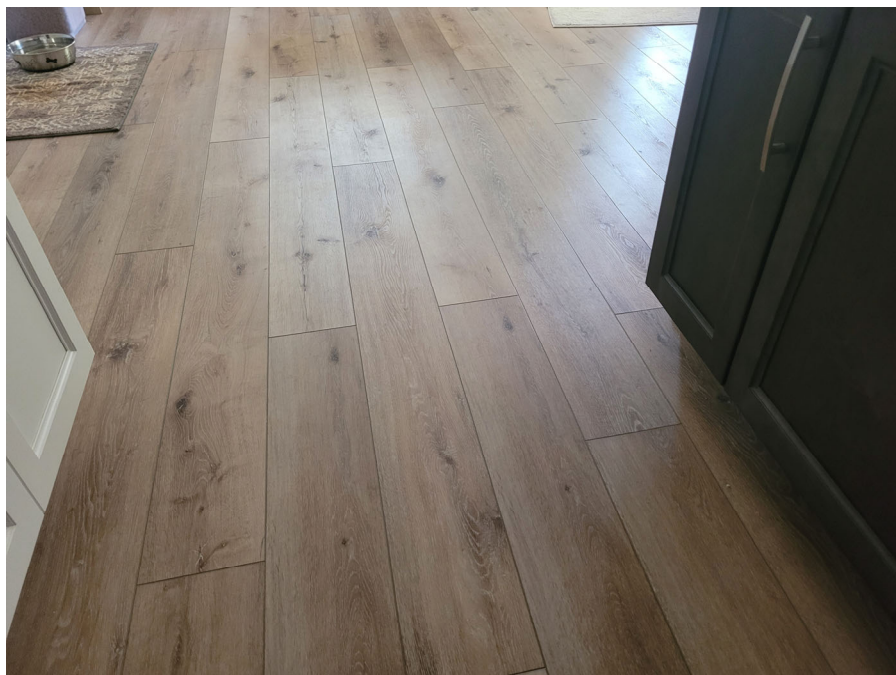
- A dip was noted in the floors at the back of the kitchen island (*see picture 6 for example*).
  - Investigation from within the crawlspace revealed that the back end of the 2<sup>nd</sup> girder from the right side of the home was low relative to the perimeter sill plate.

*Picture 6 – Example of dip in floors at kitchen island*

- To reduce the uneven floors at the back of the kitchen island, the shorter floor joists should be raised until the top of the floors are level and the ends of the joists should be shimmed into contact with their supporting members using tight-fit wood or steel shim material.

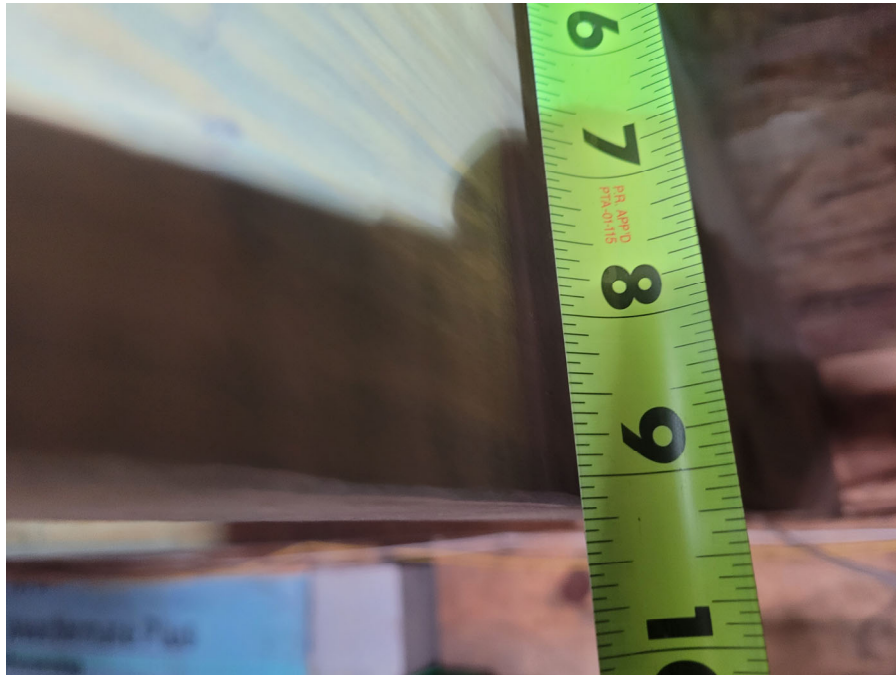
- Investigation from within the crawlspace also revealed that the floor joists at the back of the kitchen island varied in depth. Measurement by laser level revealed that the bottoms of the joists were level to within  $\frac{1}{8}$ " between girders. Additional measurements by laser level indicated that the floor sheathing was out of level as much as approximately  $\frac{1}{4}$ " between joists (*see pictures 7-8 for examples*).

- Lumber has the potential to swell when exposed to excess moisture and contract when dried. If inadequately acclimated wood is used during initial construction, it will contract as it dries which can create framing members of varying actual dimensions.

*Picture 7 – Example of floor joist beneath kitchen island*

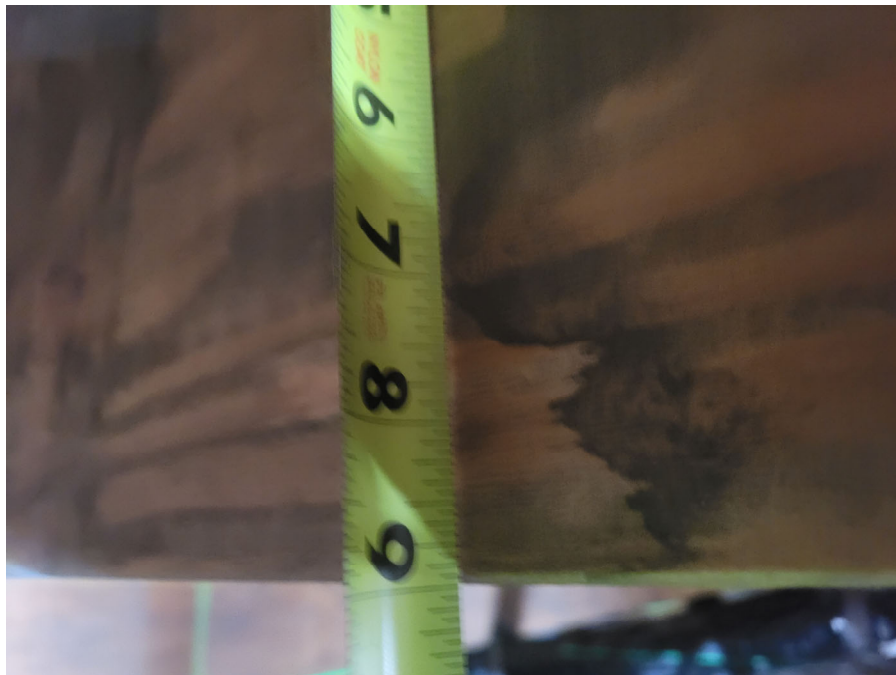
*Picture 8 – Example of floor joist beneath kitchen island*

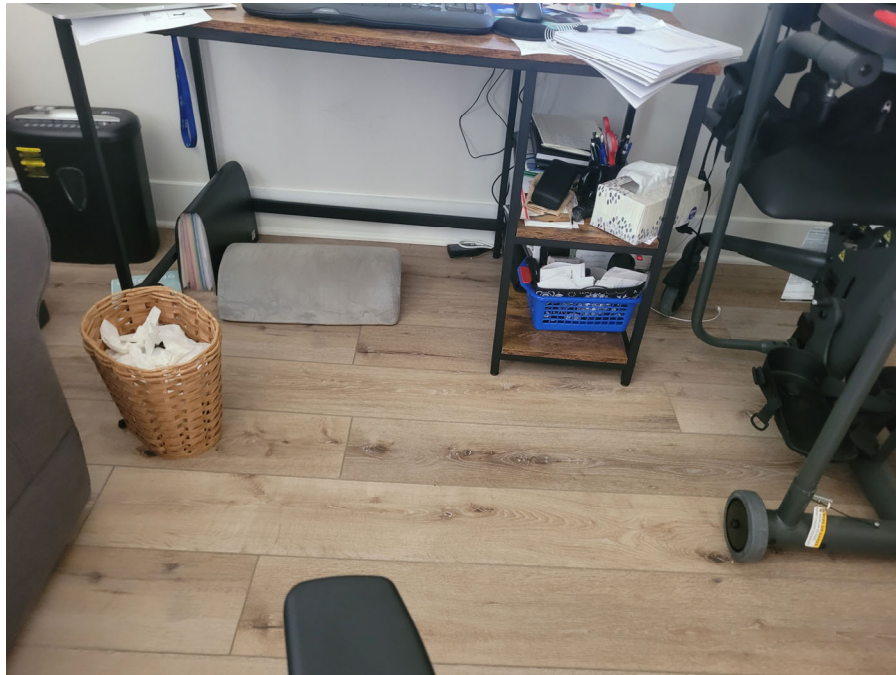
- Uneven floors were noted along the left wall of the office (*see picture 9 for example*).
  - Measurement by laser level indicated that the foundation wall at the back of the garage was down as much as approximately  $\frac{1}{4}$ " relative to the front of the home.

*Picture 9 – Example of uneven floors in the office*
