Reference: Engineering Services  
1614 McLamb Rd.  
Lillington, NC 27546  
TE&D Project No.: 2401-020923

- 1) Inspection of the framing for the accessory storage building.

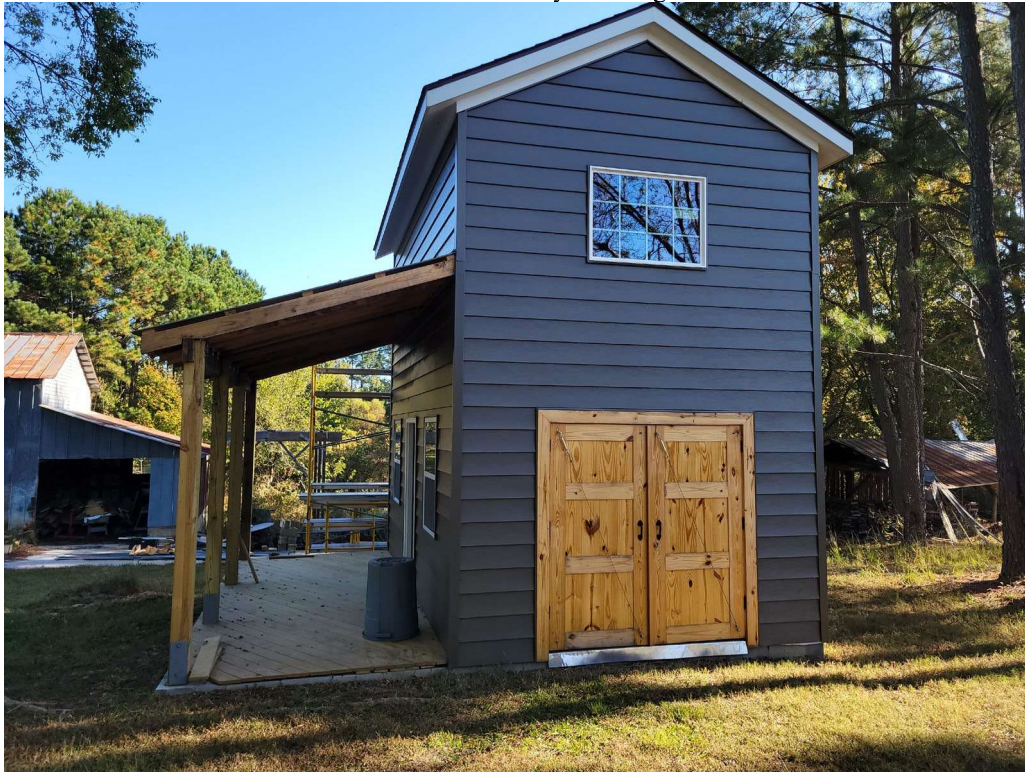
Front of Accessory Building:

- 1) We observed the accessory structure to be approximately 12' x 20' with an 8' x 20' porch. The following framing modifications/repairs are to be made:

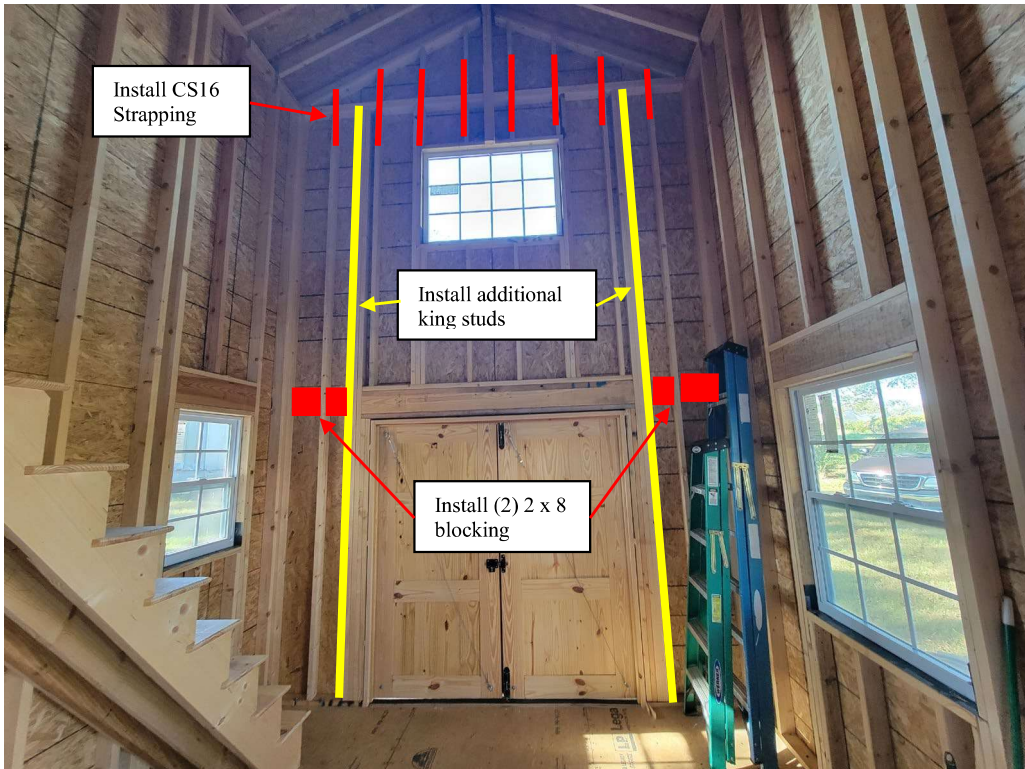
Item 1.A. Front wall reinforcement:

- A) We observed the front, right, and left stud walls of the accessory structure to extend 16' high where the walls are not broken by the second floor framing. Based on our observations and analysis, this configuration is inadequate to support the anticipated loading conditions, and the walls are to be reinforced as follows:

- The front wall is to be reinforced by installing an additional king stud at each end of the door header and new (2) 2 x 8 blocking is to be installed from the door header to the corners of the structure. Additionally, all studs are to be fastened to the gable end studs with 2' long CS16 strapping installed per the manufacturer's specifications.

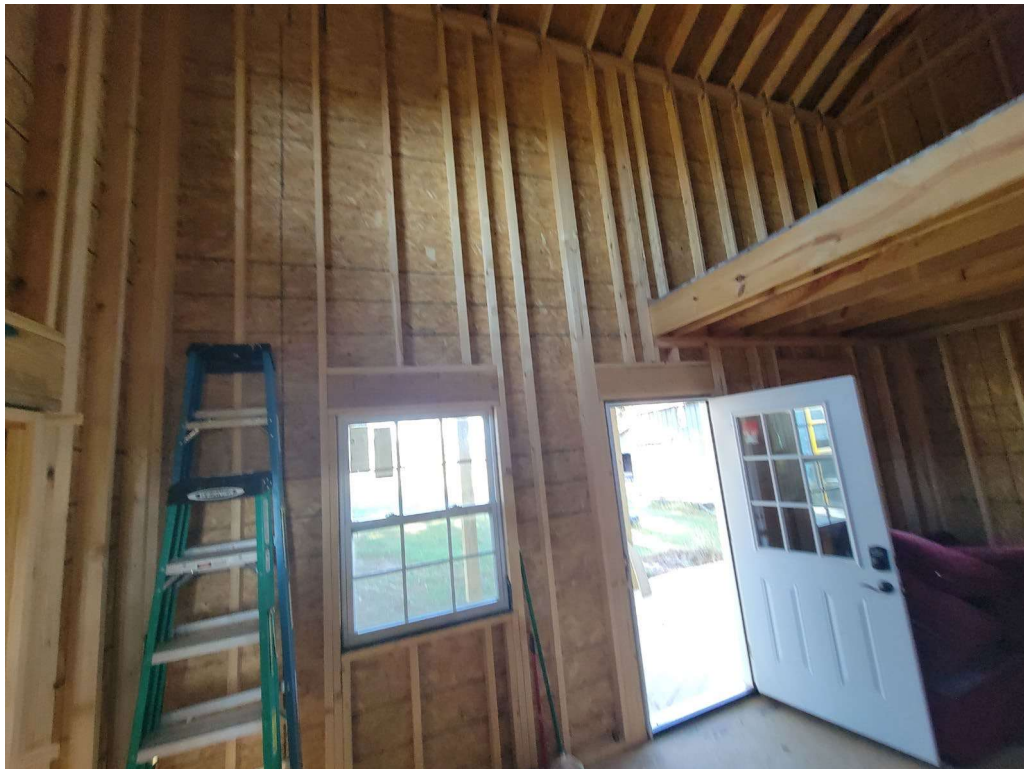
Item 1.A. Left Wall:

- The left wall is adequate as constructed as the wall is laterally braced by the shed roof over the front porch.
  - B) No header was installed over the 4'-0" wide front window. A new, minimum (2) 2 x 6 header is to be installed over the window with (2) 2 x 4 jacks and (1) 2 x 4 king stud at each end.

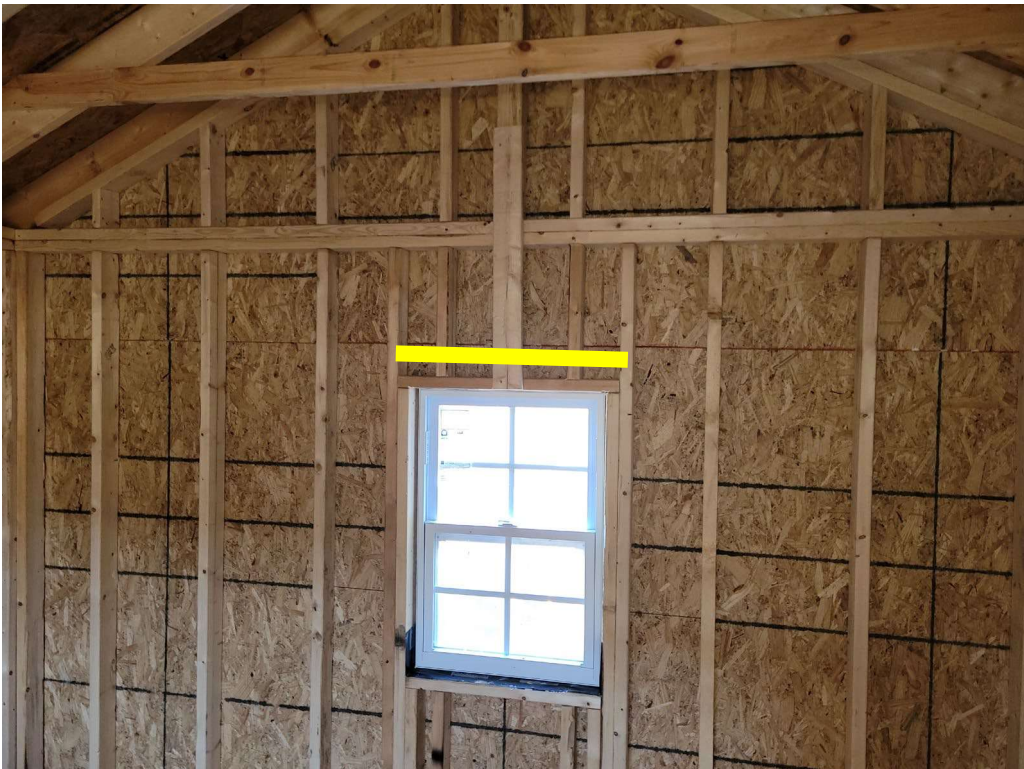
Item 1.C. New Header:

- C) No header was installed over the 2'-0" wide front window. A new, minimum (2) 2 x 6 header is to be installed over the window with (1) 2 x 4 jack and (1) 2 x 4 king stud at each end.

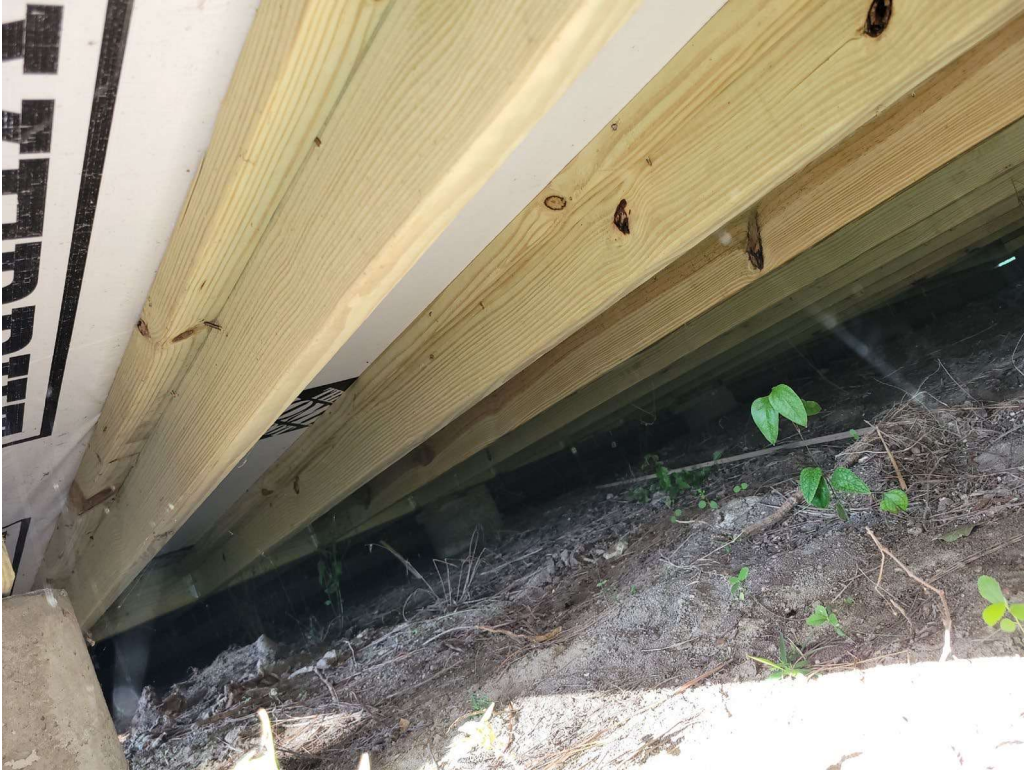
Item 1.D. Insulation Panels:

- D) We observed insulation panels installed below the first floor framing preventing visual confirmation of the first floor framing, however based on floor depth and girder location, we can assume the first floor was framed with 2 x 10 joists installed at 16" o.c. spanning a maximum of 11'-4". This configuration is adequate to support the anticipated loading conditions.
