June 14, 2023

Re: Visual Structural Inspection and Evaluation  
1040 Bethel Baptist Road  
Spring Lake, NC 28390  
Our Job #23-46

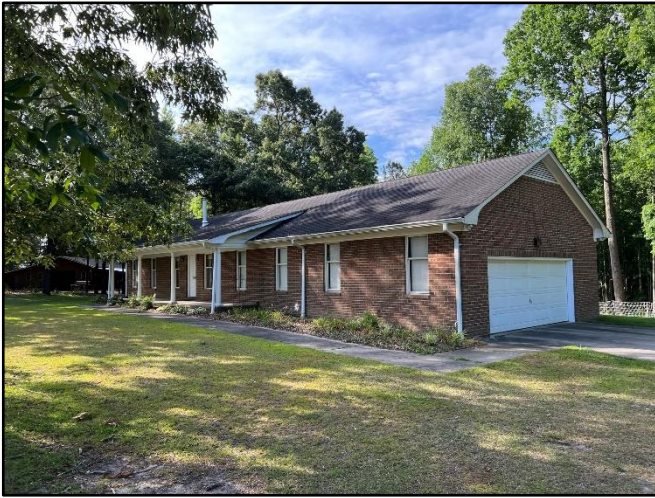
**Photo 1**  
*Front elevation.*

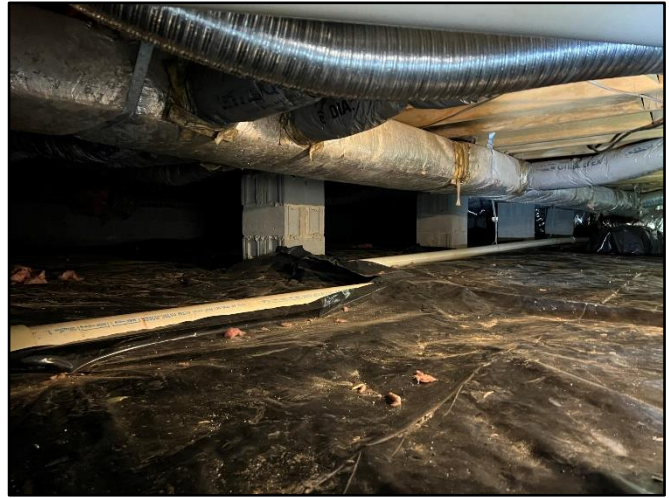
**Photo 2**  
*Existing vapor retarder and overall crawlspace.*

In regards to the observed biological growth, we recommend that permanent elements to divert surface and subterranean water, proper ventilation, and dehumidification be provided in the crawlspace. It is possible that a full or partial encapsulation system will be required. I am not a qualified professional in these fields and recommend that these items be evaluated and remedial repairs be designed by qualified water and biological growth mitigation professionals.

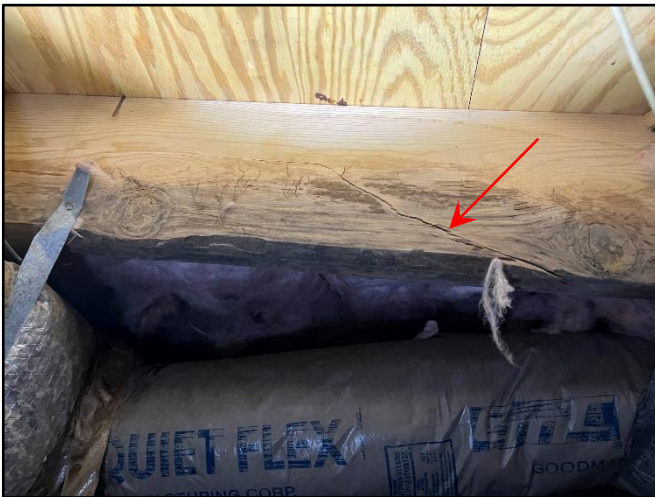
Deterioration from what appears to be long term exposure to elevated moisture was observed at some of the floor joists and girders in the crawlspace (photos 3-4, typical). The deterioration of wood elements was observed in several areas throughout the crawlspace, but primarily in the front center of the home. This location also coincided with what appears to be the least amount of ventilation in the crawlspace (behind the front porch). Some of the insulation in this area was draped, which is indicative of high humidity levels. We are not air quality or biological growth experts, but we observed growth on framing elements in several areas of the crawlspace. Long term exposure to excessive moisture can cause degradation to wood framing from mold/fungi growth and wood-destroying insects.

**Photo 3**  
*Deteriorated floor joist.*

We recommend that a contractor be hired to supplement the deteriorated portions of framing in the crawlspace by sistering the deteriorated joists. When on site, we marked approximately (14) joists that are visually deteriorated to the extent that we recommend sistering with a new No.2 Southern Yellow Pine full length sistered joist. We recommend that the new joists be fastened to the existing joists with (3) rows of 10d nails at 12" on-center. New joists should be full length, and replicate the bearing conditions of the existing joists. Prior to sistering the joists, the existing joists should be cleaned of biological growth, particularly at faying surfaces between the sistered and existing joists.

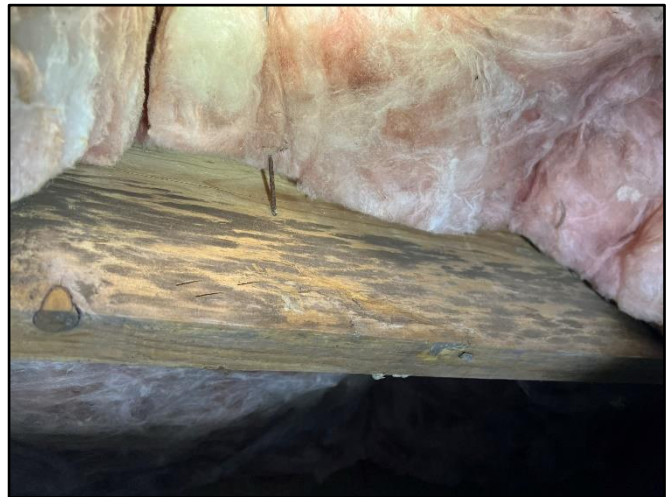
**Photo 4**  
*Deteriorated floor joist and biological growth.*
