W. Harrison Welch, PE  
Stonewall Structural Engineering, PLLC  
4800 Falls of Neuse Rd. #120  
Raleigh, NC 27609  
(919)407-8663

Re: Structural Observation — 103 Maplewood Drive, Sanford, NC 27332

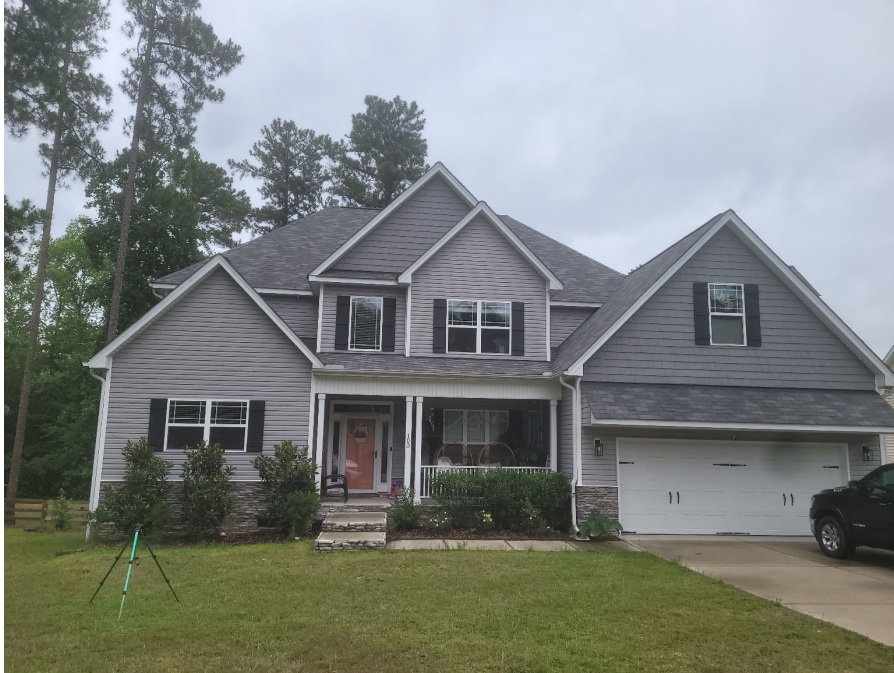
At your request, on June 21<sup>st</sup>, 2023 we performed a visual structural observation of a crack in the basement slab and a crack in the right foundation wall at the Sanford residence noted above. The structure is a conventionally framed, detached, single family residence with raised first floor framing over a partial walk-out basement and partial pier/girder foundation system with perimeter masonry foundation walls (*see picture 1*).

*Picture 1 – 103 Maplewood Drive  
Sanford, NC 27332*

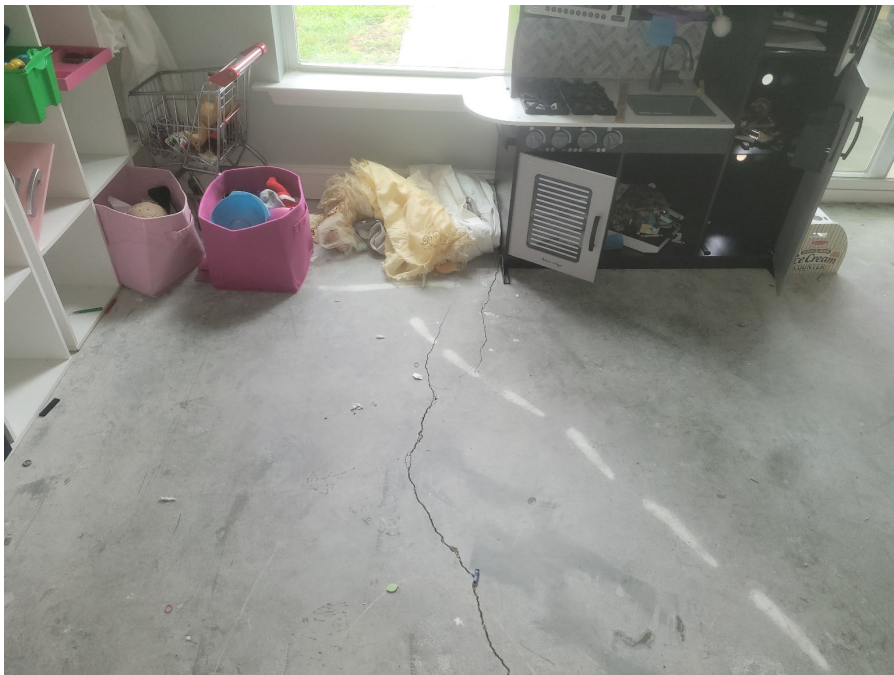
- A crack with front-to-back orientation was noted in the basement slab (*see picture 2*).
  - The slab was flush across the above-noted crack (*see picture 3 for example*).
  - The above-noted crack appeared to “feather” in various locations (*see picture 4 for example*).
  - Measurement by laser level indicated that the basement slab was level to within approximately  $\frac{1}{4}$ ”.

- The above-noted basement slab crack has been the result of normal shrinkage of the concrete. All concrete cracks as it shrinks during curing, and as it expands and contracts during seasonal temperature changes. Crack control joints are installed as intentionally weakened planes in slabs to direct cracking for cosmetic purposes. The minor, cyclical movements of slabs can cause cracking to occur outside of the control joints, and they are not considered to be structural concerns.

*Picture 2 – Basement slab crack*

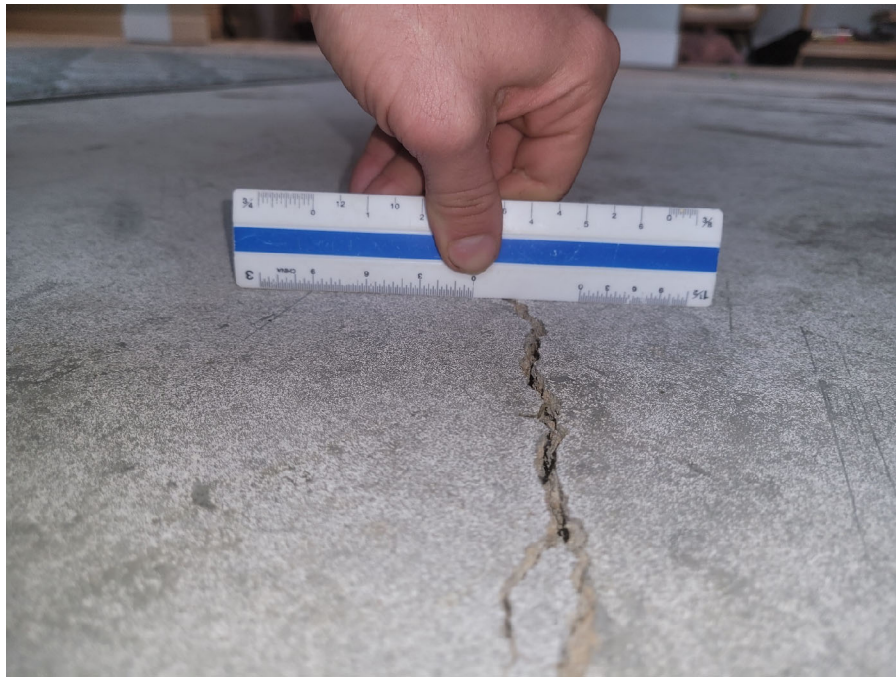
*Picture 3 – Example of basement slab flush across crack*

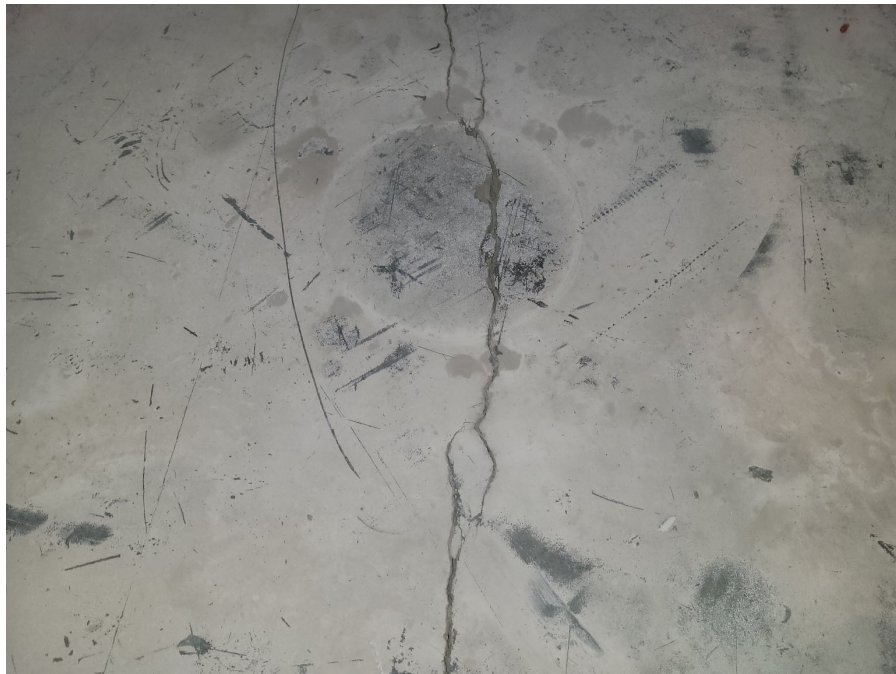
*Picture 4 – Example of basement slab crack “feathering”*

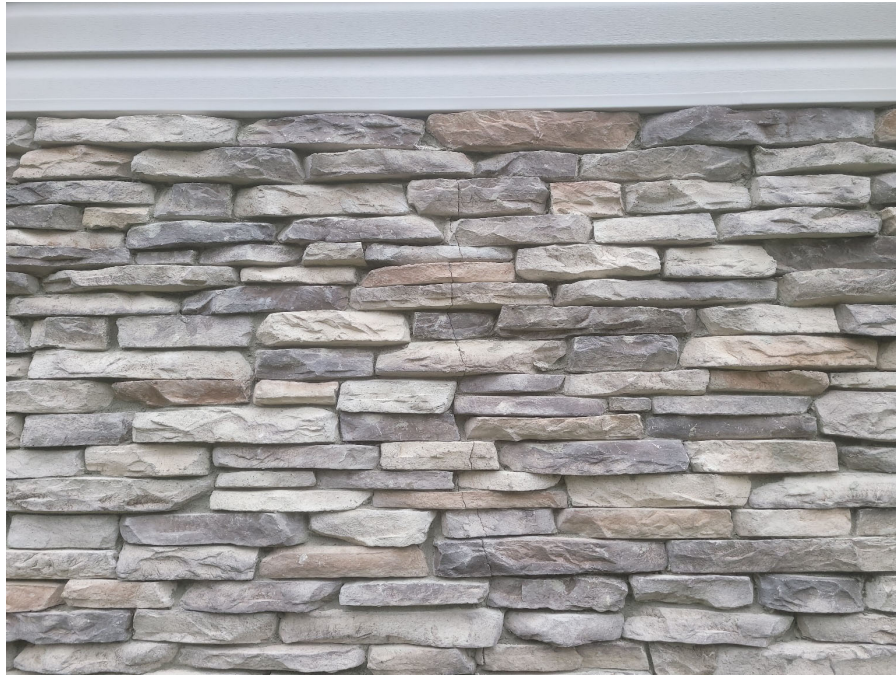
- A crack was noted in the stone veneer on the exterior face of the foundation wall along the right side of the home (*see picture 5*). The crack was located at the intersection of the basement and garage and the section of stone veneer in front of the crack was noted to be offset away from the garage (*see picture 6*).
  - Investigation from within the garage revealed a gap between the garage slab and the right foundation wall (*see picture 7*). Additionally, at the back-right corner of the garage the right foundation wall appeared to have shifted towards the exterior by approximately  $\frac{1}{2}$ ” (*see picture 8*).
  - Measurement by laser level indicated that the foundation wall along the right side of the home was level to within approximately  $\frac{1}{4}$ ”.

- The above-noted foundation wall crack has been the result of lateral movement of the foundation wall along the right side of the garage due to the loads applied to the wall by the retained fill material.

*Picture 5 – Crack in stone veneer*

- Remove an at least 4'-0" wide section of the existing slab along the right side of the garage and excavate to verify at least an 8" wide footing projection is present at the base of the foundation wall. If the existing footing projection is less than 8" wide, install an 18" wide x 8" thick footing extension along the length of the foundation wall. Install a new 8" wide CMU wythe or "header block" over the perimeter footing. The header block is to be fully mortared and anchored to the interior face of the foundation wall with stainless steel helical brick ties (Simpson Heli-Ties or similar product) installed at 32" o.c. horizontal and 8" o.c. vertical (stagger locations). Repour the removed portion of the slab using 4" thick concrete with welded wire fabric at mid-depth over at least 4" of compacted gravel fill.

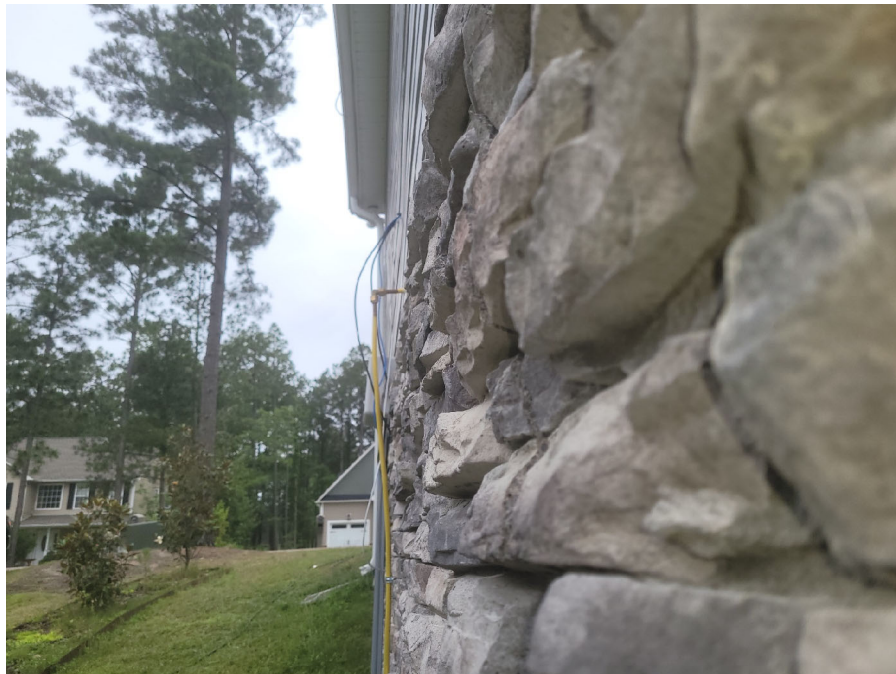
*Picture 6 – Stone veneer offset across crack*

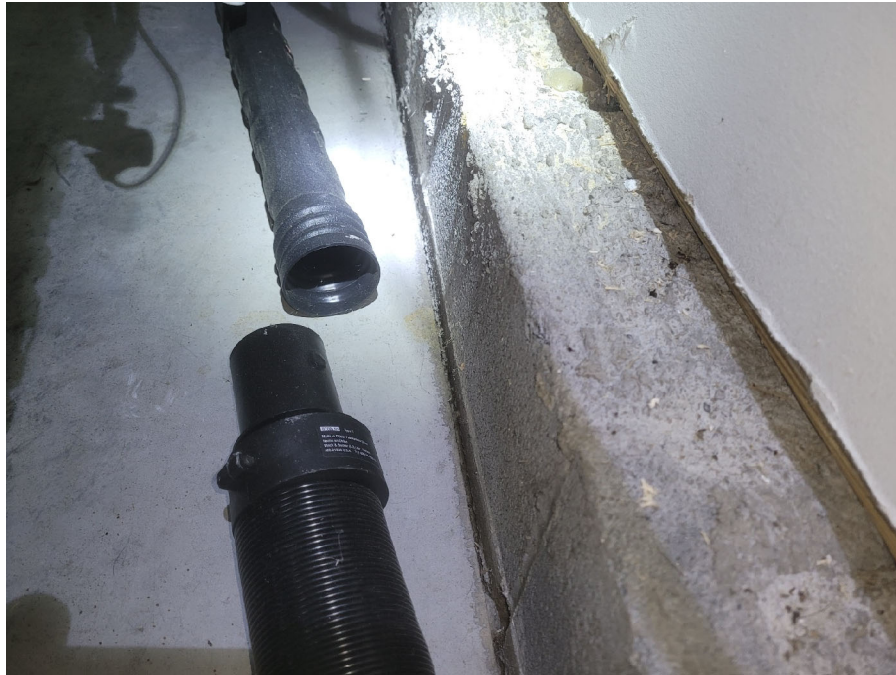
*Picture 7 – Gap between garage slab and foundation wall*

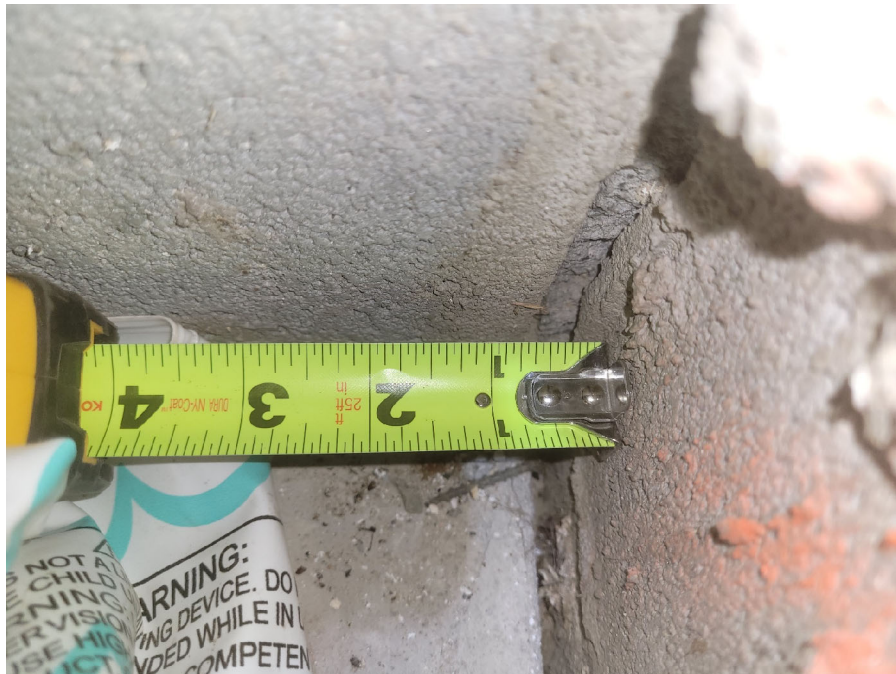
*Picture 8 – Visibly shifted foundation wall at corner of garage*
