RE: Structural reparability evaluation

Sparks Engineering, PLLC was asked to evaluate certain structural issues at 5071 Titan Roberts Road, Erwin, NC 28339. Inspection was conducted on 2/5/2024.

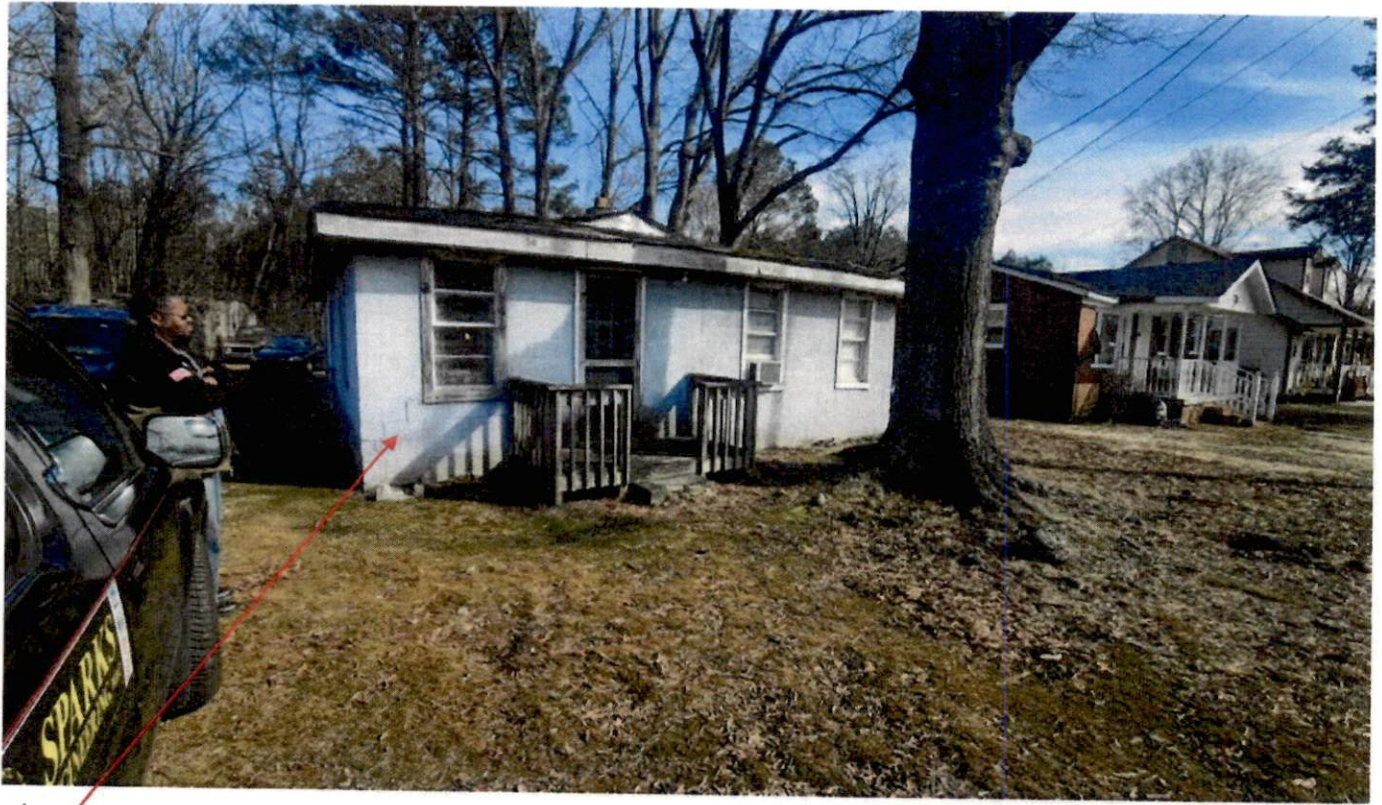
A

1. Photo **A** Crack in corner of CMU wall. Walls are plumb. Crack is repairable.
2. Photo **B** Crack in corner of CMU wall. Walls are plumb. Crack is repairable.
3. Photo **C** Roof and truss system needs to be completely removed and replaced.
4. Photo **D** Rear CMU wall is plumb.

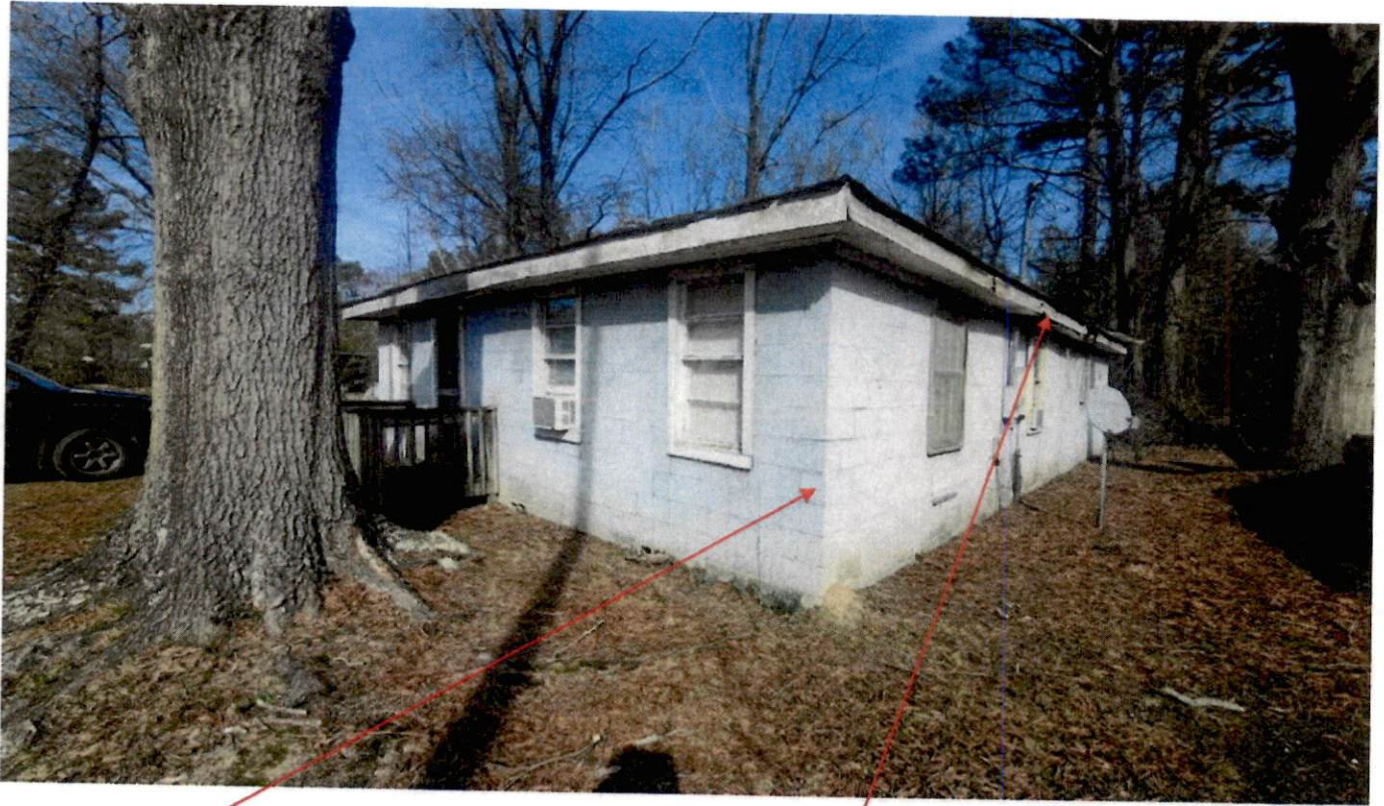
5. Photo E Roof and truss system needs to be completely removed and replaced.
6. Photo F Crack in corner of CMU wall. Walls are plumb. Crack is repairable.
7. Photo G Roof and truss system needs to be completely removed and replaced.

The CMU walls are plumb and the foundations supporting them do not show deflection. This is an home that is at the end of its life cycle. The roof system is close to failure. Home will have to be gutted and complete rebuilt. Although the cost will be substantial, I can recommend that his home be completely rebuilt to current codes.
