RE: Asbestos Inspection

148 Cemetery Lane, Lillington, North Carolina 27546

EI Project No: IHMO210289.00

ReBuild NC Batch ID: APP-07184 , INSP-0009354

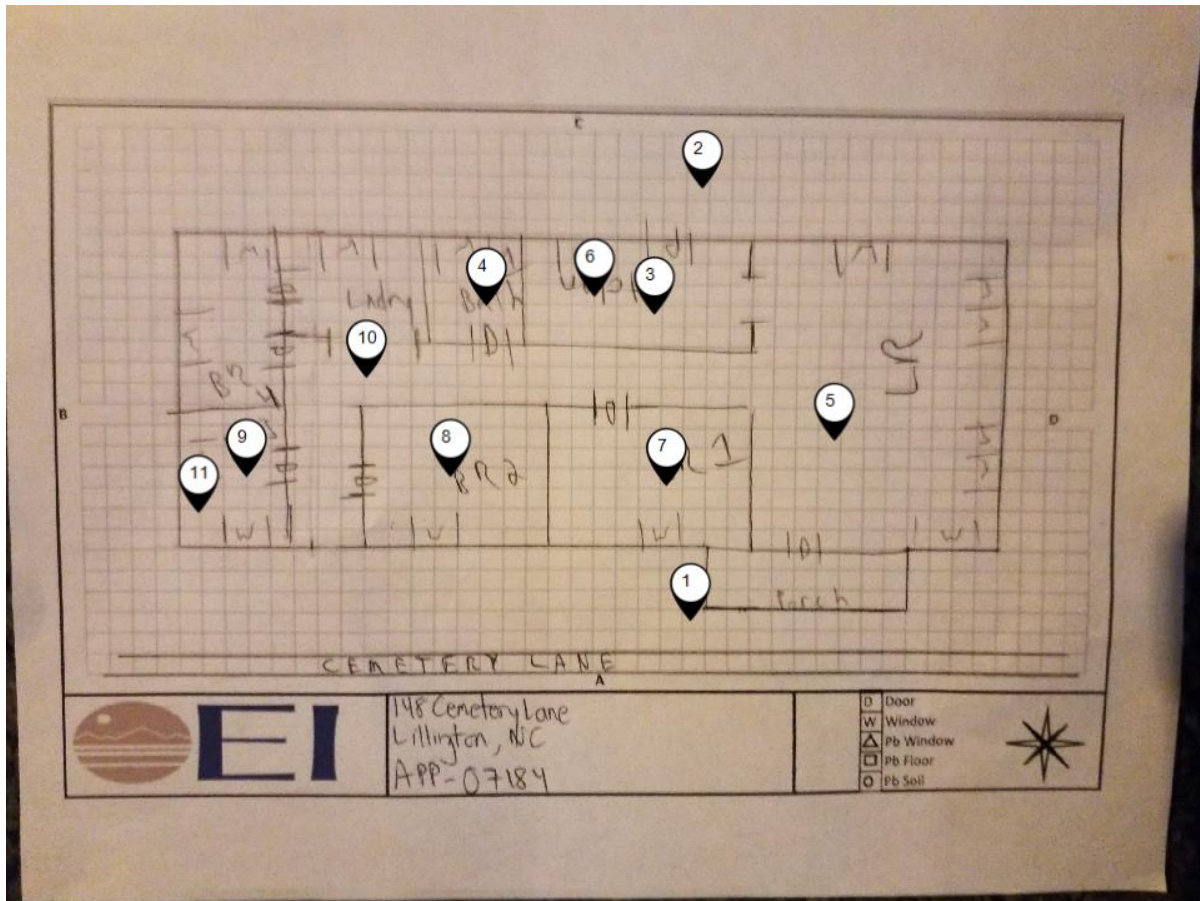
All Sample Locations for Main Floor

Map ID	Sample ID	Section Name	Space Name	Material	Lab Result	Analytical Result
1	001A	Main Floor	Side A	001 - Roofing, Composite Shingle	Tested Negative by Lab (No Asbestos Detected)	N/A
2	001B	Main Floor	Side C	001 - Roofing, Composite Shingle	Tested Negative by Lab (No Asbestos Detected)	N/A
3	002A	Main Floor	Kitchen	002 - Beige Floor, Sheet Vinyl Paper Backing	Greater Than 1% Asbestos by Lab (ACM)	40% Chrysotile (Serpentine group)
3 & 4	002A	Main Floor	Kitchen/Bathroom	002- Yellow Mastic	Greater Than 1% Asbestos by Lab (ACM)	3% Chrysotile (Serpentine group)

Map ID	Sample ID	Section Name	Space Name	Material	Lab Result	Analytical Result
4	002B	Main Floor	Bathroom	002 - Beige Floor, Sheet Vinyl Paper Backing	Assumed Positive (Not Tested by Lab)	N/A
5	003A	Main Floor	Living Room	003 - Gypsum Wallboard Surface Texture/Skim Coat	Greater Than 1% Asbestos by Lab (ACM)	3% Chrysotile (Serpentine group)
6	003B	Main Floor	Kitchen	003 - Gypsum Wallboard Surface Texture/Skim Coat	Assumed Positive (Not Tested by Lab)	N/A
7	003C	Main Floor	Bedroom 1	003 - Gypsum Wallboard Surface Texture/Skim Coat	Assumed Positive (Not Tested by Lab)	N/A
8	003D	Main Floor	Bedroom 2	003 - Gypsum Wallboard Surface Texture/Skim Coat	Assumed Positive (Not Tested by Lab)	N/A
9	003E	Main Floor	Bedroom 3	003 - Gypsum Wallboard Surface Texture/Skim Coat	Assumed Positive (Not Tested by Lab)	N/A
10	004A	Main Floor	Hallway	004 - Gypsum Wallboard System (Wallboard, Joint Tape, and Joint Compound)	Less Than or Equal to 1% Asbestos by Lab (Trace)	N/A

11	004B	Main Floor	Bedroom 3	004 - Gypsum Wallboard System (Wallboard, Joint Tape, and Joint Compound)	Less Than or Equal to 1% Asbestos by Lab (Trace)	N/A

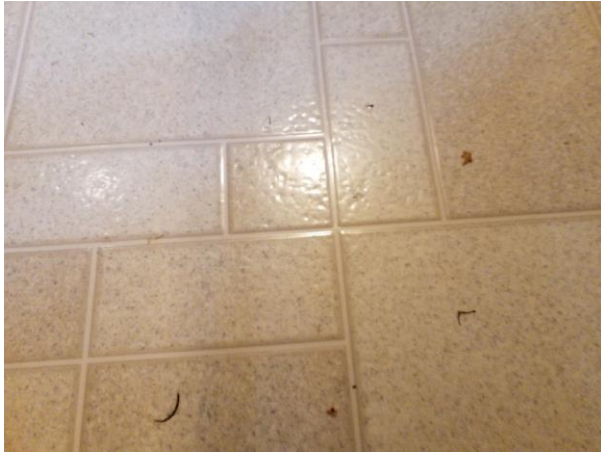
Material	Floor/Section	Location	Asbestos Amount	Condition	Approximate Quantity
002 - Beige Floor, Sheet Vinyl Paper Backing & Associated Yellow Mastic	Main Floor	Bathroom & Kitchen	40% & 3 % Chrysotile (Serpentine group)	Good	100 sq. ft.
White Ceiling Texture	Main Floor	Throughout	3% Chrysotile (Serpentine group)	Good	1150 sq. ft.

002A, 002 - Beige Floor, Sheet Vinyl Paper Backing, Kitchen, Main Floor

If the above identified materials containing >1 % asbestos are to be disturbed the owner must then adhere to all local, state and federal regulations regarding the removal and disposal of asbestos-containing materials (National Emission Standards for Hazardous Air Pollutants, Section 40 CFR Part 61.150). Any additional suspect materials identified outside of this survey should be presumed positive for ACM until further testing is completed.

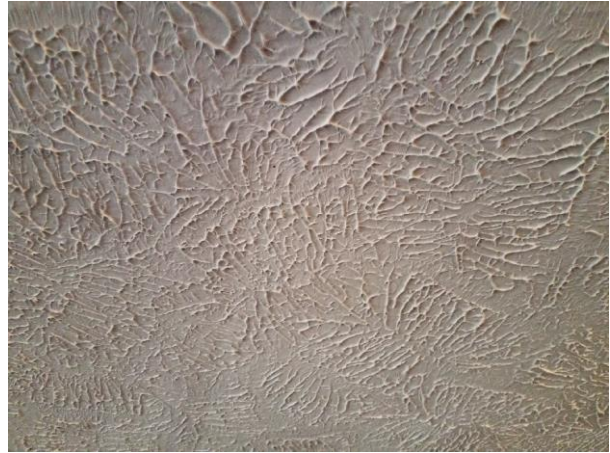
003A, 003 - Gypsum Wallboard Surface Texture/Skim Coat, Living Room, Main Floor

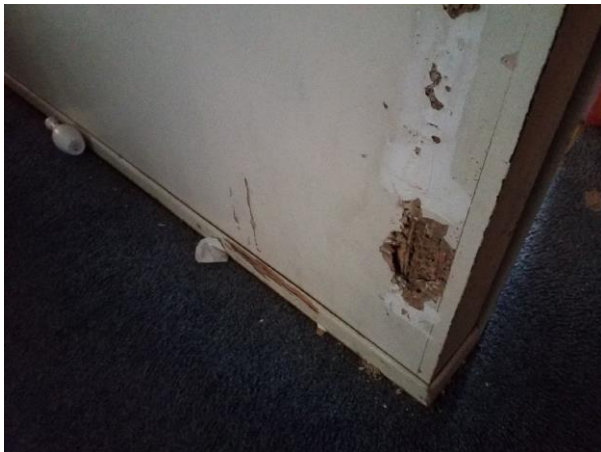
004A, 004 - Gypsum Wallboard System (Wallboard, Joint Tape, and Joint Compound), Hallway, Main Floor

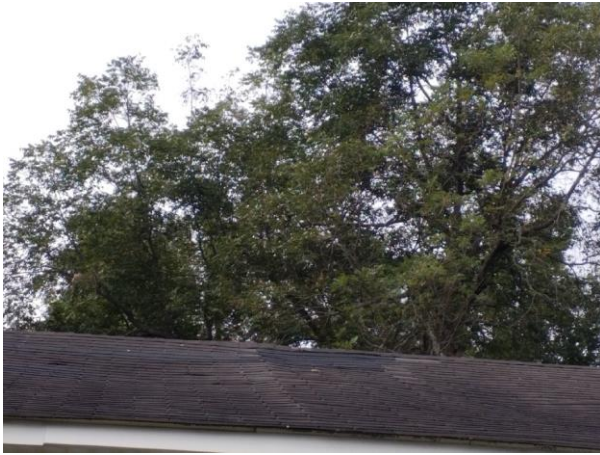
001A, 001 - Roofing, Composite Shingle, Side A, Main Floor
