Jeffrey J. Moss, P.E.
Senior Structural Engineer

Re: Structural Investigation
Project #23148

I made a site inspection of the house located at the above referenced address. The house is a single-family house with a wood-framed superstructure over a crawl space foundation system.

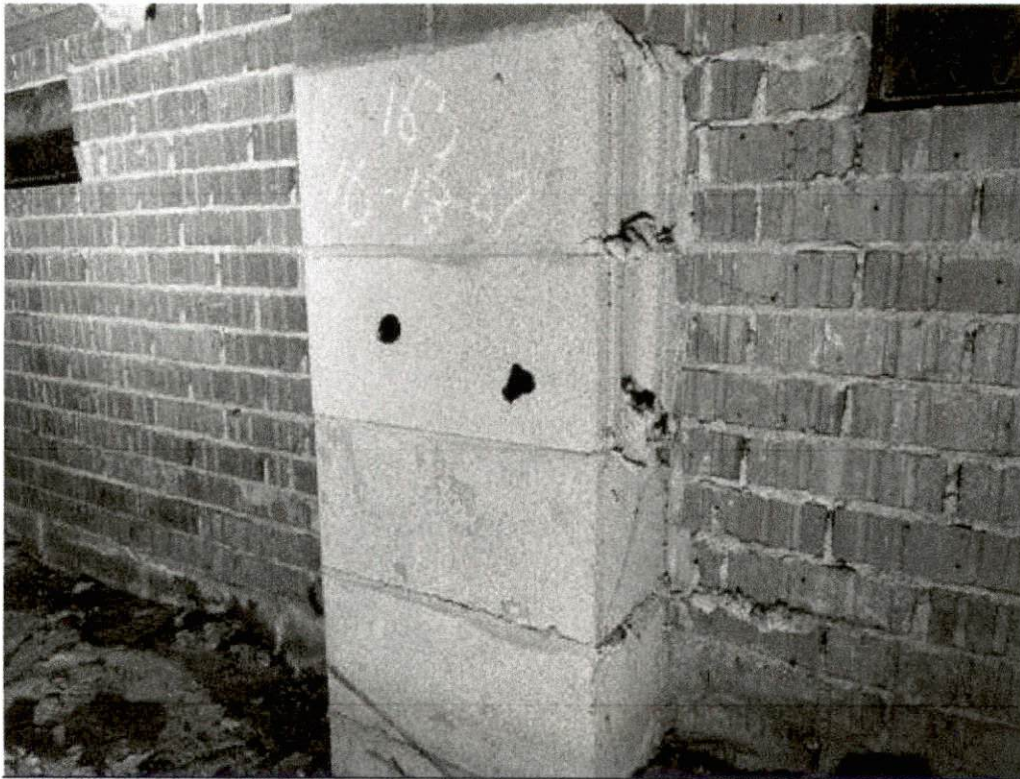
PHOTO 1

- There were holes in the block piers at the perimeter of the crawl space (photos 1 & 2).
- The girder at the rear has two areas of termite damage (photos 3 to 6).
- The area under the tub has wood rot damage in the floor sheathing and floor joists (photo 7).
- New floor joists were "sistered" to each side of the existing floor joists in this area (photos 8 & 9).
- The floor sheathing wasn't repaired.
- There was blocking added between the floor joists. At least one of the blocking pieces was framed into an existing floor joist with wood rot.
- There were some darkened water stains at the laundry (photo 10). These stains are not a structural issue.

The holes in the block piers are minor and not a structural issue at this time.
