Re: Limited Structural Inspection  
93 Marian Lane  
Spring Lake, NC

At your request, a limited structural inspection of the above property was performed on December 12, 2022. The report that follows has been prepared based on that inspection. The inspection was performed by Tyler Royster, EI of Giles Flythe Engineers.

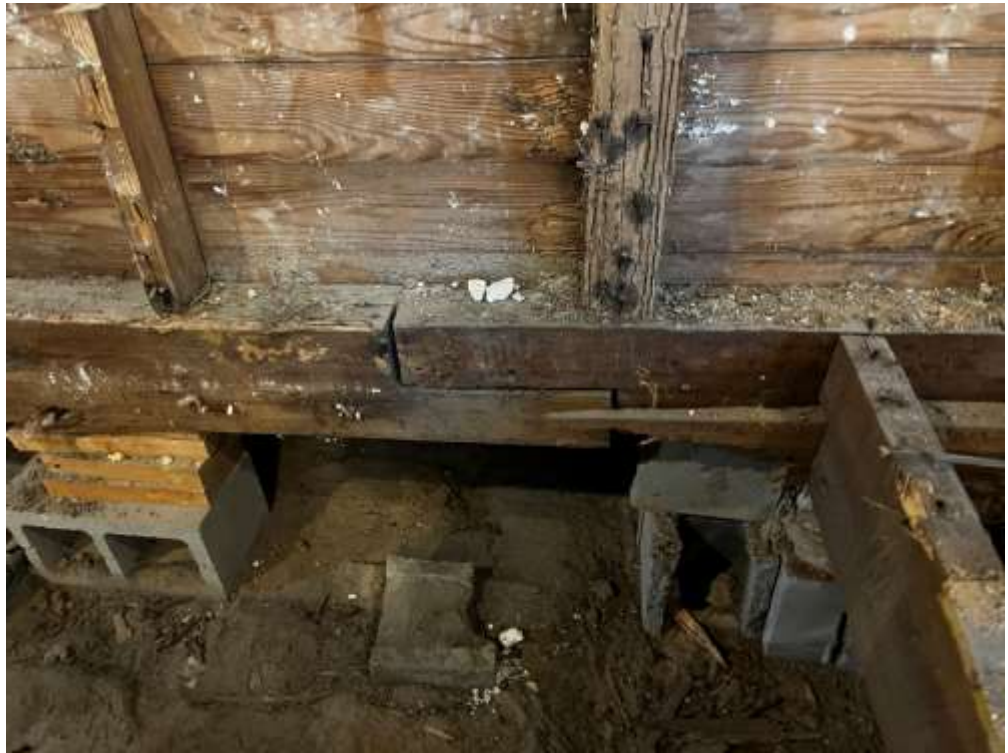
**Photo No.**  
**7**

A view of the unsupported perimeter band splice

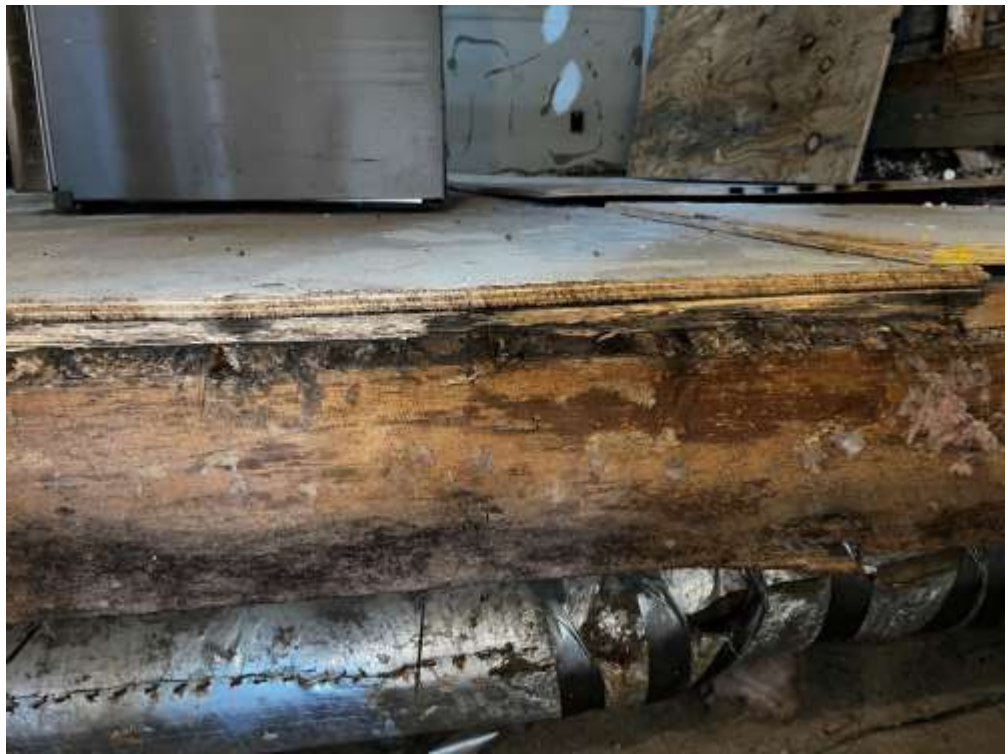
**Photo No.**  
**8**

- e. Multiple sections of subflooring throughout the crawl space was noted to exhibit significant wood-destroying insect damage. The homeowner stated that the subfloor would be removed and replaced in its entirety.

A typical view of wood-destroying insect damage in the subfloor of the home

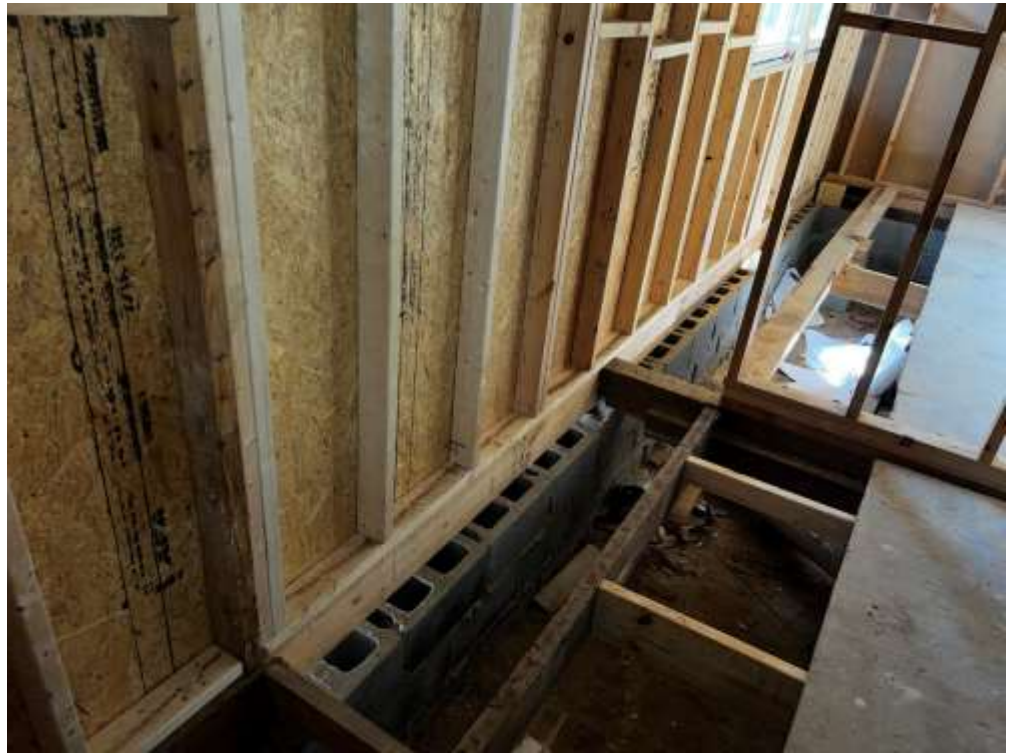
**Photo No.**  
**9**

A typical view of repairs made to the wall framing and the condition of the perimeter foundation wall

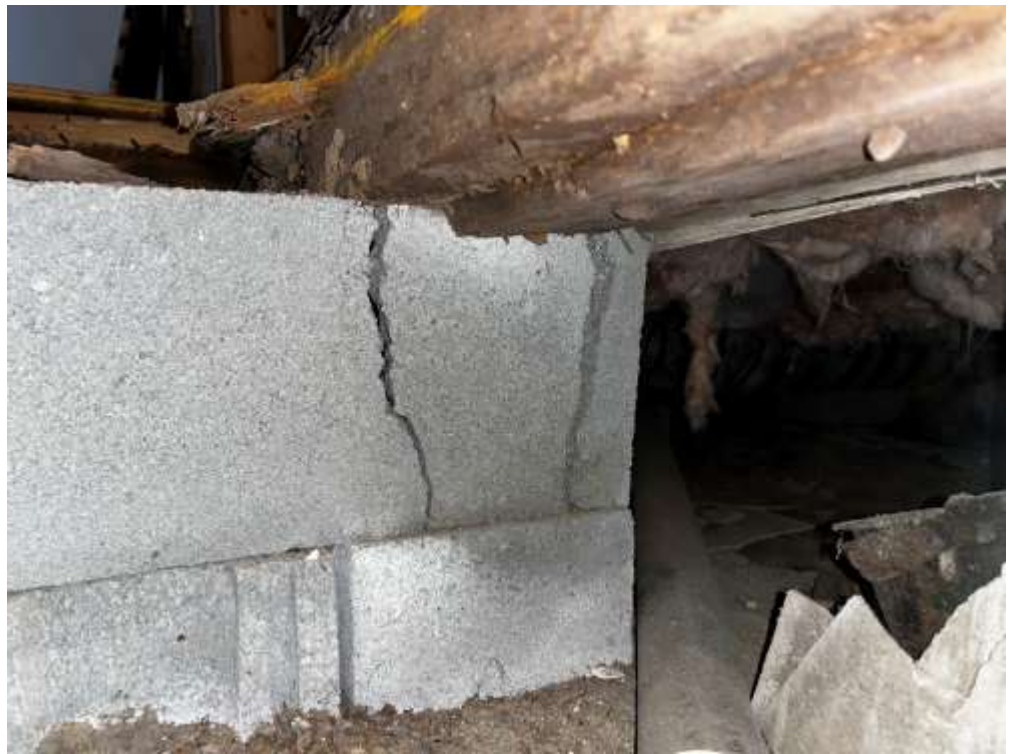
**Photo No.**  
**10**

- c. Multiple CMU piers were noted to be improperly installed and were noted to be cracked at the center of the crawl space. The presence of concrete footings beneath the CMU piers could not be determined at the time of the inspection.

A typical view of damaged CMU piers in the crawl space

3. We recommend replacing the existing central girders in both crawl spaces to properly support the floor framing. Each new girder shall consist of a 4-2x8 member and shall span continuously between supports and be supported by new 8x16 CMU piers spaced at a maximum of 5'-6" apart. The new CMU piers shall bear directly on new 20"x20"x8"-thick concrete footings (unless otherwise noted). Provide 2x pressure-treated blocking between the floor girder and new piers. (See attached sketch)

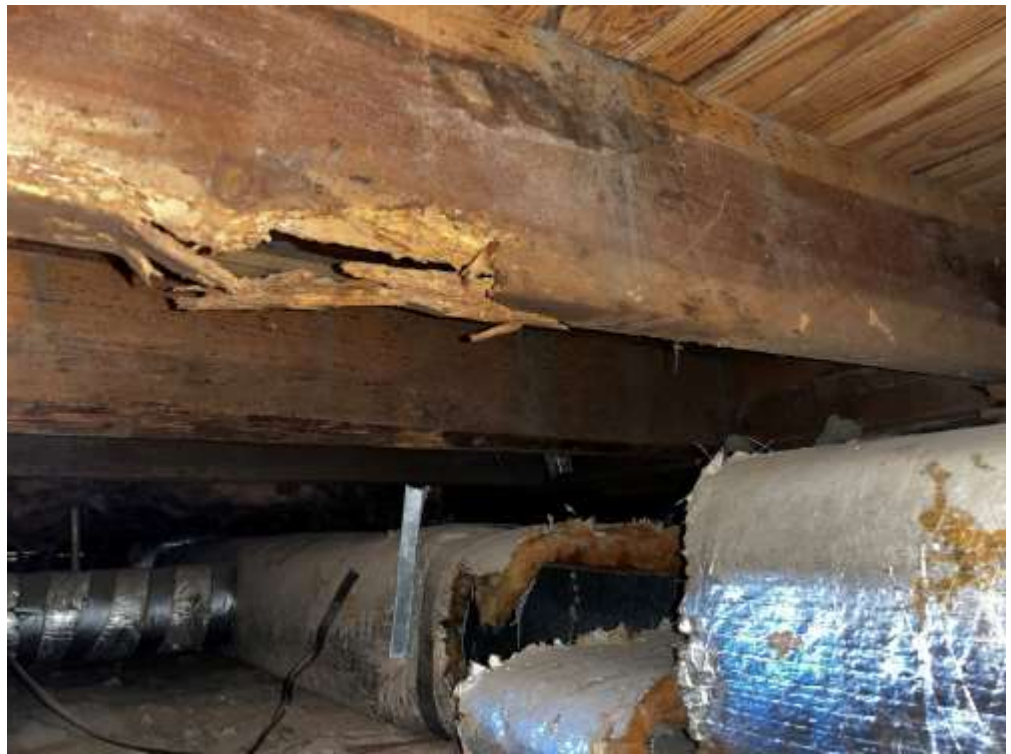
**Photo No.**  
**12**

- a. At the rear of the home, multiple floor joists were noted to exhibit significant wood-destroying insect deterioration. The joists were probed with an awl and exhibited up to 3” of cross-sectional losses at the time of the inspection.

A typical view of wood-destroying insect damage in the floor joists of the crawl space

4. We recommend replacing all damaged floor joists with new 2-2x8 floor joists attached at both ends with new Simpson LUS28-2 joist hangers. The floor joists should be spaced at a maximum of 16" on-center. We recommend fully sistering the remaining floor joists with a new 2x8 member attached with (3) 10d nails at 16" on-center. The newly sistered joists should be attached at both ends with Simpson LUS28-2 hangers.
