Re: Wall Removal Letter
93 Marian Lane
Spring Lake, NC

Re: Limited Structural Inspection
93 Marian Lane
Spring Lake, NC

At your request, a limited structural inspection of the above property was performed on December 12, 2022. The report that follows has been prepared based on that inspection. The inspection was performed by Tyler Royster, EI of Giles Flythe Engineers.

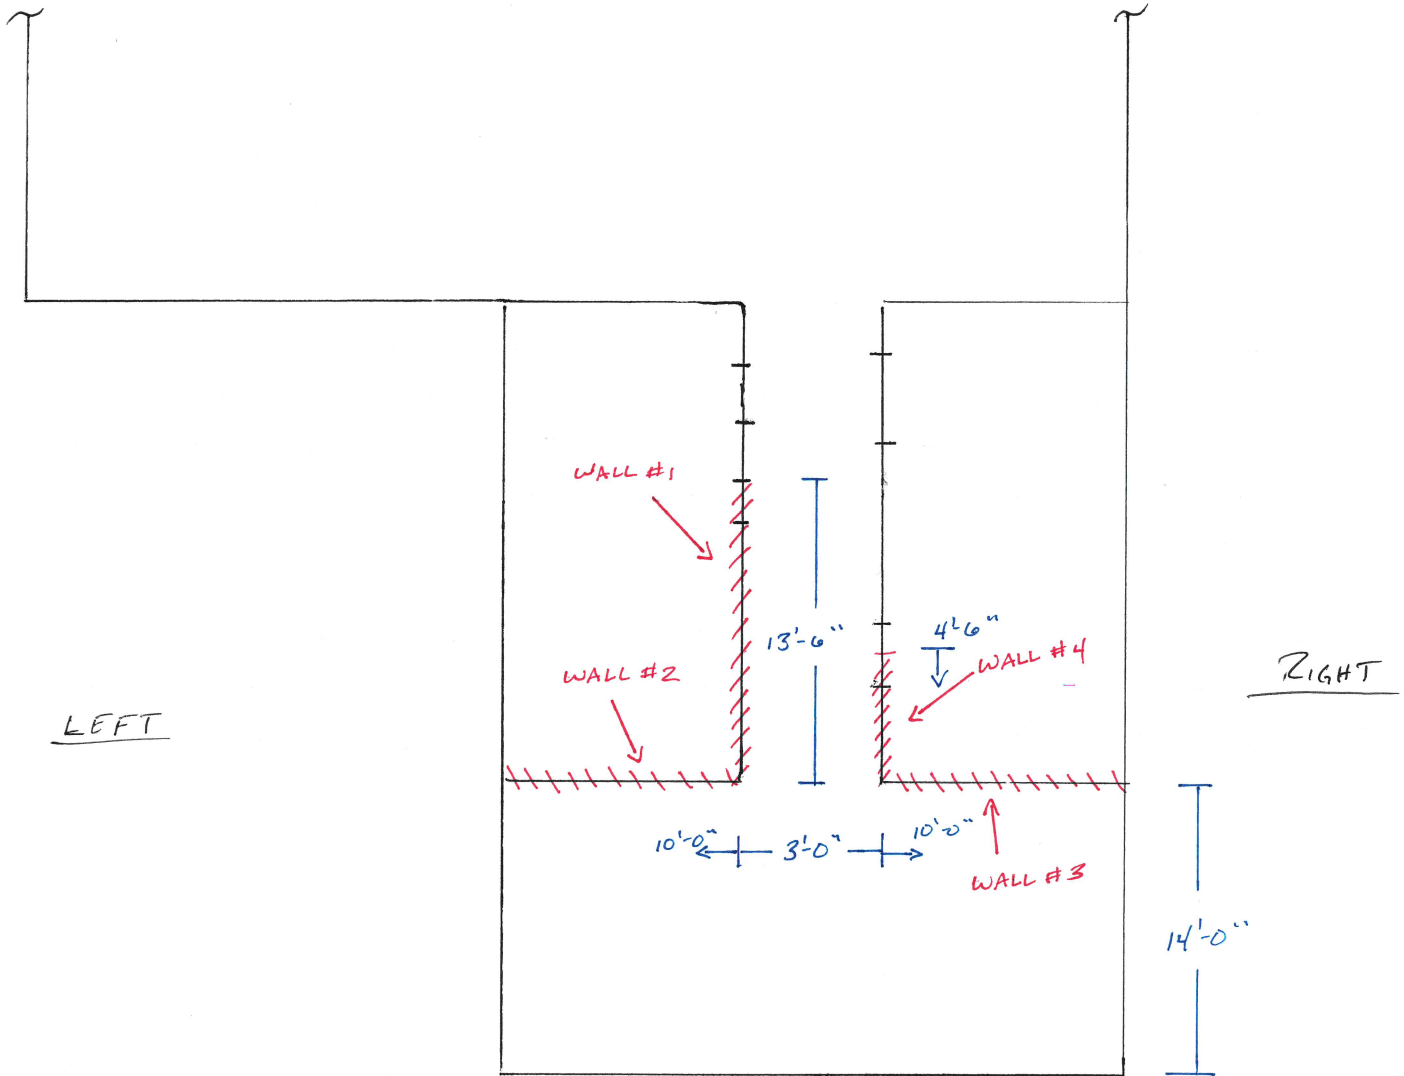
WALL REMOVAL LOCATION SKETCH

Wall #1 – This section of wall spanning front to rear is located near the front of the home approximately 10'-0" from the left perimeter wall. The section of wall to be removed begins approximately 27'-6" from the front perimeter wall of the home and extends to the front approximately 13'-6".

Wall #2 – This section of wall spanning left to right is located near the front of the home approximately 14'-0" from the front perimeter wall of the home. The section of wall to be removed begins at the left perimeter wall and extends to the right approximately 10'-0".

Wall #3 – This section of wall spanning left to right is located near the front of the home approximately 14'-0" from the front perimeter wall of the home. The section of wall to be removed begins at the right perimeter wall and extends to the left approximately 10'-0".

Wall #4 – This section of wall spanning front to rear is located near the front of the home approximately 10'-0" from the right perimeter wall. The section of wall to be removed begins approximately 13'-6" from the front perimeter wall of the home and extends to the rear approximately 4'-6".

- Based on the observed site conditions, it appears that a portion of the wall (colinear with Wall #4) was previously removed. The ceiling joists in the attic overlap above the wall that makes up Wall #4 and were noted to be unsupported at the front 14'-0" of the home. We have included these unsupported ceiling joists in our calculations and have specified the appropriate attachment.

- These walls are not load-bearing and may be removed.

- We recommend installing a 2-1.75"14" LVL beam spanning a maximum of 19'-0" between the load-bearing points. The new beam should be supported by 3-2x4 jack studs at each of the load-bearing points.

- To install the new LVL beam as a flush beam, temporary walls should be installed directly beneath both sides of the existing ceiling joists (not greater than 18" from the existing Wall #4) and the ceiling joists should be cut back to allow the installation of the new member with the bottom of the new LVL beam installed flush with the bottom of the existing ceiling joists. The existing ceiling joists should be attached to the new LVL beam with new Simpson LUS26 hangers (or equivalent). New CS16 straps that extend a minimum of 1'-4" in each direction should be installed along the bottom edge of the discontinuous ceiling joists.

- A new 16x16 grouted CMU block pier should be installed below the jack studs at the rear bearing point. The new pier is to be supported by a new 30"x30"x10"-thick concrete footing at the rear bearing location. Note, 2x blocking is to be installed between the jack studs and masonry piers within the floor cavities. Note, the contractor shall verify the presence of a minimum 12" wide continuous concrete footing below the front foundation wall. If the concrete footing is not present or inadequate, we recommend installing a new 24"x24"x10"-thick concrete footing below existing foundation wall at the front bearing location.

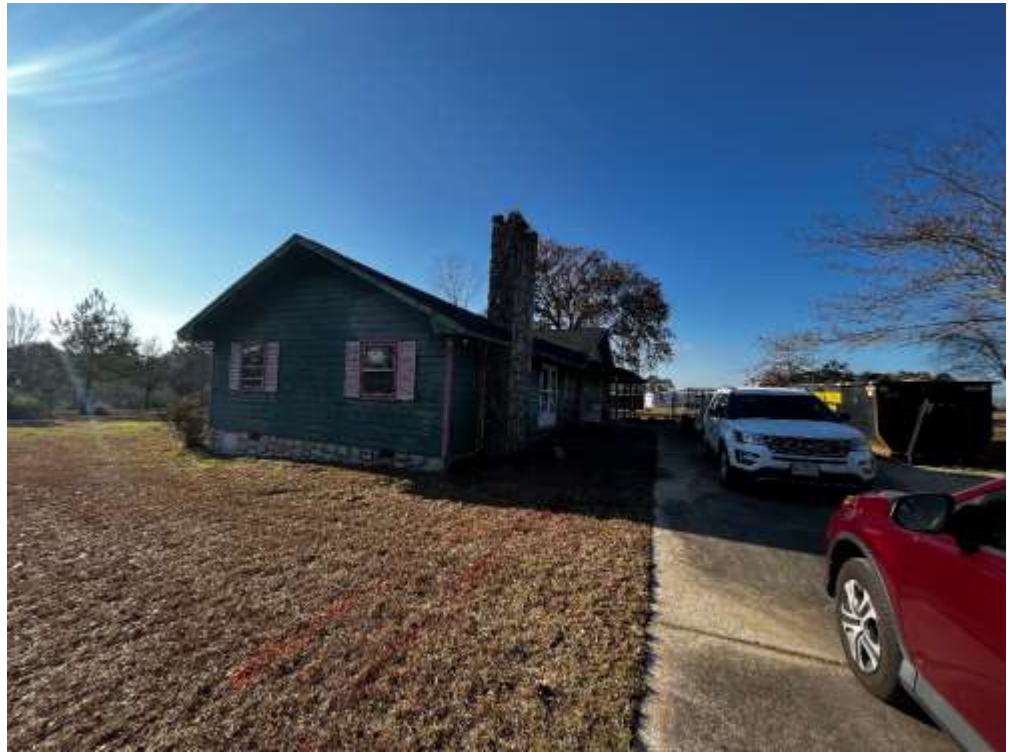
Photo No.
1

A view of the front right corner of the home

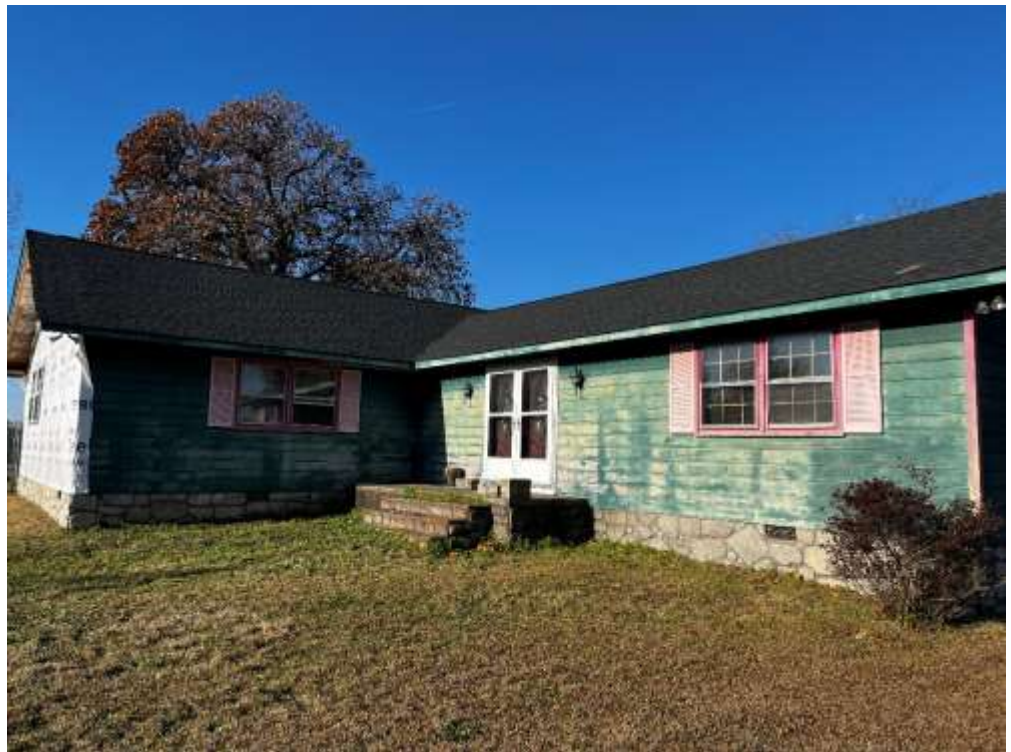
Photo No.
2

A view of the front left corner of the home

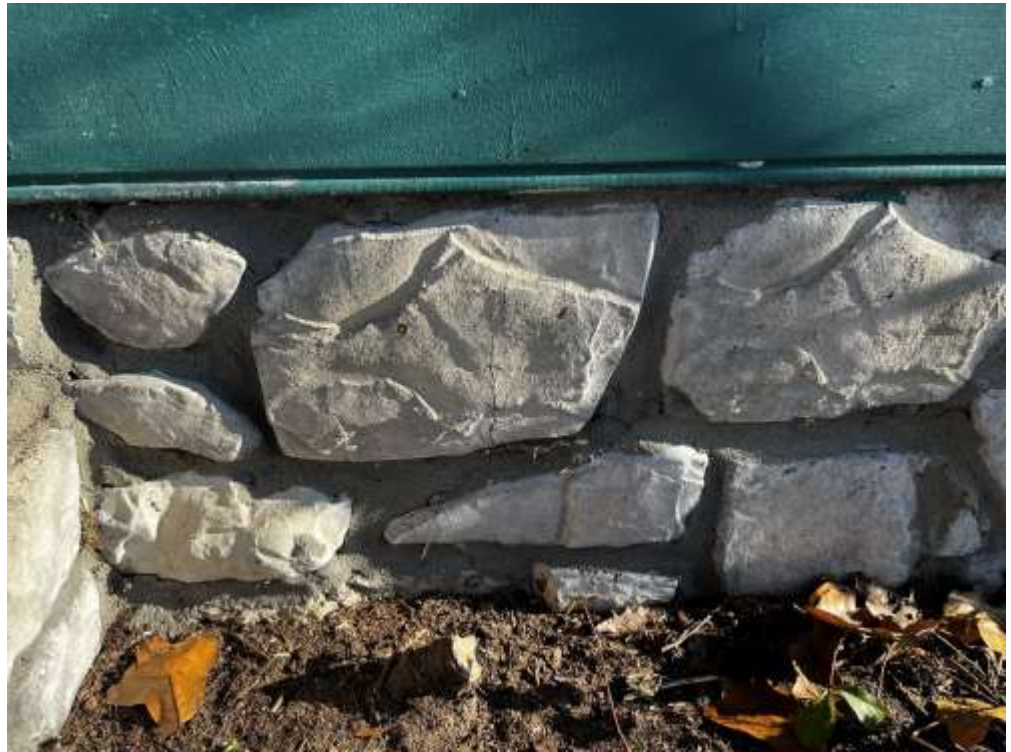
Photo No.
3

4. The foundation walls were noted to be covered by stone veneer at the exterior perimeter of the home. The CMU foundation walls were not visible from the exterior. No significant cracks were noted in the stone veneer at the time of the inspection.
5. Multiple instances of water damage were noted in the siding at the exterior perimeter of the home. The condition of the wall framing could not be determined due to the presence of the siding material at the time of the inspection.
6. Gutters and downspouts were installed on portions of the home. Grade was noted with a relatively neutral slope along the perimeter wall(s) of the home.

A typical view of the stone veneer at the exterior perimeter of the home

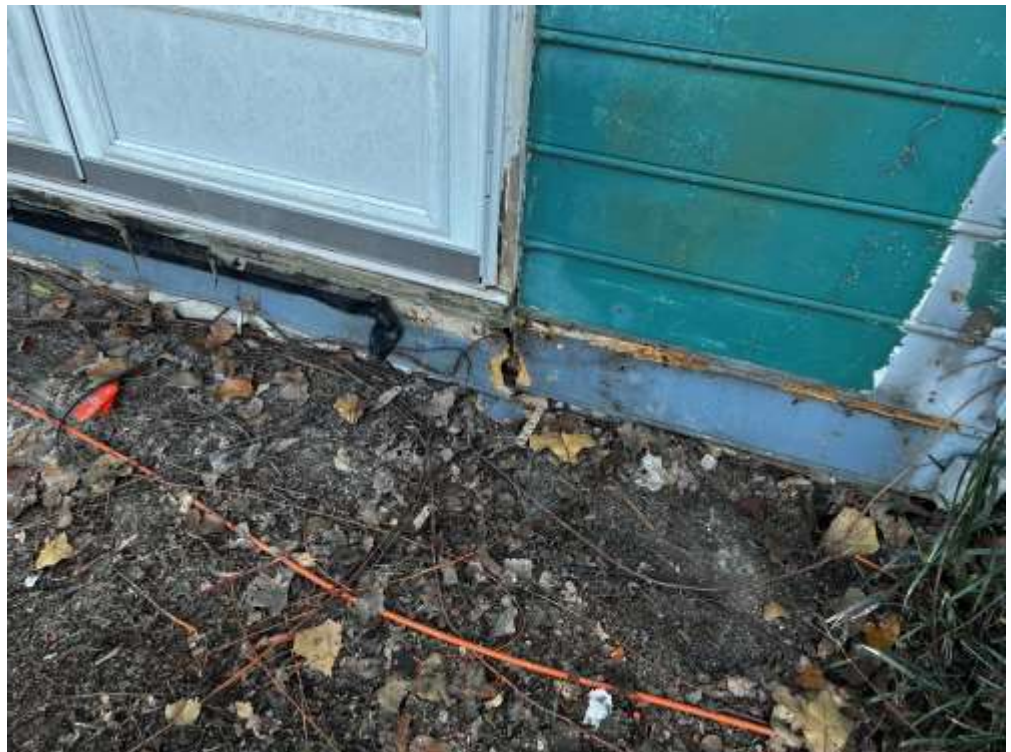
Photo No.
4

A view of visible moisture damage in the exterior siding

- ii. Within the central 1/3 span (approximately 4-feet long at the center span).
2. We recommend removing the bottom 2-3' of siding at the exterior of the home and evaluating the existing perimeter band/girder for moisture/wood-destroying insect damage. If the perimeter band exhibits greater than 1/2" of cross-sectional losses, we recommend replacing the damaged portions with a new 2-2x8 member. The floor joists should be attached to the new perimeter band with Simpson LUS28-2 hangers.

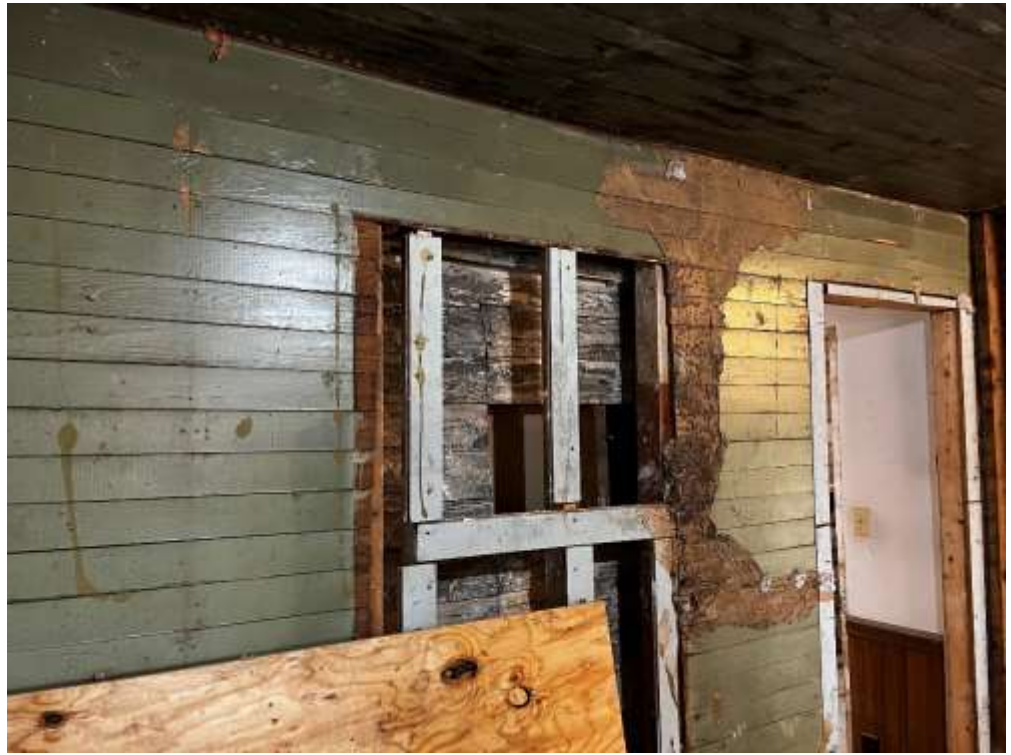
Photo No.
5

A typical view of wood-destroying insect damage at the interior of the home

1. We recommend removing the existing subfloor and wall finish material throughout the home to determine the extent of the moisture/wood-destroying insect damage in the floor framing. Wall studs that exhibit cross-sectional losses of 1/2" or greater should be replaced in like kind and be continuous from the bottom sill plate to the wall top plate. Joists that require repairs shall be determined as follows:

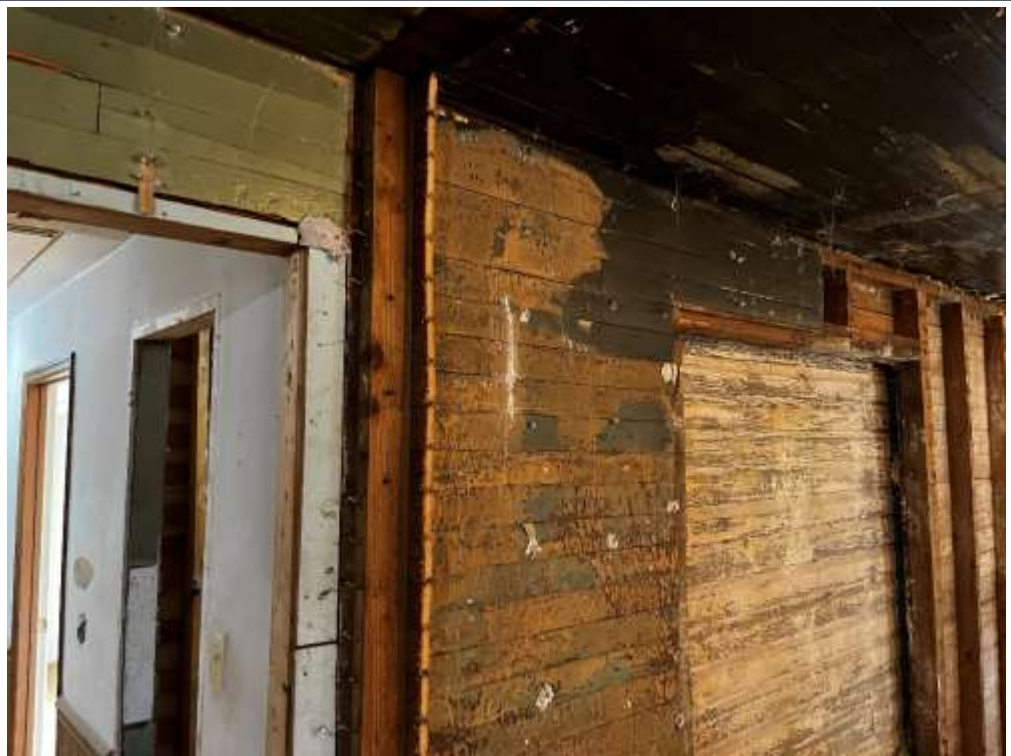
Photo No.
6

A typical view of wood-destroying insect damage at the interior of the home

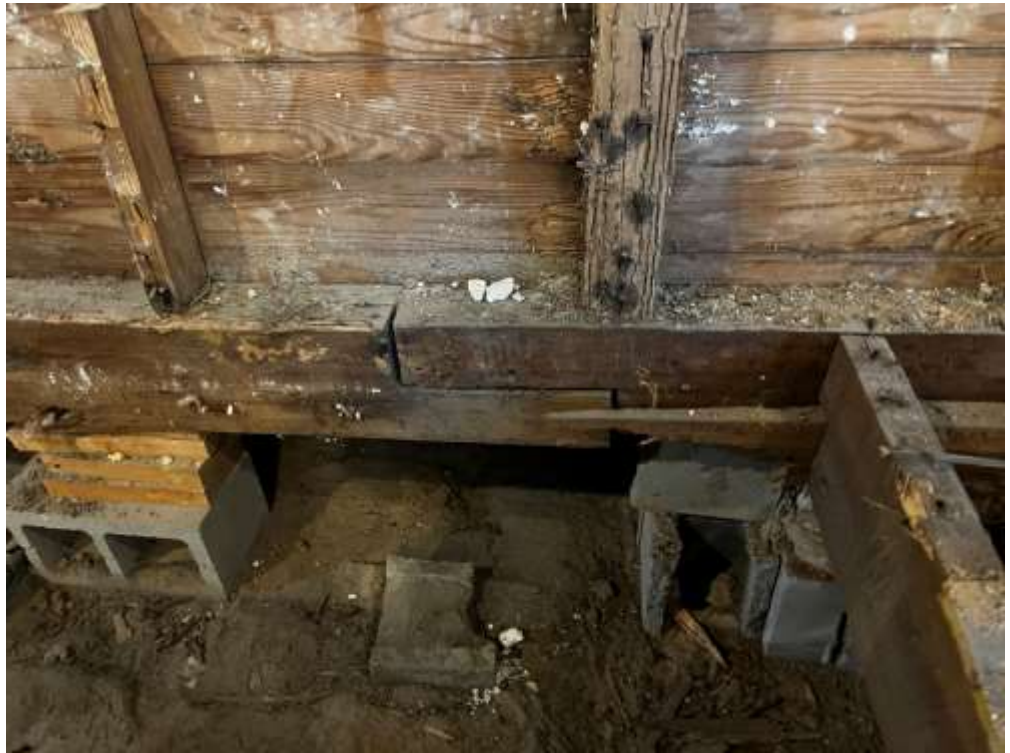
Photo No.
7

A view of the unsupported perimeter band splice

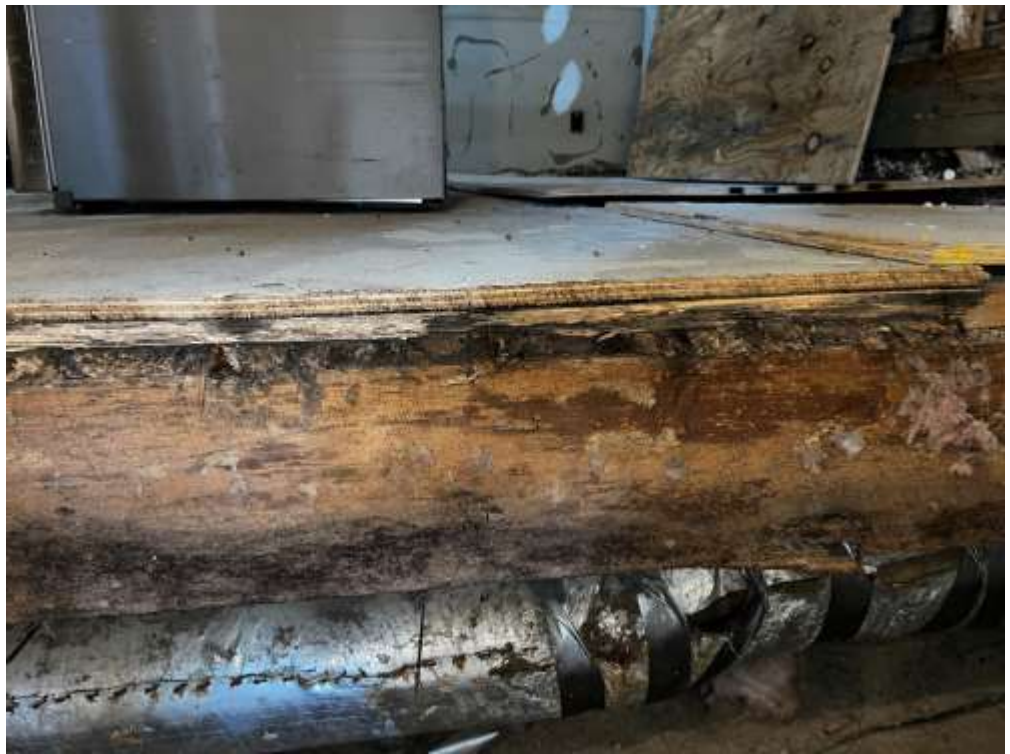
Photo No.
8

- e. Multiple sections of subflooring throughout the crawl space was noted to exhibit significant wood-destroying insect damage. The homeowner stated that the subfloor would be removed and replaced in its entirety.

A typical view of wood-destroying insect damage in the subfloor of the home

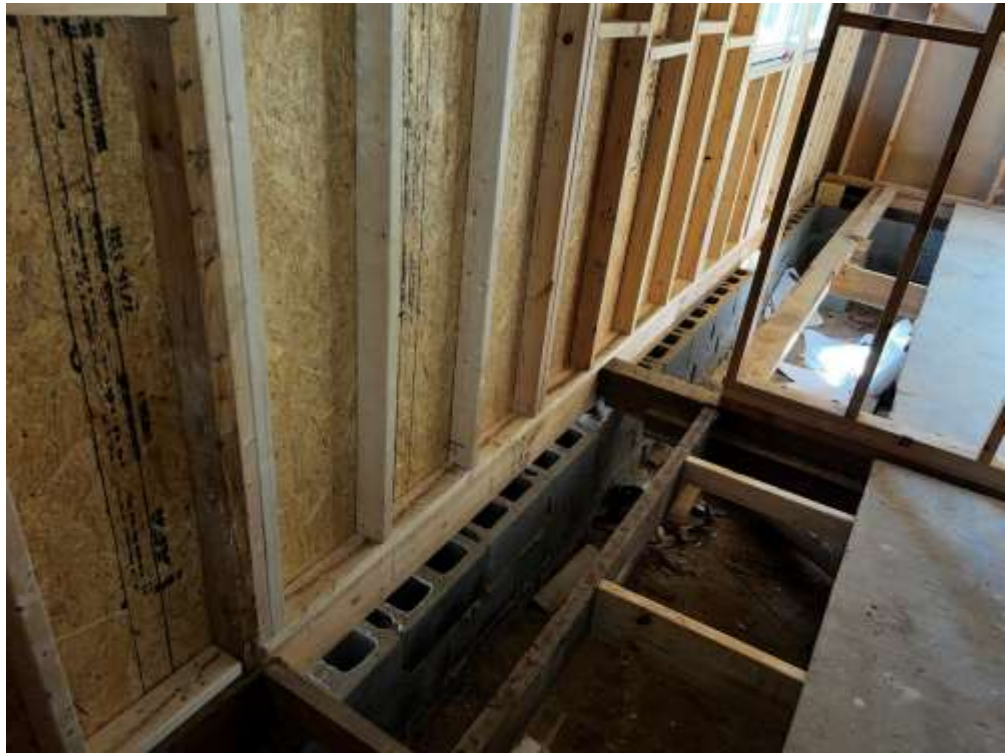
Photo No.
9

8. Evidence of moisture intrusion in the form of efflorescence and water staining was noted on the perimeter foundation walls. Water staining and what appear to be organic substances on the wood framing were also noted. Additionally, widespread evidence of moisture and wood-destroying insect intrusion was noted throughout the wood framing of the crawl space at the time of the inspection.

A typical view of repairs made to the wall framing and the condition of the perimeter foundation wall

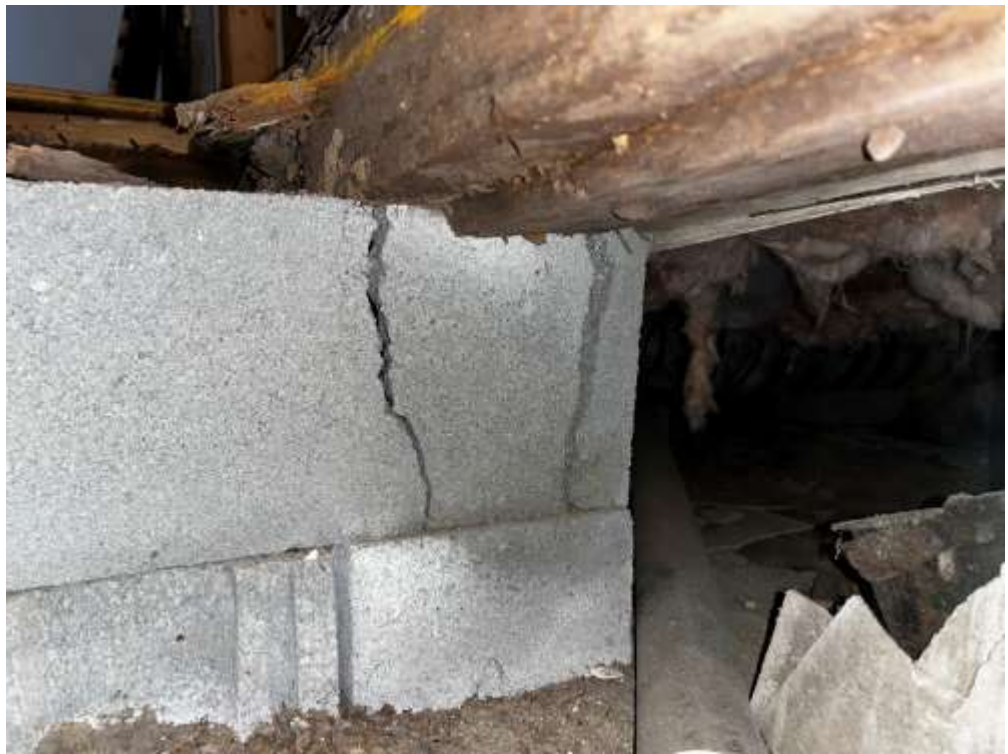
Photo No.
10

- c. Multiple CMU piers were noted to be improperly installed and were noted to be cracked at the center of the crawl space. The presence of concrete footings beneath the CMU piers could not be determined at the time of the inspection.

A typical view of damaged CMU piers in the crawl space

3. We recommend replacing the existing central girders in both crawl spaces to properly support the floor framing. Each new girder shall consist of a 4-2x8 member and shall span continuously between supports and be supported by new 8x16 CMU piers spaced at a maximum of 5'-6" apart. The new CMU piers shall bear directly on new 20"x20"x8"-thick concrete footings (unless otherwise noted). Provide 2x pressure-treated blocking between the floor girder and new piers. (See attached sketch)

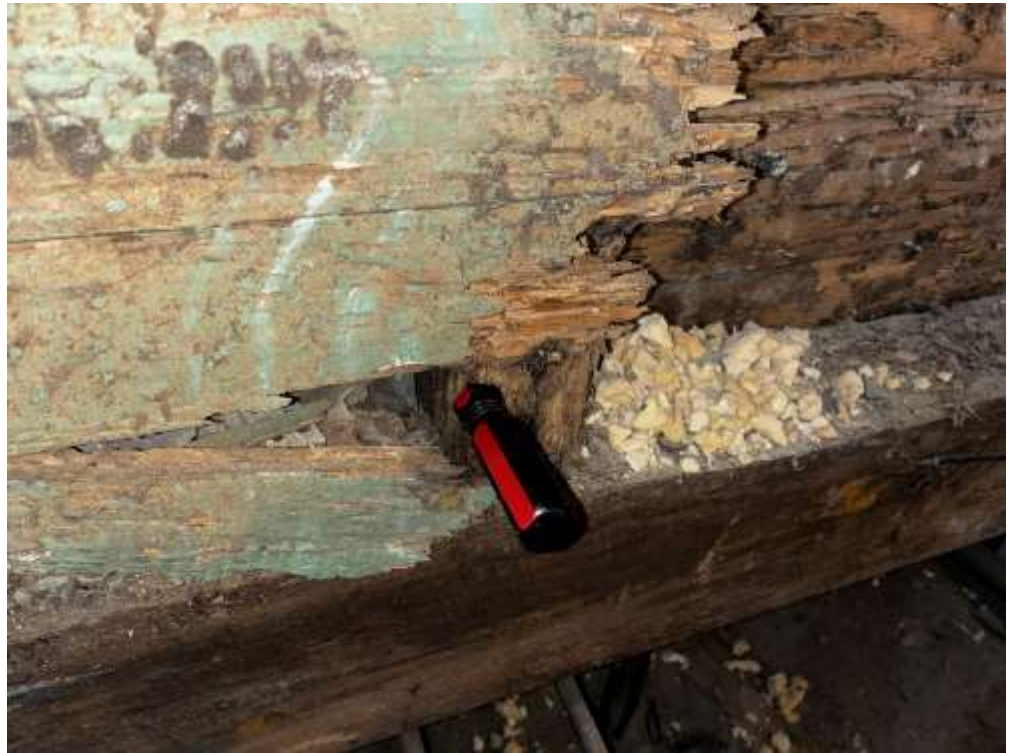
Photo No.
11

A view of wood-destroying insect damage in the wall framing at the interior of the home

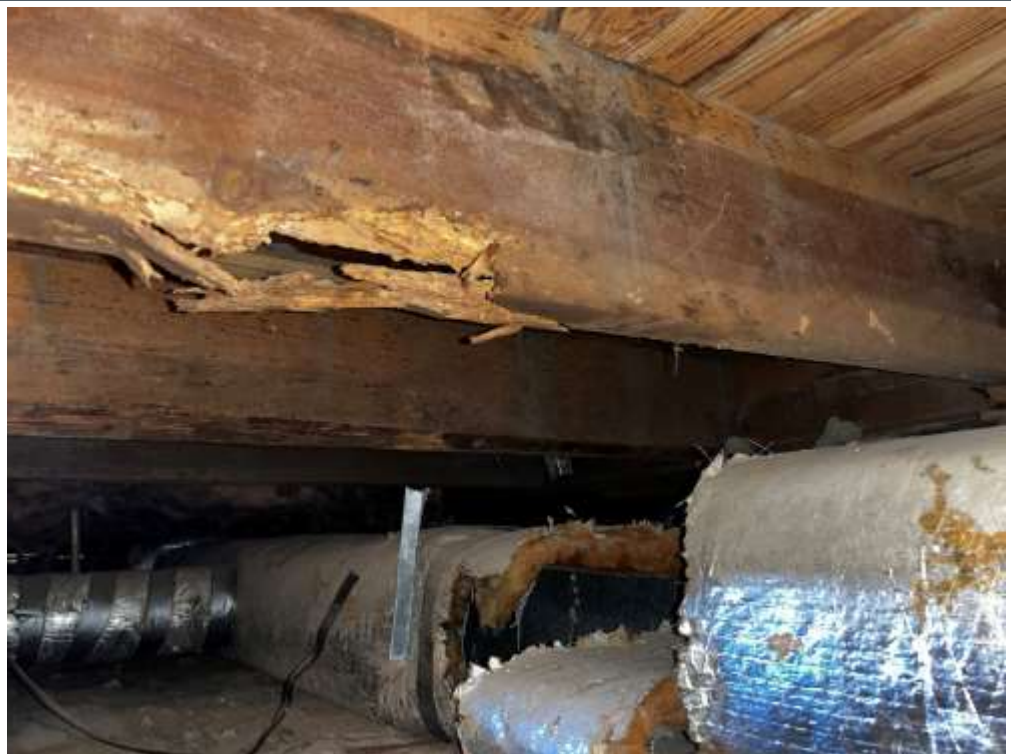
Photo No.
12

- a. At the rear of the home, multiple floor joists were noted to exhibit significant wood-destroying insect deterioration. The joists were probed with an awl and exhibited up to 3” of cross-sectional losses at the time of the inspection.

- d. At the front of the crawl space, multiple floor joists were noted to exhibit significant wood-destroying insect damage. The joists were probed with an awl and exhibited up to 2” of cross-sectional losses.

A typical view of wood-destroying insect damage in the floor joists of the crawl space

4. We recommend replacing all damaged floor joists with new 2-2x8 floor joists attached at both ends with new Simpson LUS28-2 joist hangers. The floor joists should be spaced at a maximum of 16" on-center. We recommend fully sistering the remaining floor joists with a new 2x8 member attached with (3) 10d nails at 16" on-center. The newly sistered joists should be attached at both ends with Simpson LUS28-2 hangers.

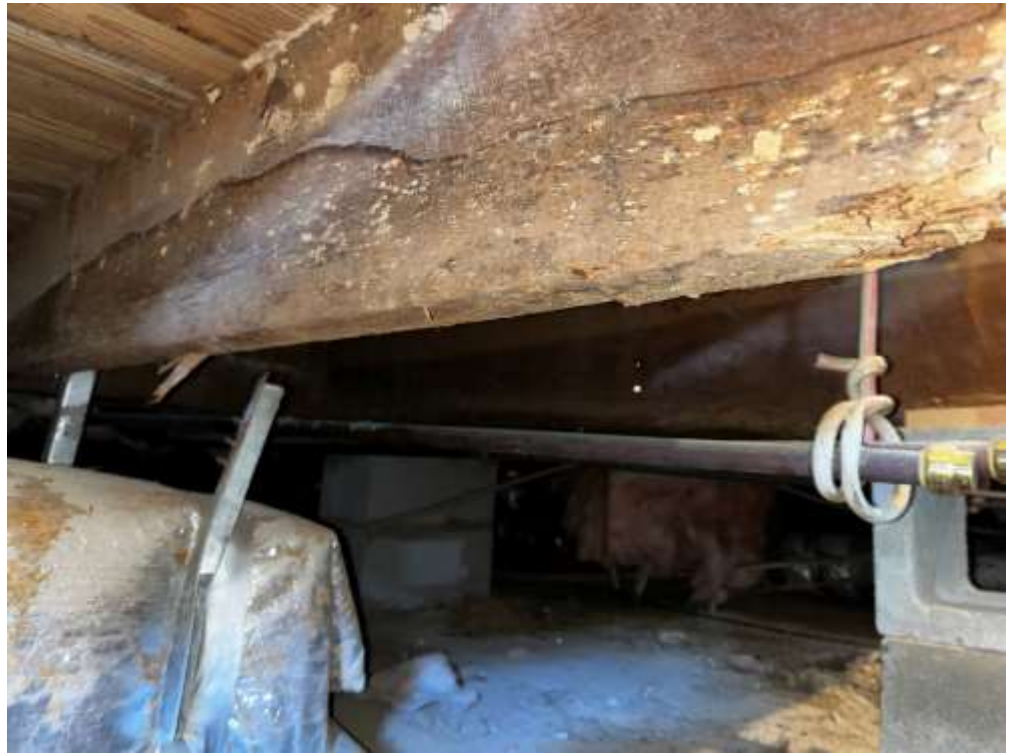
Photo No.
13

The significant damages to the floor framing are likely due to the moisture content in the crawl space in combination with previous wood-destroying insect activity. If the floor framing continues to experience the high moisture content noted above, the wood framing will continue to deteriorate and lose strength. The previous repairs in this section of the crawl space are considered to be incomplete and are inadequate to support the imposed loads on the floor framing. The high moisture content and damaged framing components in the crawl space are structural concerns. Additionally, the existing floor joist spans and girder spans exceed the maximum allowable spans per the 2018 North Carolina Building Code: Residential Code. A floor framing member that is overspanned may cause overstressed conditions, variable floor slope and allow for excessive deflection at the midspan of the joist. We have provided recommendations to address these issues.

A typical view of moisture and wood-destroying insect damage in the floor joists of the crawl space

6. To help further reduce and regulate moisture levels in the crawl space, we recommend installing a new vapor barrier throughout the crawl space to cover all exposed soils. This is especially important where floor framing is in close proximity to ground (less than 18"). Also, we recommend opening the foundation vents and ensuring the vents are clear of debris to allow air circulation in the warm seasons. If moisture levels remain high (greater than 15.0%), an appropriately sized dehumidification system may be required.

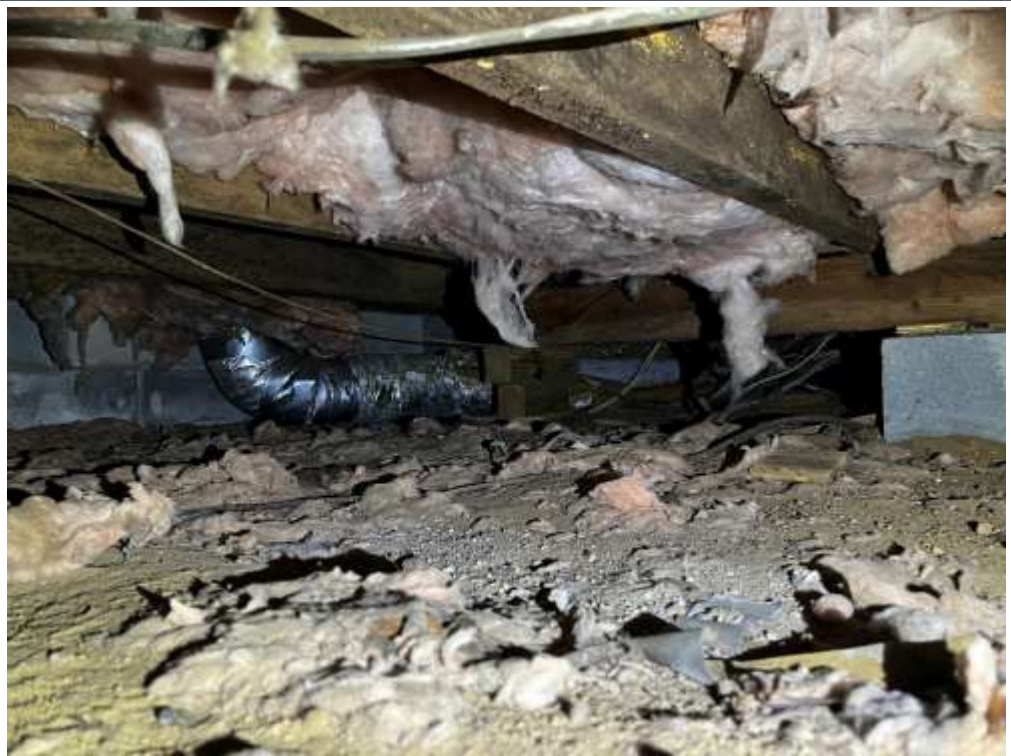
Photo No.
14

9. Multiple auxiliary wooden supports were noted in the crawl space supporting floor joists.
10. A vapor barrier was not installed and the moisture content in the floor framing was elevated at the time of the inspection. Multiple moisture readings were taken with a General MMD4E moisture meter and measured lumber moisture contents of up to 18.6%. Saturated soils were noted in the rear right corner of the crawl space.

A view of the crawl space conditions at the right side of the home

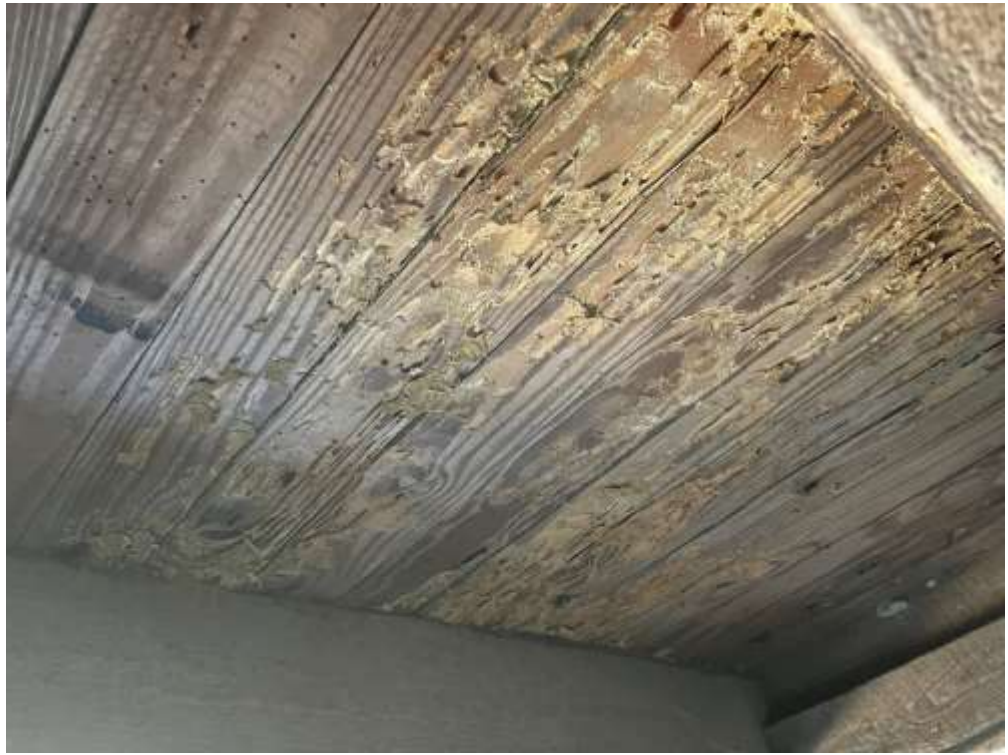
Photo No.
15

A view of wood-destroying insect damage noted in the subfloor near the front of the home

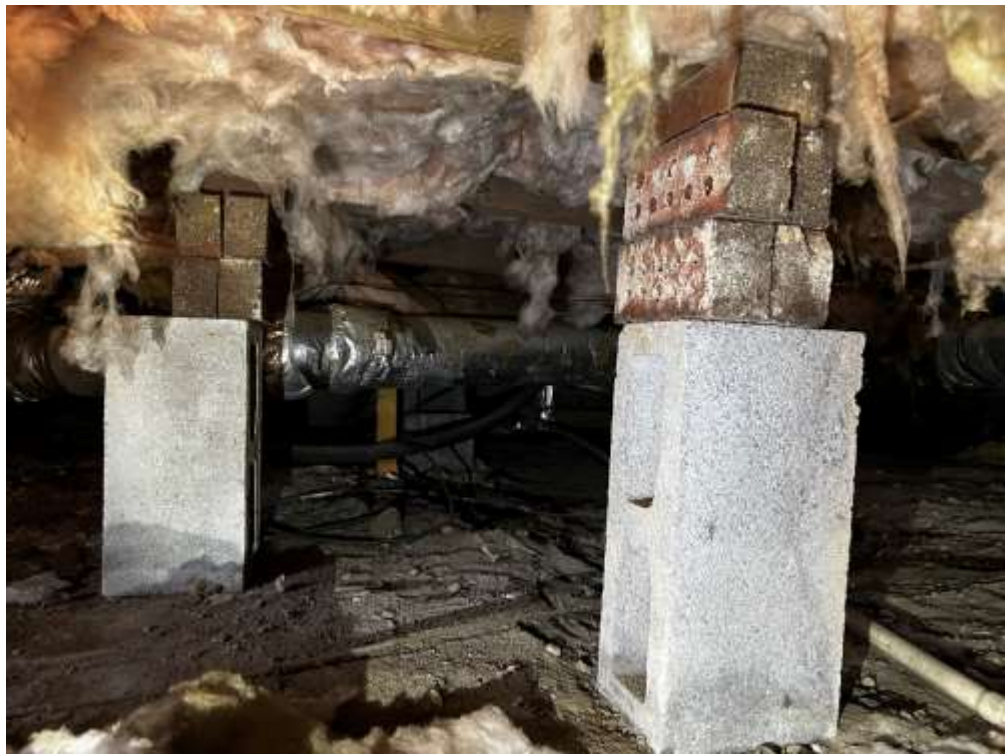
Photo No.
16

The auxiliary girders and supported noted in the crawl space are not considered permanent supports per 2018 North Carolina Building Code: Residential Code. These were likely installed to compensate for damaged floor framing and/or alleviate minor deflection or “bounce” in the floor. The auxiliary supports were noted to be installed improperly. We have provided recommendations below to remove these supports and address the floor framing.

A view of improperly installed auxiliary supports in the crawl space
