W. Harrison Welch, PE
Stonewall Structural Engineering, PLLC
4800 Falls of Neuse Rd. #120
Raleigh, NC 27609
(919)407-8663

Re: Structural Observation — 30 Albert Court, Sanford, NC 27332

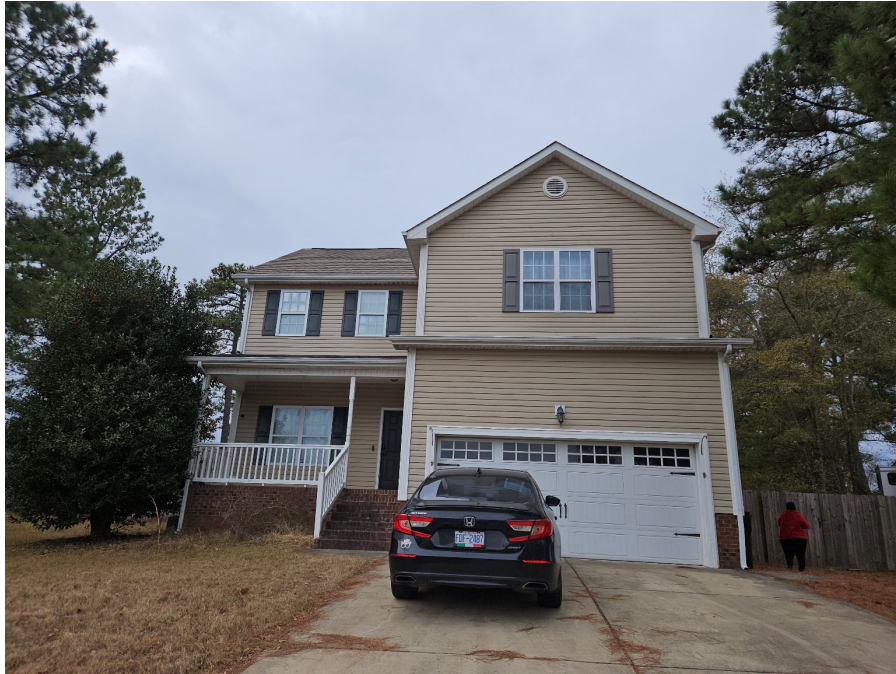
At your request, on December 1, 2023 we performed a review of the structural plan proposed by *Tarheel Basement Systems* for the foundation and 1st floor framing replacement work at the Sanford residence noted above. The structure is a conventionally framed, detached, single family residence with raised first floor framing over a pier/girder foundation system with perimeter masonry foundation walls (*see picture 1*).

Picture 1 – 30 Albert Court, Sanford, NC

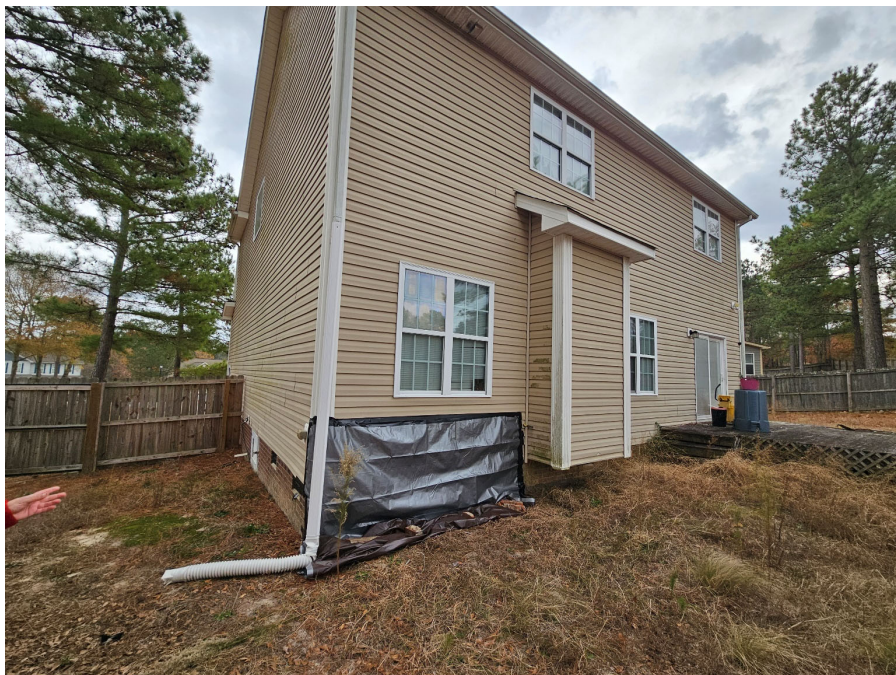
- A vehicle was reported to have impacted the back-right of the home. The following damages to the foundation and 1st floor framing were noted through investigation from the crawlspace (*see pictures 2-4*).
 - Along the back of the home, the rightmost 10’ of the foundation.
 - The joists and rim along this portion of the foundation were damaged beyond salvable repair. The rightmost 12’ of the sill plate was damaged beyond repair or had rotated.
 - Along the right of the home, the backmost 2’ of the foundation.
 - The right most span of the backmost girder had rotated.

Picture 2 – Location of car impact

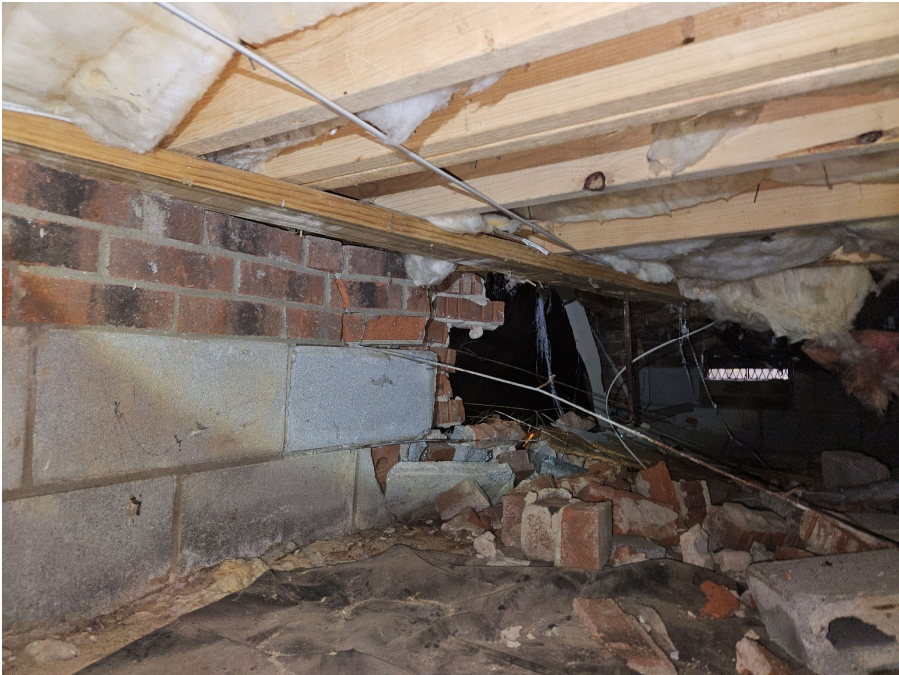
Picture 3 – Damaged foundation

- 1) Remove damaged portions of the foundation wall for installation of a conventional 8” wide foundation wall with 8” solid cap block.
 - a) The existing footing is likely in good condition. Excavate the soils for inspection of the footing. The existing footing may be reused if it has not rotated or broken. If the footing has been damaged, it should be replaced with a new footing matching the dimensions of the existing.
 - i) If applicable, dowel the new footing into the existing footing using (2) horizontal #4 bars x 24” long at the footing mid-depth. Drill 6” into the existing and epoxy using Simpson “Set-3G” or similar epoxy installed per manufacturer specifications.
 - b) Install a new full height 2x rim that bears over a treated 2x sill plate anchored to the wall with ½” diameter bolts with 7” embedment into the top course of the

wall, at 6'-0" on center spacing and 12" max / 5" min from plate ends and breaks.

- i) Alternatively, Simpson "Flat Retrofit Foundation Plates" may be used in lieu of ½" diameter bolts.
- 2) Reinforce each of the joists in the back bay where the foundation is being replaced with an additional full depth ply of 2x #2 Southern Yellow Pine (SYP), fastened to the side of the existing using (3)10d common nails at each end and at 12" on center staggered top and bottom along the lengths of the joists. Sistered material should span continuously between end supports.

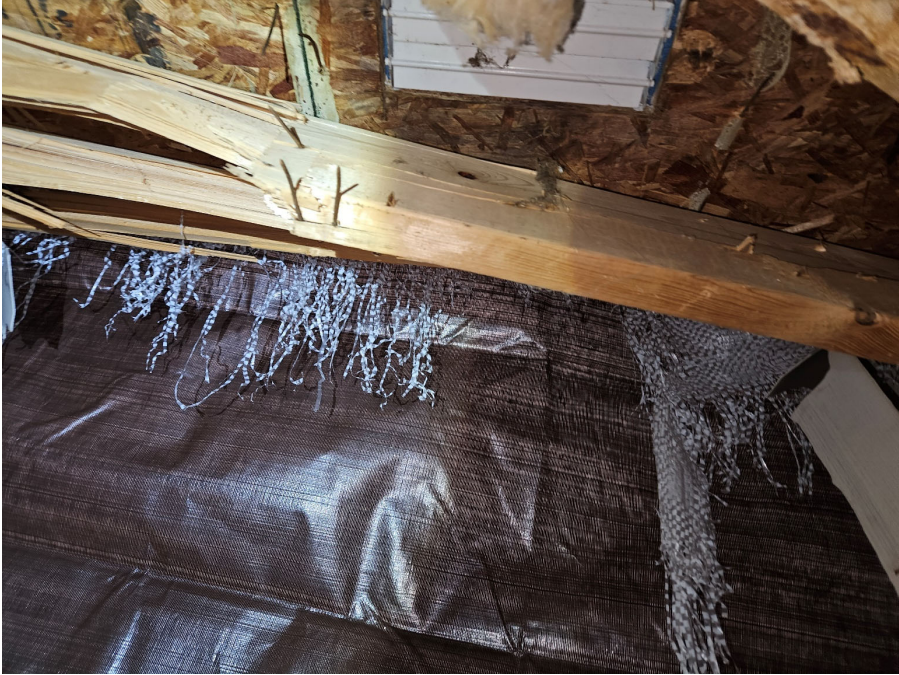
Picture 4 – Damaged framing

- a) Verify all floor sheathing edges are properly supported by floor framing. Joists may be removed and replaced entirely with matching materials if necessary. If so, fasten sheathing of matching thickness to the new floor framing using 8d common nails at 6" o.c. at panel boundaries, and 12" o.c. to joists within the panel field. Splice panels over centerlines of joists as needed with 1/8" minimum edge nail distance. No section of sheathing should be smaller than 2'-0" in any direction.

- 3) Replumb the above noted rotated girder.
- 4) Any additional cracks in perimeter masonry walls that are not specified to be replaced should be closed with a clear or color-matching flexible sealant and should be monitored for signs of further movement.
