March 28, 2024

Reference: Engineering Services
50 Otto Rd.
Lillington, NC 27546
TE&D Project No.: DRB2301-0466_B

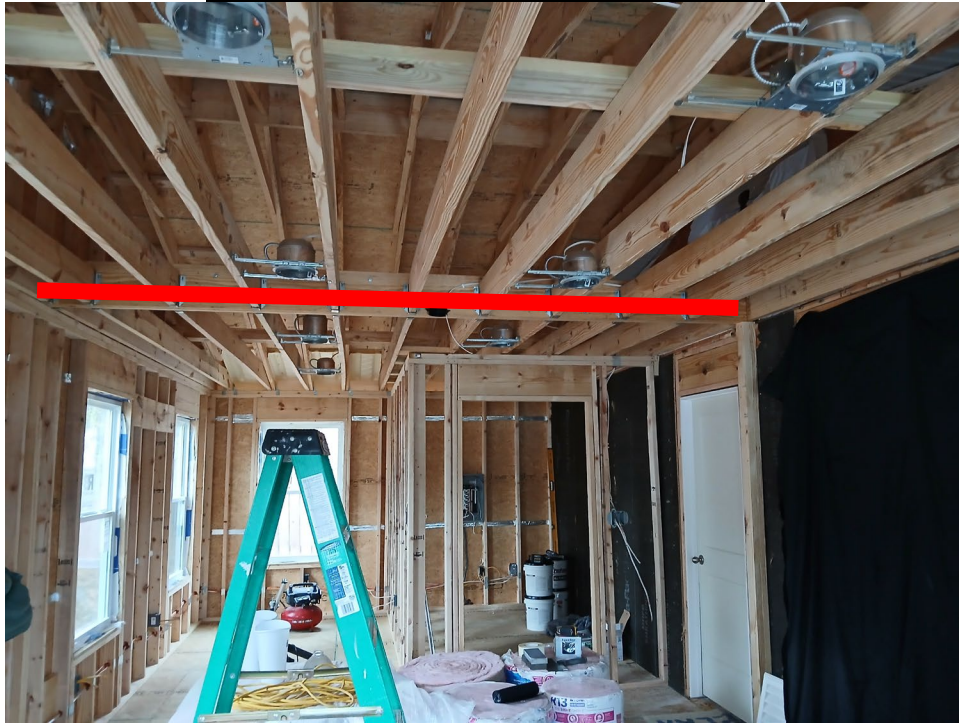
1. We observed a (2) 2 x 10 beam spanning left to right supporting the ceiling of the addition was installed in lieu of the (2) 1-3/4" x 11-7/8" LVL specified in the structural plan. Based on our observations and analysis, the existing configuration is inadequate to support the anticipated loading conditions. TE&D recommends replacing the existing beam with a (2) 1-3/4" x 11-7/8" LVL per plan.

Item 1) Install (2) 1-3/4" x 11-7/8" LVL Per Plan.

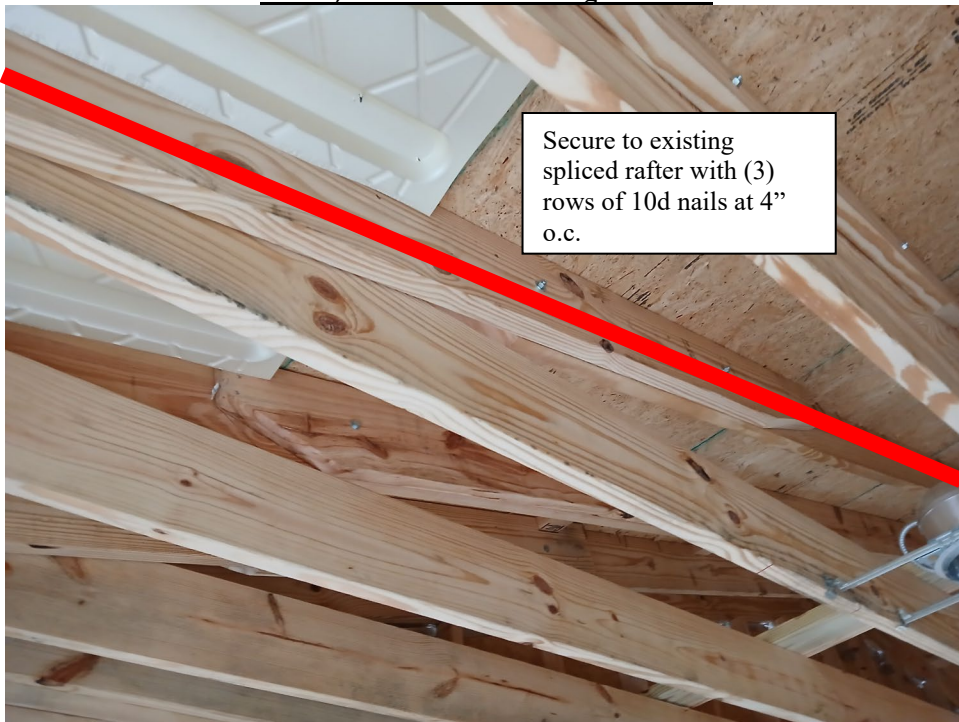
2. We observed the rafters were spliced with an approximate 7'-10" long member at the lower end. Based on our observations and analysis, the existing configuration is inadequate to support the anticipated loading conditions. TE&D recommends installing new continuous 2 x 8 rafters at 16" o.c. spanning from the ridge to the exterior wall. The new rafters are to be fastened to the existing lower portion of the rafter splices with (3) rows of 10d nails at 4" o.c. 2 x 4 collar ties are to be fastened to the new rafters at 32" o.c.

Item 2) Install New Full-Length Rafters

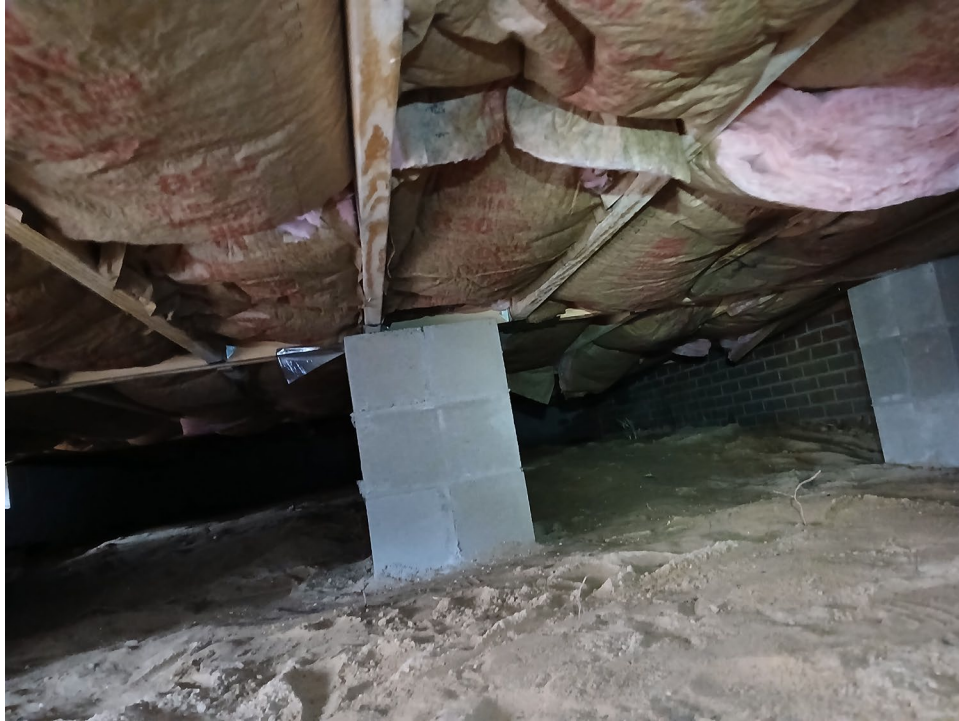
3. We observed a (2) 2 x 10 girder spanning left to right supporting the floor at the center of the addition was installed in lieu of the (3) 2 x 10 girder specified on the plans. Based on our observations and analysis, this configuration is adequate to support the anticipated loading conditions. No further modification is required.

Item 3) Girder Analyzed.

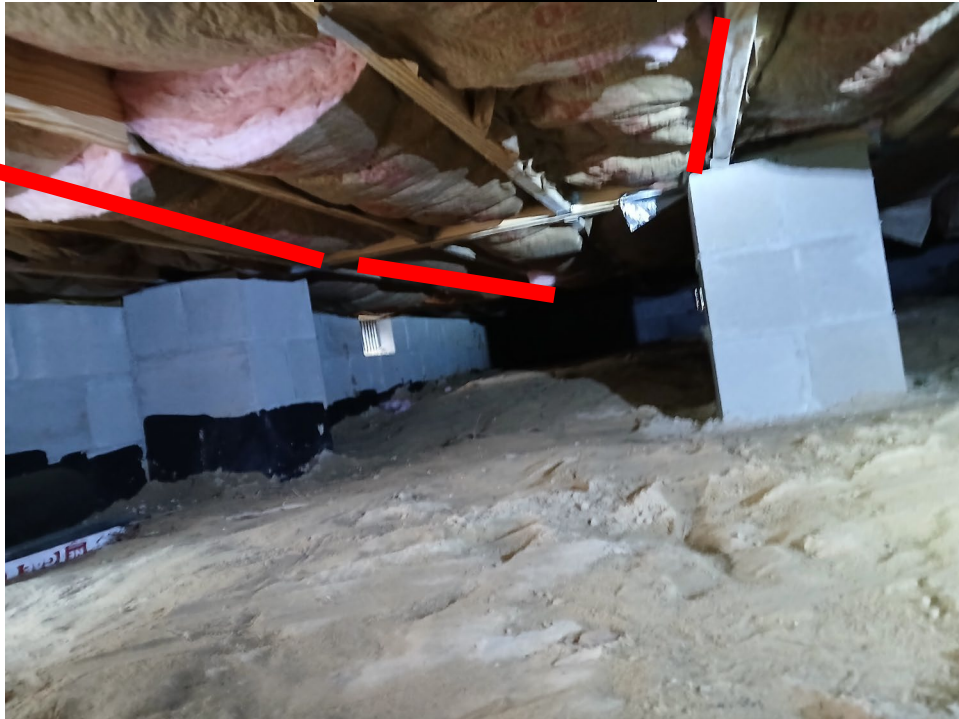
4. We observed the floor of the addition was framed with 2 x 10 joists at 16" o.c. spanning up to 14'-8". Based on our observations and analysis, the existing configuration is inadequate to support the anticipated loading conditions. TE&D recommends sistering an additional 2 x 10 joist to every third existing joist.

Item 4) Double Every 3rd Joist
