Reference: Engineering Services
400 Mason Dr.
Erwin, NC 28339
TE&D Project No.: 2401-020174_A

- 1) Analysis of fire damaged house framing.

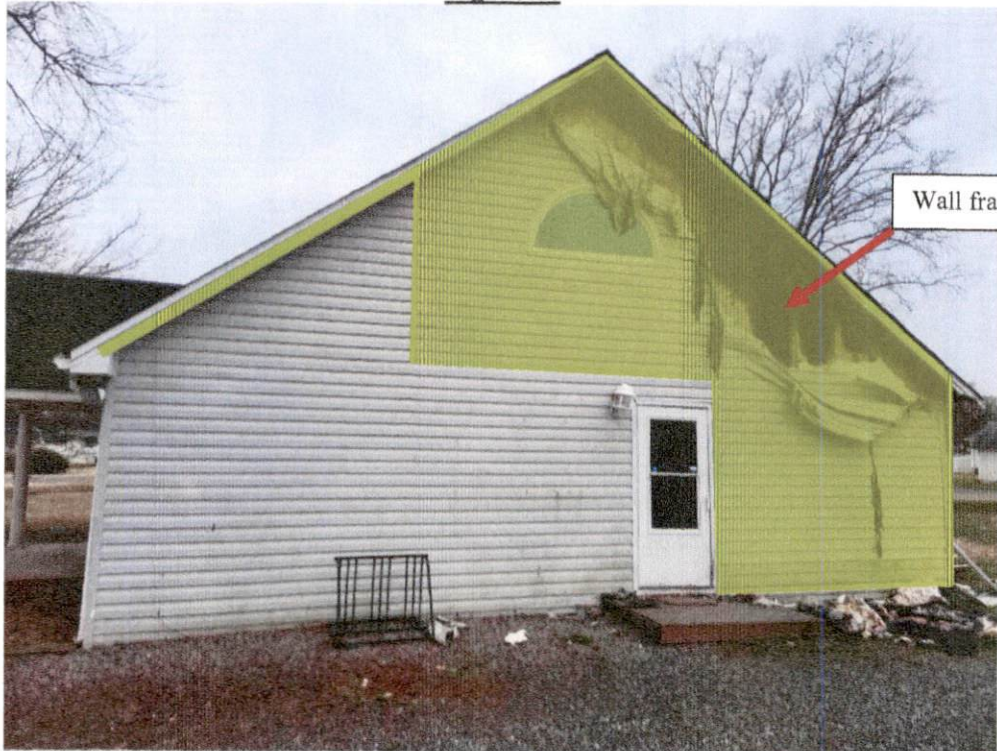
Right Side

Wall framing to be replaced

- F) The rear 12'-0" of the left exterior wall framing on the first floor is to be removed and replaced.
 - G) The rear 12'-0" of the right exterior wall framing on the first floor is to be removed and replaced.

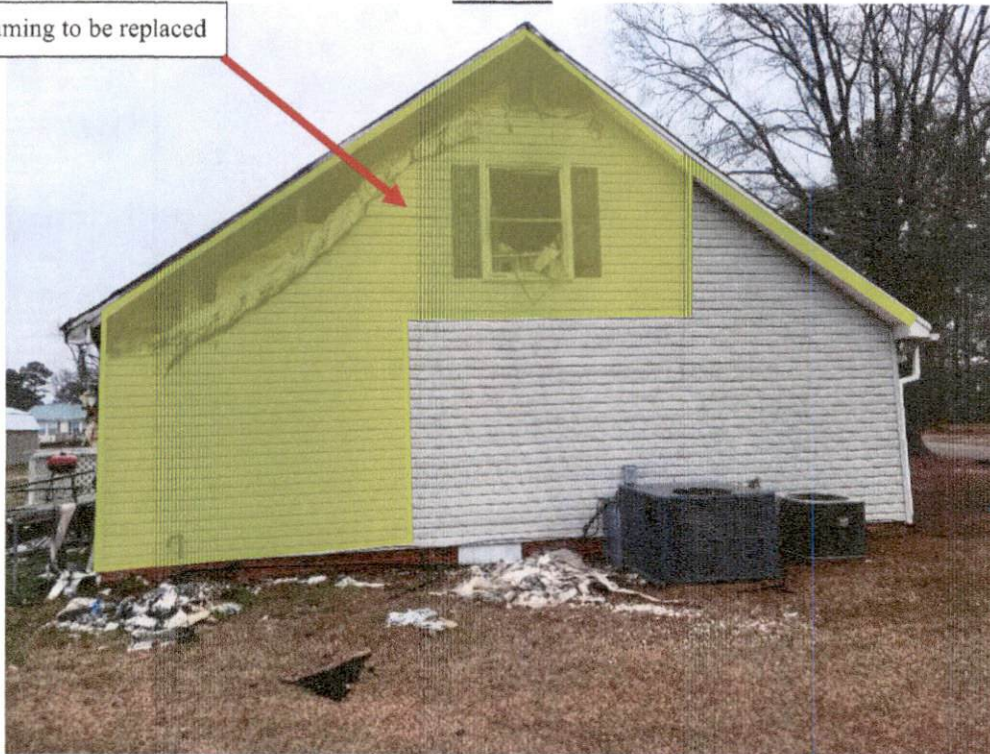
Left Side

Wall framing to be replaced

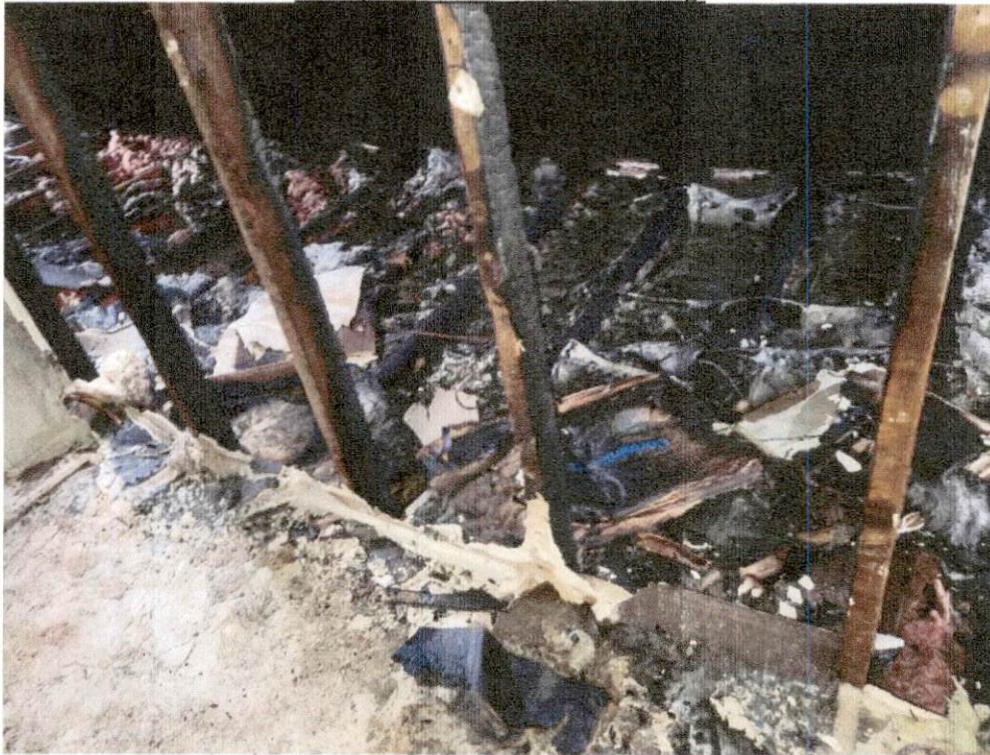
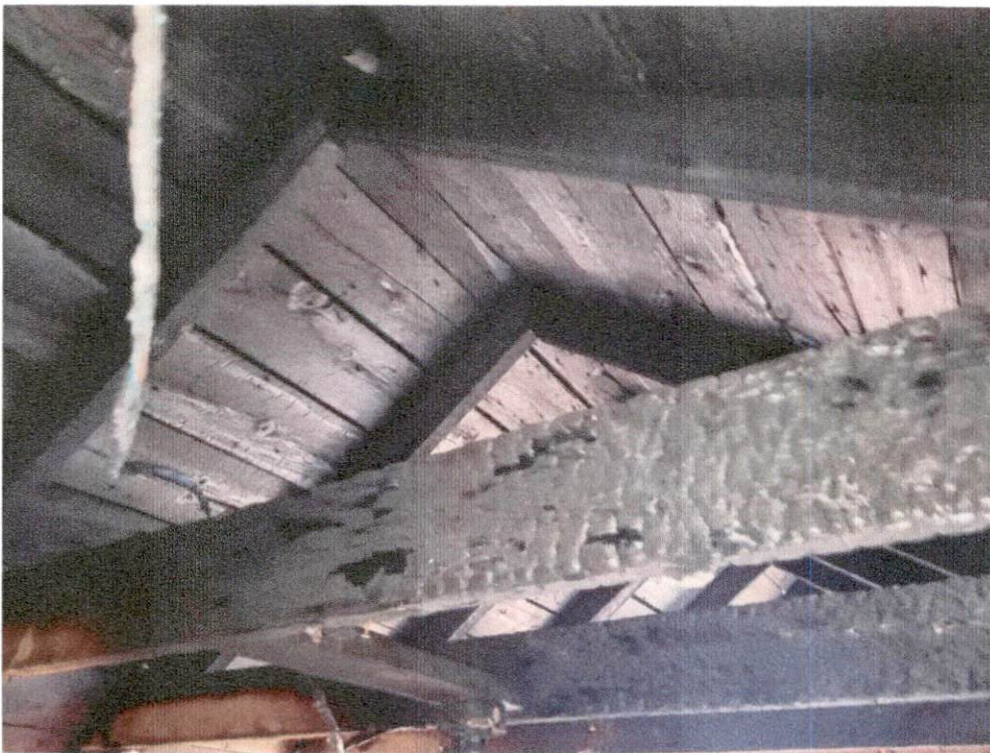
- 1) We observed numerous framing members throughout the first and second floors of the house to be severely damaged by fire, heat and smoke. TE&D recommends removing and replacing the following fire damaged framing (Note: the recommended repairs are made to comply with the 2018 NC Residential Building Code):

Examples of Fire Damaged Framing:

- A) All existing 2 x 4 rafters (Front and Back of the house) are to be removed and replaced with new 2 x 8 rafters at 16" o.c.
 - B) All existing 2 x 6 collar ties are to be removed and replaced with new 2 x 6 collar ties at 16" o.c.

- C) All 2 x 6 ceiling/second floor joists spanning front to back over the back-left bedroom, the kitchen, and the laundry room are to be removed and replaced with 2 x 10 joists installed at 12" o.c.

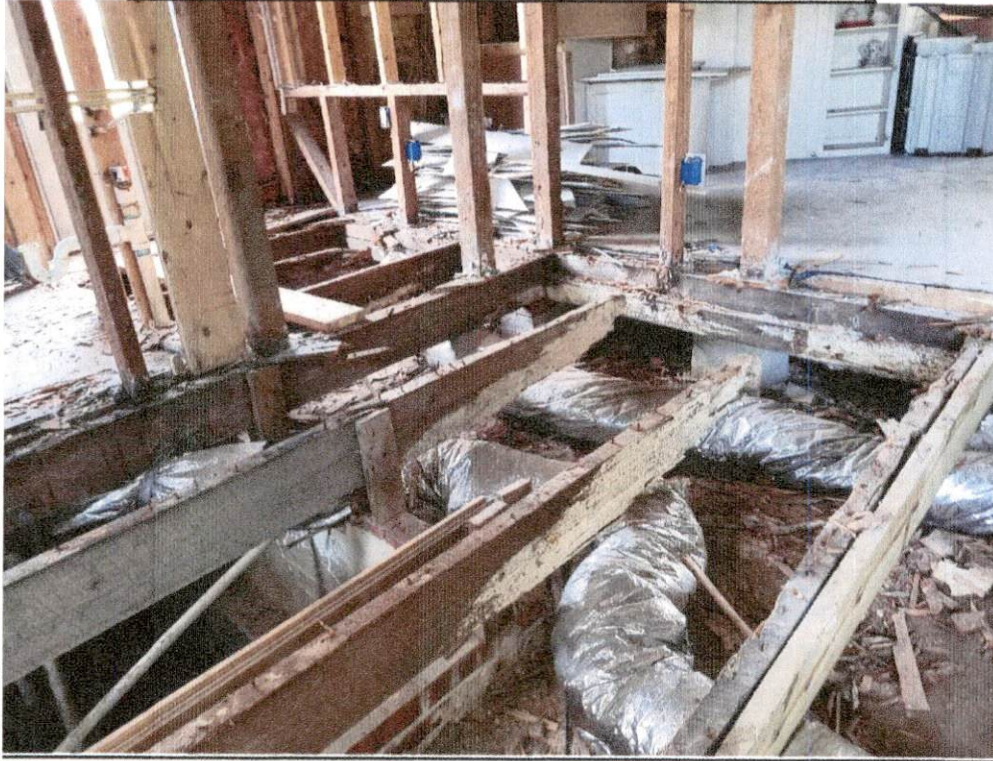
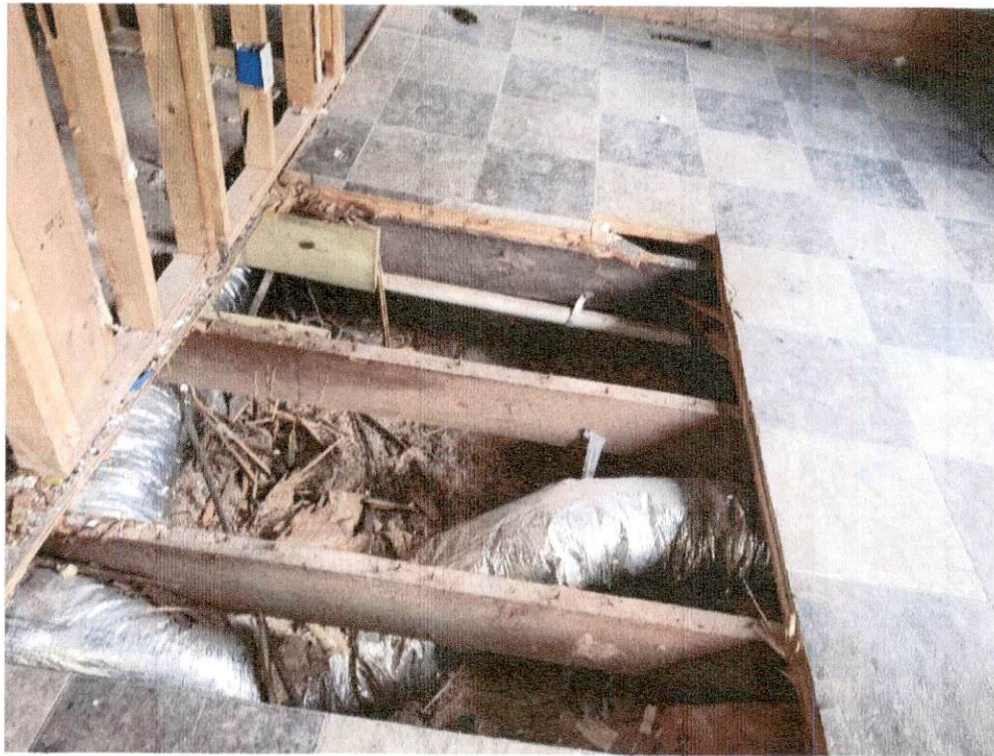
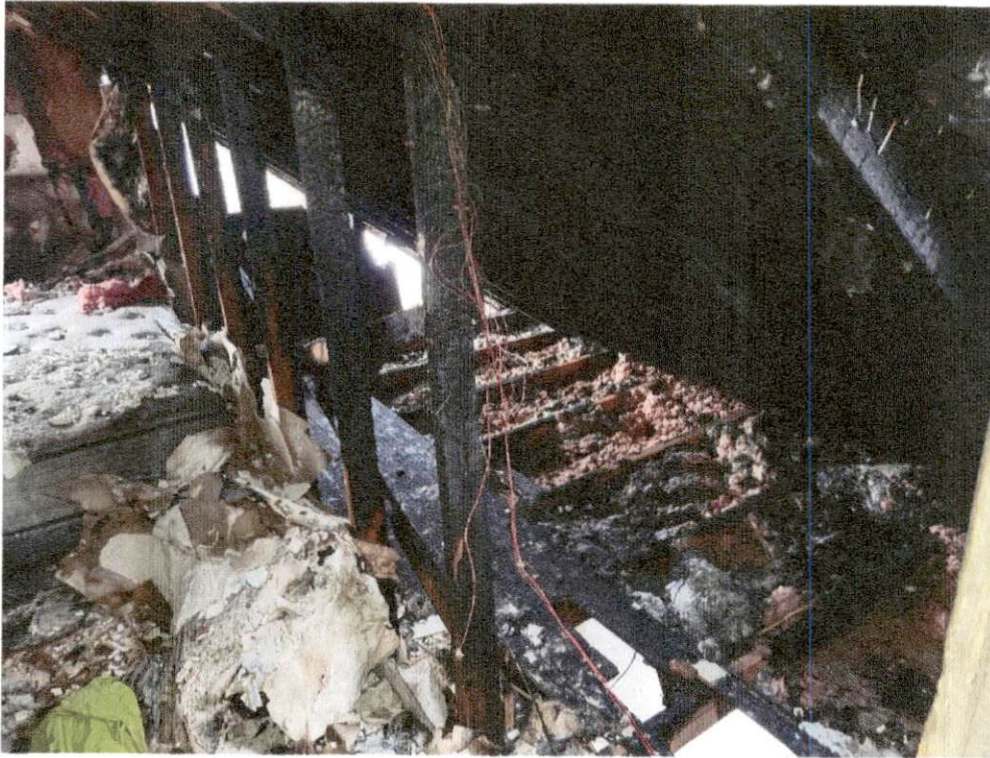
Example of Moisture and Insect Damage in the First Floor Framing

Additionally, while no fire damage was observed within the crawlspace/first floor framing, we observed moisture and insect damage within the first-floor framing. TE&D recommends removing the first-floor framing below back-left bedroom, the kitchen, and the laundry room and new, treated 2 x 10 joists should be installed at 12" o.c.

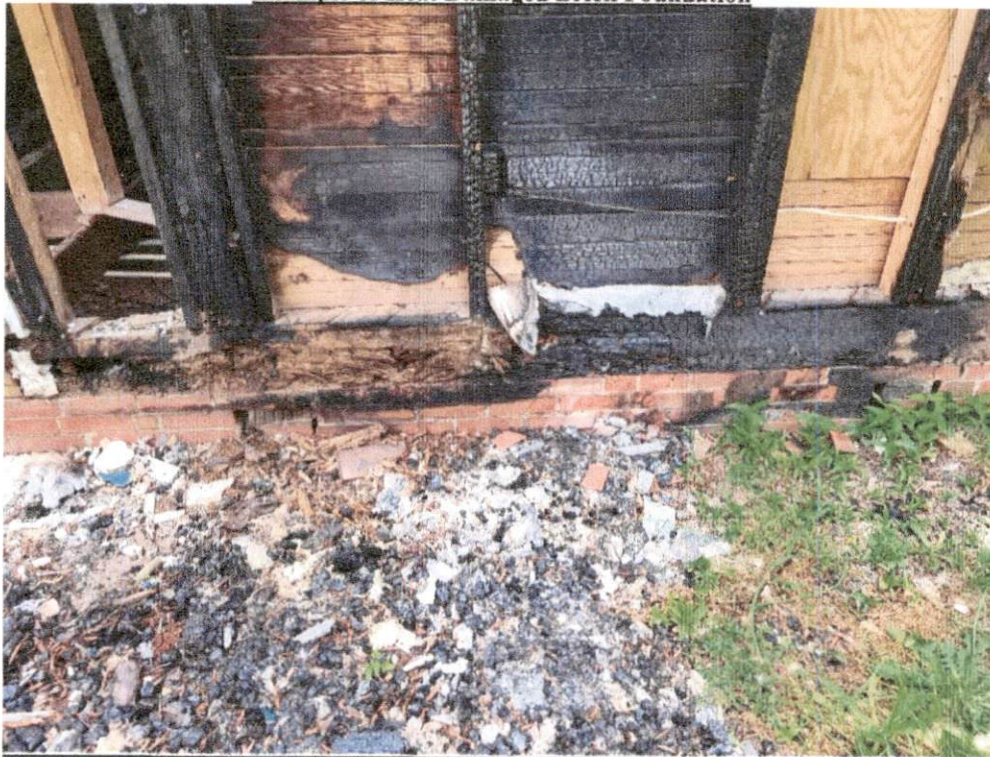
Example of Heat Damaged Brick Foundation

- H) The left and right exterior wall framing on the second floor is to be removed and replaced.
 - I) We observed heat damage to an approximately 10'-0" wide section of the rear foundation wall causing the brick to crack and chip. The 10'-0" section of the foundation wall centered approximately 3'-0" to the left of the rear exterior door is to be replaced with new masonry.

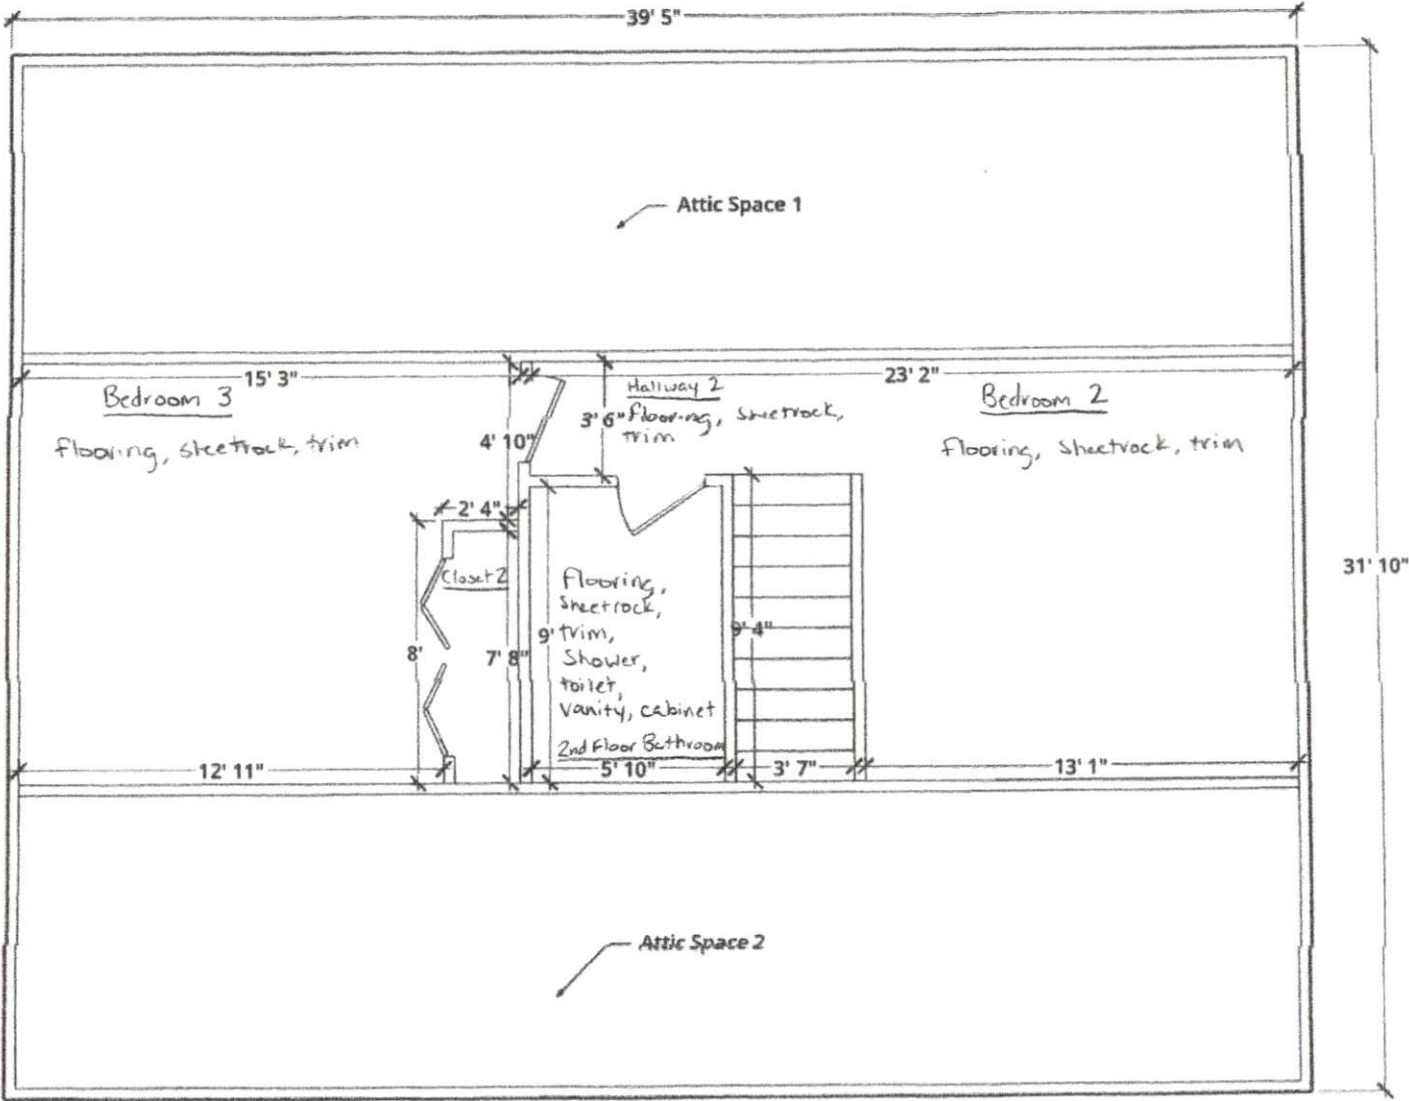
Demo Plan

Electrical throughout to be replaced

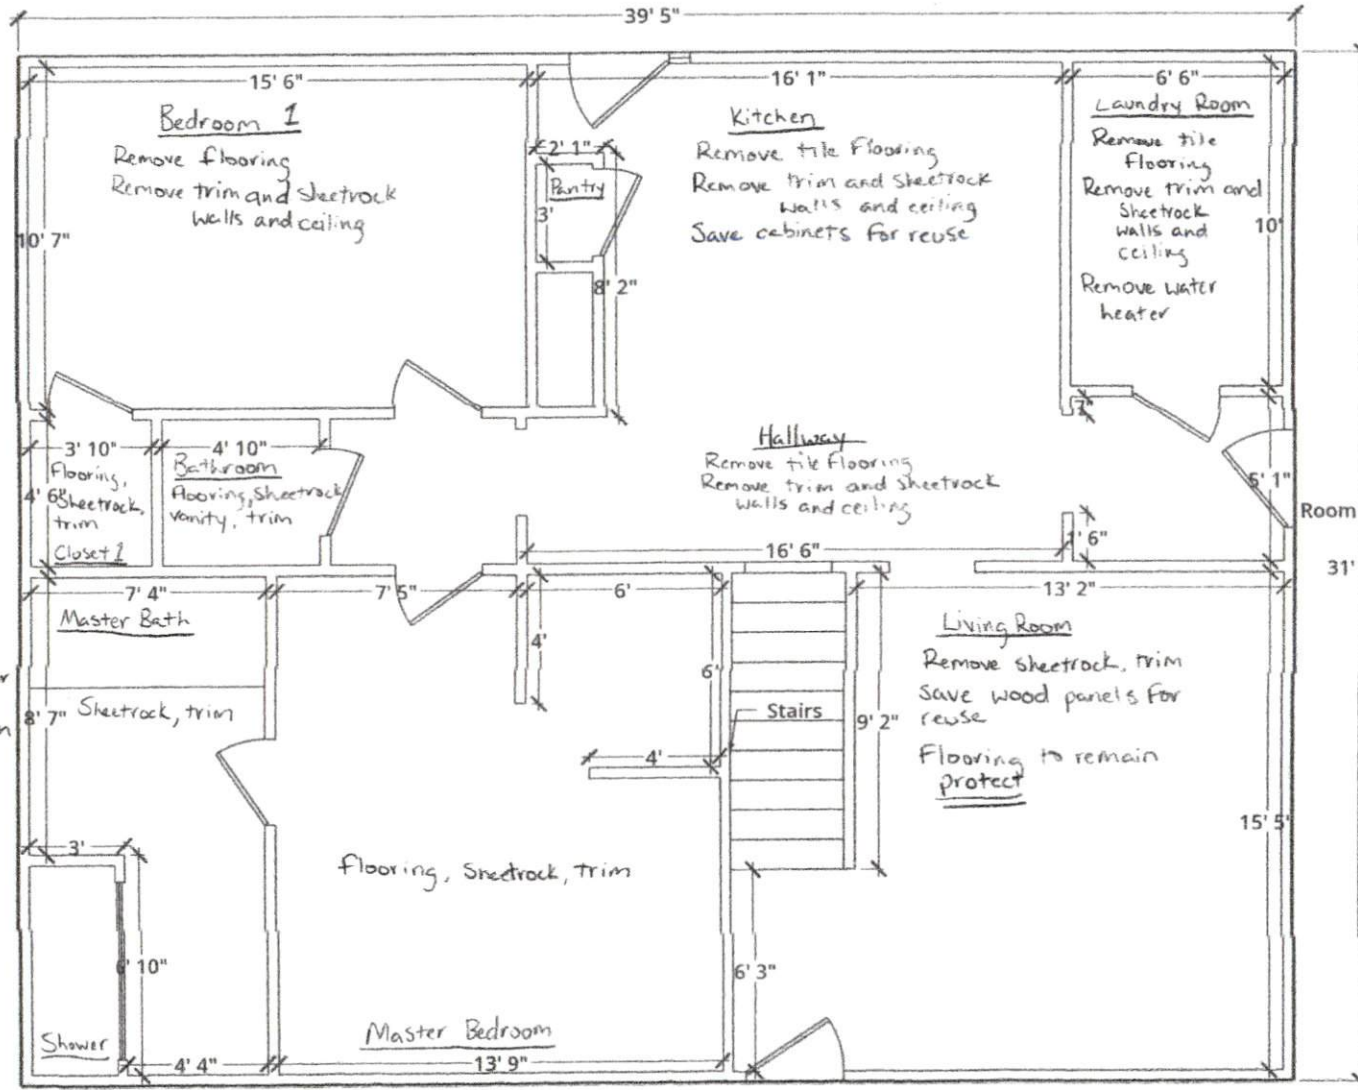
Tile in master bath to remain, clean only
Save vanity for reuse
