Reference: Engineering Services
400 Mason Dr.
Erwin, NC 28339
TE&D Project No.: 2401-020174_B

As requested by the client, a representative of Tyndall Engineering & Design, PA (TE&D) was on-site to inspect and observe the foundation and floor framing of the fire damaged house.

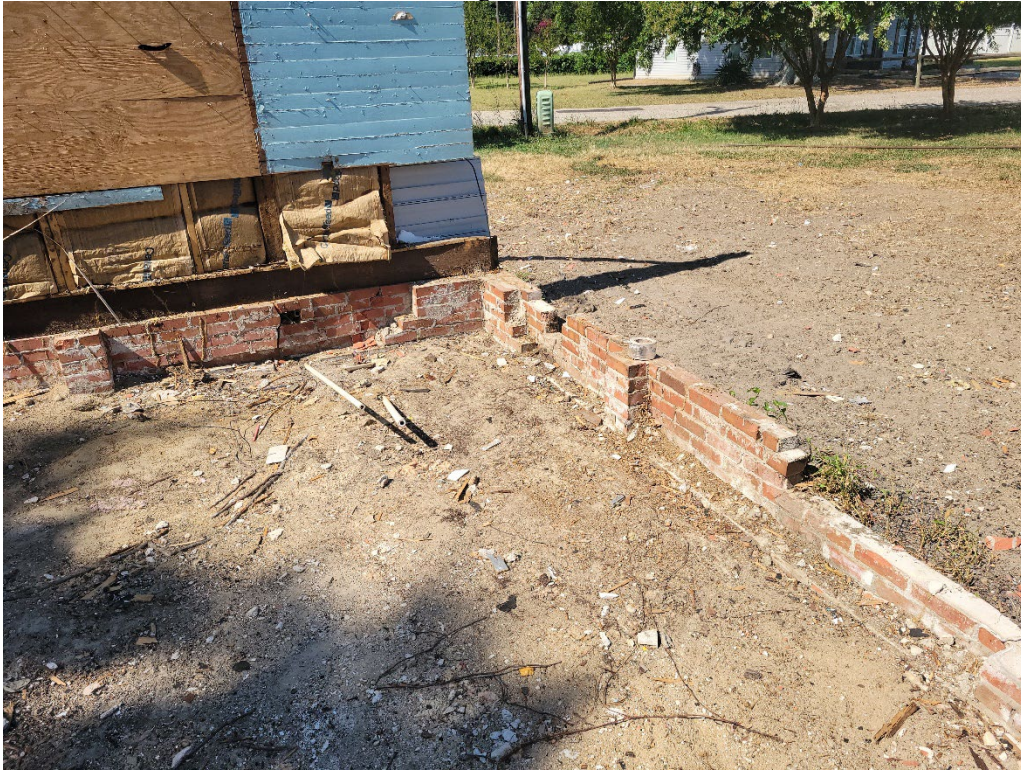
Existing Foundation:

- 1) We observed the foundation to be comprised of 8" x 8" brick piers with a 4" brick curtain wall between the piers. The piers and curtain wall were supported by a brick leveling pad. The remaining floor was framed 2 x 10 joists spanning a maximum of 15'-6". The joists were supported by 2 x 10, (2) 2 x 10, and (3) 2 x 10 girders. Based on our observations and analysis, TE&D recommends the following:
 - A) The existing pier and curtain wall foundation is inadequate to support the anticipated loading conditions. The existing foundation is to be removed and rebuilt per the 2018 North Carolina Residential Building Code.
 - B) Due to moisture and insect damage as well as improper installation, the remaining floor framing is inadequate to support the anticipated loading conditions. The floor framing is to be removed and rebuilt per the 2018 North Carolina Residential Building Code.
