February 12, 2024

Re: Limited Structural Inspection  
220 Curragh Cove  
Fuquay-Varina, NC

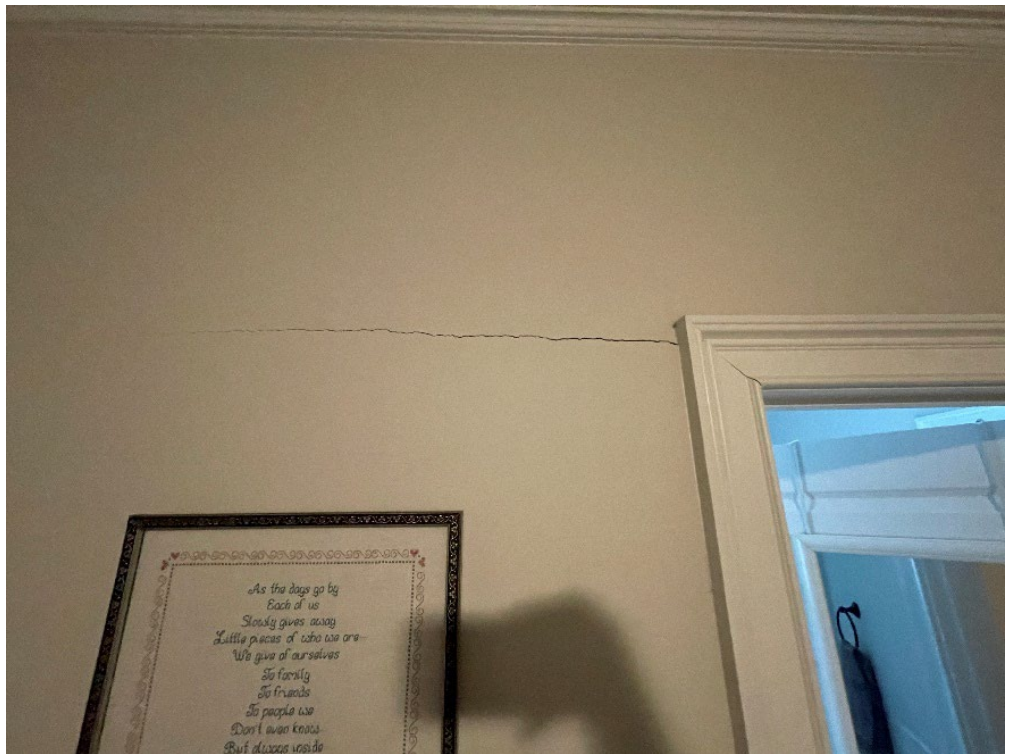
**Photo No.**  
**2**

1. Multiple cracks (up to 1/16" wide) and nail pops were noted in the drywall finish materials at the following locations:
  - a. A horizontal crack was noted at the door opening to the master bathroom approximately 7'-3" from the left perimeter wall and 16'-0" from the rear perimeter wall. Note, this crack was present on both the front and rear side of this wall.
  - b. A diagonal crack was noted at the door opening to the master closet approximately 7'-3" from the left perimeter wall and 6'-3" from the front perimeter wall.
  - c. A crack was noted in the kitchen approximately 22'-6" from the right perimeter wall and 15'-0" from the rear perimeter wall.
2. Floor slope (up to 3/16" vertical over 4'-0" horizontal) was noted sloping left to right at the left side of the kitchen island approximately 13'-3" from the right perimeter wall and 6'-9" from the rear perimeter wall.

Typical view of interior drywall cracks observed throughout the interior of the home.

6. If desired, we recommend installing a new 4x4 post at the midspan of the double floor joists located beneath the interior drywall cracks noted above (Observation #1a – b). The post should provide a full uniform bearing platform for the floor framing above and bear on a new 12"x12"x8" thick concrete footing.

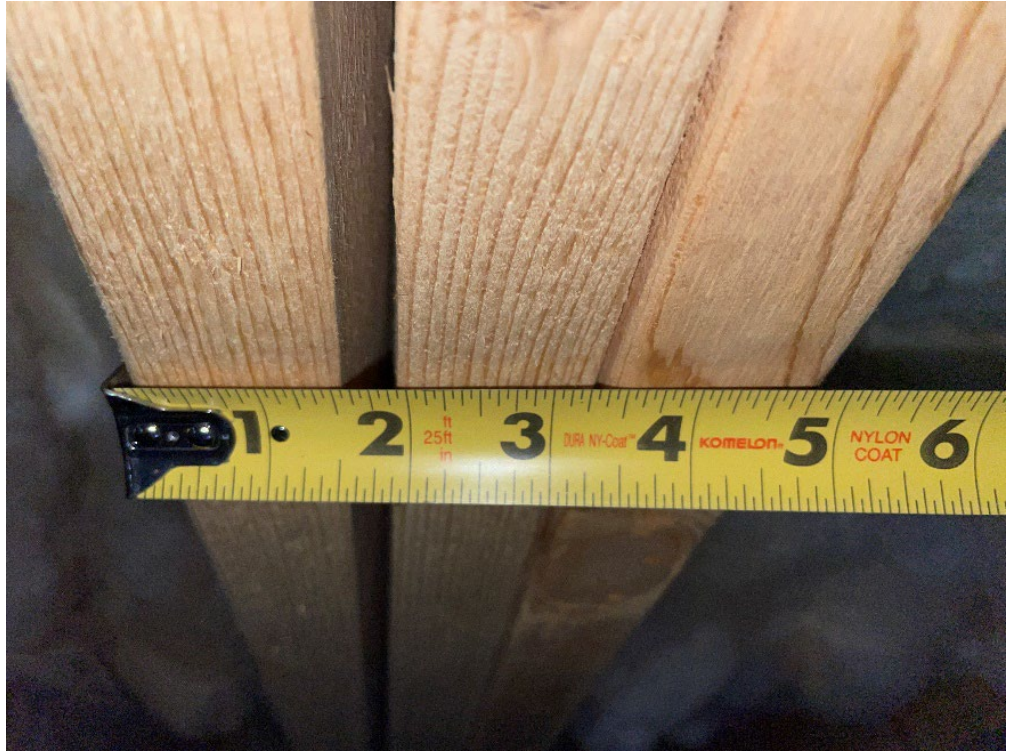
**Photo No.**  
**3**

7. Flaring (up to 1/4") was noted in the 2-2x10 floor joist spanning left to right approximately 6'-0" from the front perimeter foundation wall. The left end of the double floor joist was noted to bear on the left perimeter foundation wall.

8. Flaring (up to 1/2") was noted in the left-most ply of the 3-2x10 floor joist spanning front to rear approximately 15'-6" from the right perimeter foundation wall. The rear end of the triple floor joist was noted to bear on the rear perimeter foundation wall.

The flaring in the double joists noted above in the front crawl space is likely due to the vertical loads on the beam causing slight rotation in the plies of the member. This effect can lead to increased vertical deflection and improper bearing at the load-bearing supports. The flaring at the spans is considered significant and is a structural concern. We have provided a recommendation below to repair the flaring in the double joist spans.

Typical view of flaring  
floor joists.

1. The flaring double joists noted above should be temporarily clamped to bring the plies into full contact, and the plies should be reattached with (3) Simpson SDWS Screws (or equivalent) spaced at 16” on-center alternating sides.

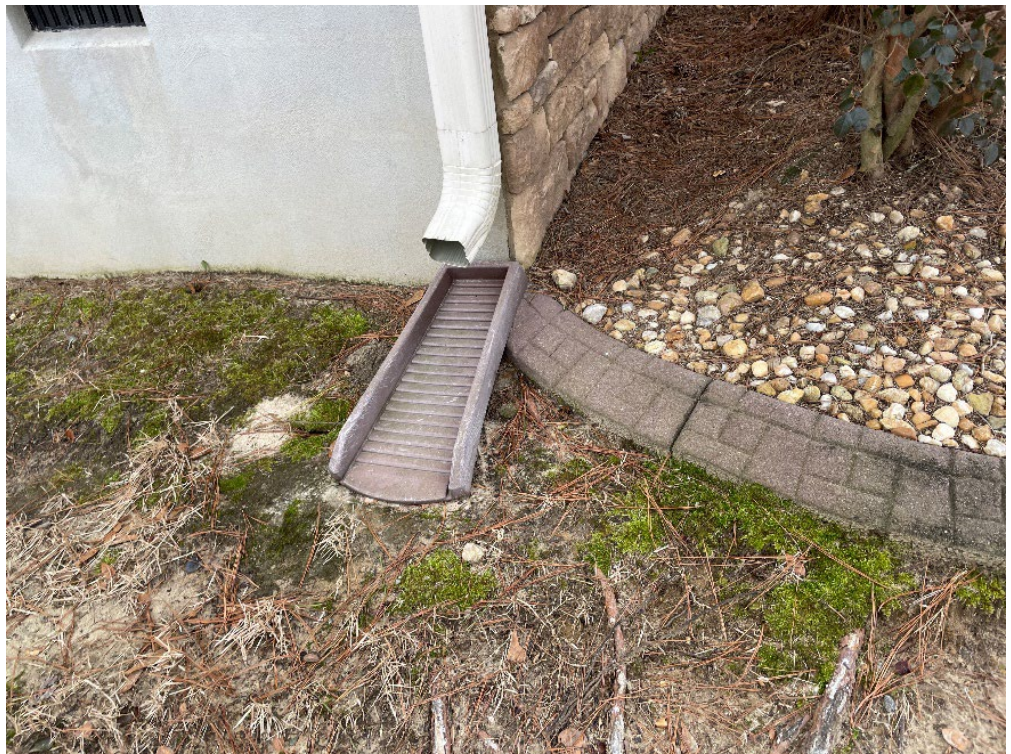
**Photo No.**  
**4**

3. Multiple minor hairline cracks (less than 1/16" wide) were noted in the parge coating with concentrations at the foundation vents around the house.
4. A stair-step crack (approximately 1/16" wide) was noted in the right perimeter foundation wall approximately 12'-9" from the rear-right corner.
5. A stair-step crack (approximately 1/16" wide) was noted in the right perimeter foundation wall approximately 7'-6" from the rear-right corner.
6. Gutters and downspouts (with leaders) were noted installed on the home. Grade was generally neutral slope at the front and right of the house with a positive slope at the left and rear of the house.

Positive grade away from the foundation should be created, where possible, to help reduce moisture infiltration under the foundation. Additional soil consolidation and settlement can occur due to water infiltration into soils and subsequent drought conditions which dry out the soils below foundations. Creating positive drainage away from the perimeter foundation walls is vital to the long-term structural integrity of the foundation.

Typical view of drainage  
observed on the exterior  
of the home.

4. We also recommend ensuring that stormwater drains positively away from the home to minimize the risk of future water infiltration. This can be accomplished by installing leaders on downspouts and ensuring gutters, downspouts, and leaders remain clear of debris and properly functioning to direct the drainage away from the home. Also, creating a positive grade around the perimeter of the home, where possible, will aid in stormwater evacuation. Water infiltration can cause further undermining of the soil and foundation settlement.

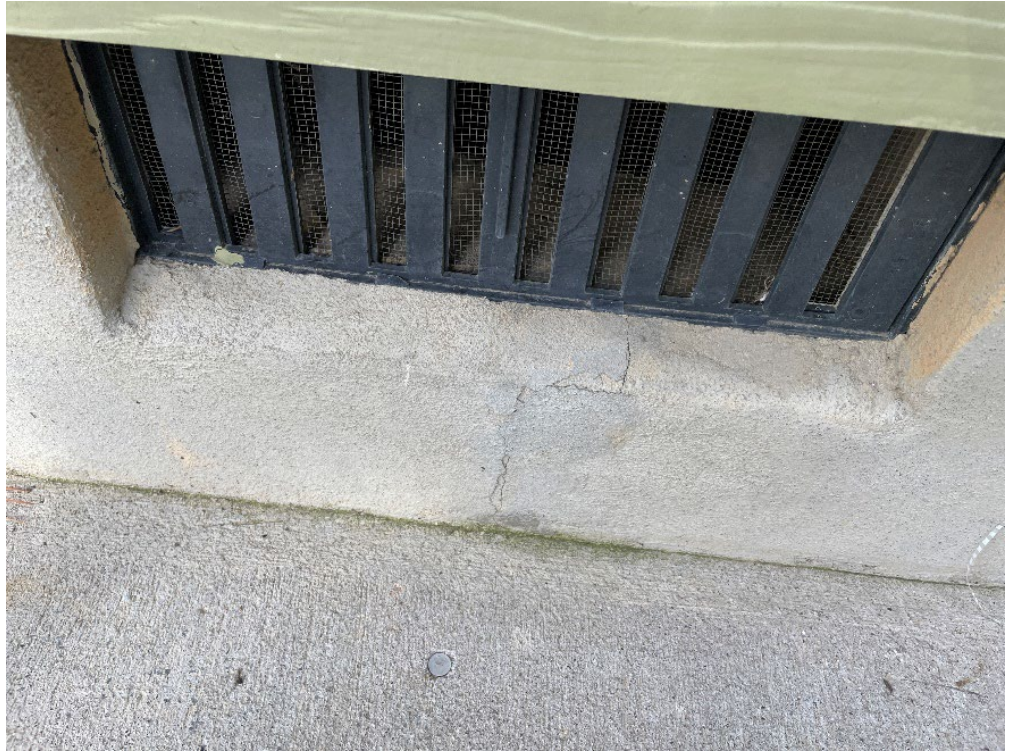
**Photo No.  
5**

The minor cracking in the parge coating in the perimeter foundation walls is likely the result of shrinkage. As cement-based materials harden and dry, they typically shrink, largely due to the evaporation of excess water. This shrinkage causes a buildup of internal forces in the material, commonly resulting in minor cracking, therefore naturally alleviating the internal stresses. The parge coating is an aesthetic component installed on the foundation walls and is not a structural concern. The condition of the walls does not appear to be affecting their load-bearing function. Monitoring the cracks for additional movement is an acceptable approach at this time.

Typical view of cracks  
in parge coating of the  
foundation wall

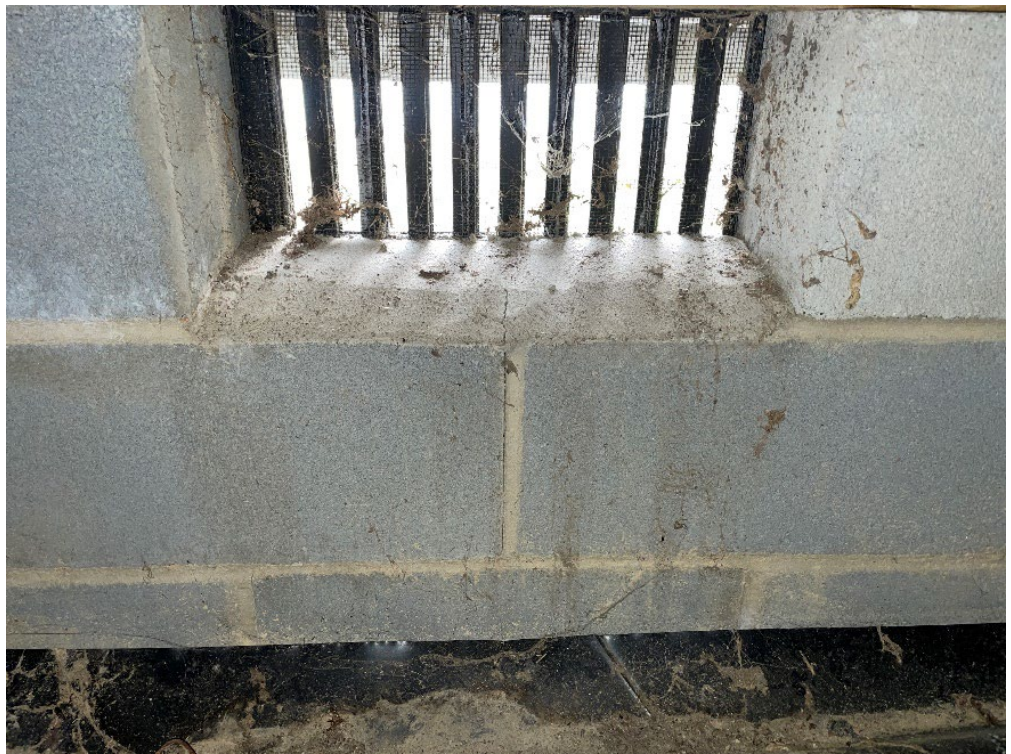
**Photo No.  
6**

10. Vertical cracks (up to 1/16" wide) were noted in the foundation walls at the following locations:
  - a. A vertical crack was noted in the left perimeter foundation wall approximately 20'-0" from the rear foundation wall

- b. A vertical crack was noted in the rear perimeter foundation wall approximately 26'-9" from the left perimeter foundation wall.
11. A vapor barrier was noted installed throughout the crawl space and there was no evidence of excessive moisture or water damage in the floor framing members at the time of inspection.

The cracks in the foundation walls noted above are likely due to limited differential foundation settlement. The clay soils in this area are considered “expansive” type soils and will typically expand and contract with fluctuations in the moisture content. This expansion and contraction of load-bearing soil materials can lead to soil consolidation and foundation cracking/movement. If conditions around the foundation remain relatively dry, the likelihood of future significant settlement will be reduced, but we cannot predict the extent of future settlement. The condition of the foundation wall does not appear to be a significant structural deficiency and improving exterior drainage and monitoring cracks for additional propagation is an acceptable approach at this time.

Typical view of cracks  
in the foundation wall.

3. Monitor the cracks in the foundation walls. If the cracks widen significantly (expand by an additional 1/8") or additional significant cracks (greater than 1/4" wide) propagate, then further evaluation by a structural engineer may be needed at that time.

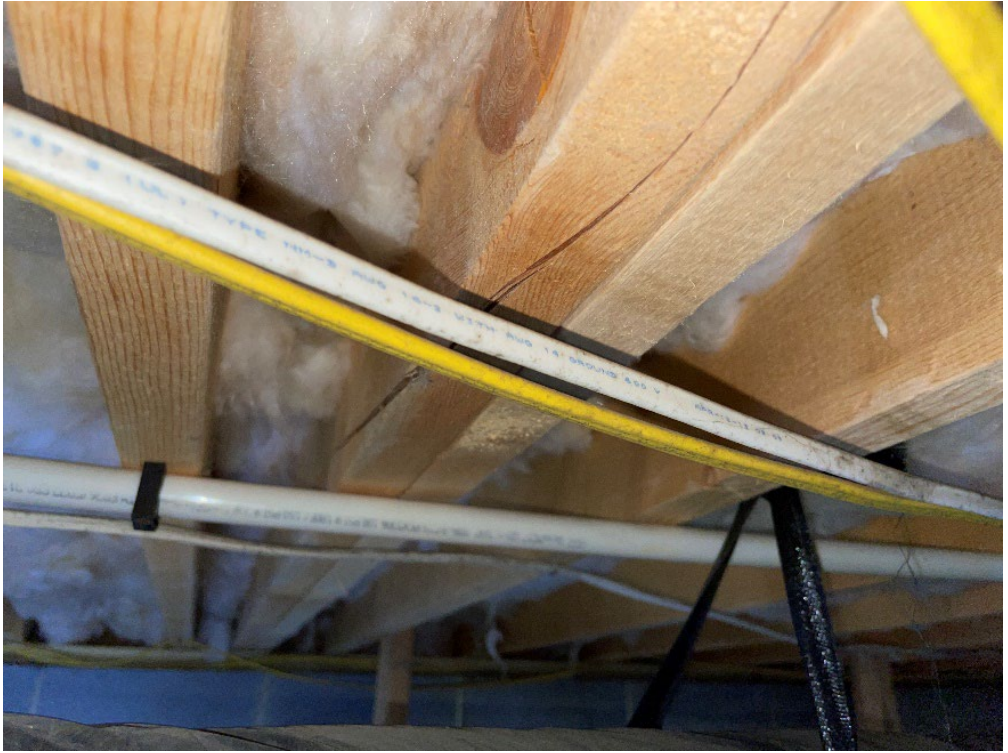
**Photo No.**  
**7**

9. A cracked 2x10 floor joist was noted approximately 11'-9" from the right perimeter foundation wall. Note, this location seemingly corresponds with the location of the kitchen island noted above.

**Description**  
View of damaged floor joist.

2. We recommend fully sistering the damaged floor joist noted above for the full length (bearing point to bearing point). The new sistered member should match the size of the existing joist and be attached with (3) 10d nails at 16" O.C.
