Matthew C. Murphy, PE
Stonewall Structural Engineering, PLLC
9203 Baileywick Rd. #200
Raleigh, NC 27615
(919)407-8663

Re: Revised Structural Observation — *101 North 12th Street, Erwin, NC 28339*

Repair Plan

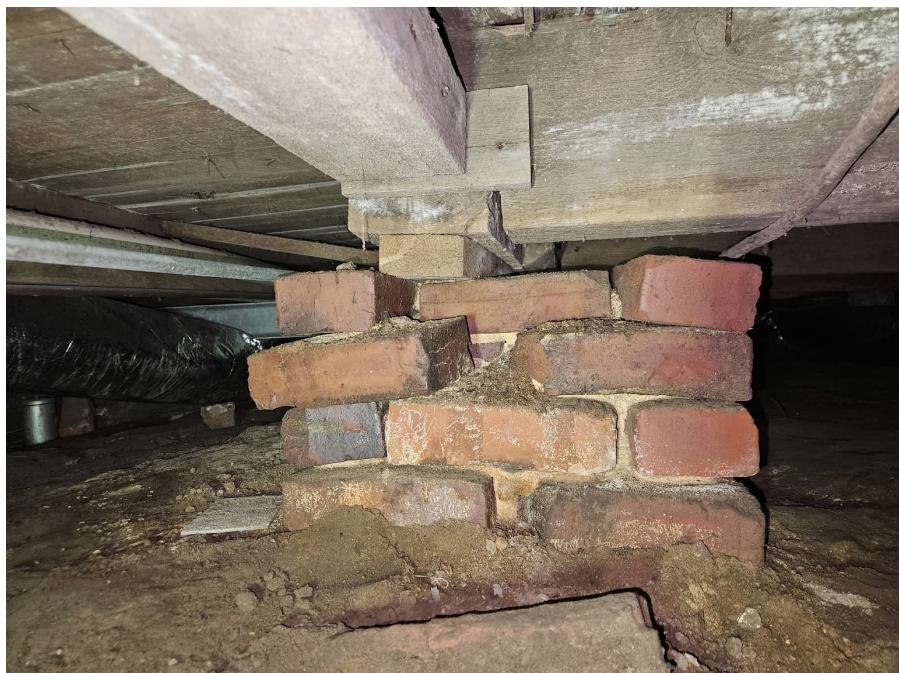
- Numerous brick support piers were noted to be in poor condition and providing inadequate support (see *repair plan for approximate locations* and *pictures 2-3 for examples*).

Picture 2 – Inadequate brick pier

- 1) Remove and replace all improper brick pier supports with new CMU piers constructed per the attached detail (see *Detail 1*) and centered over a 24"x24"x10" thick poured concrete footings.

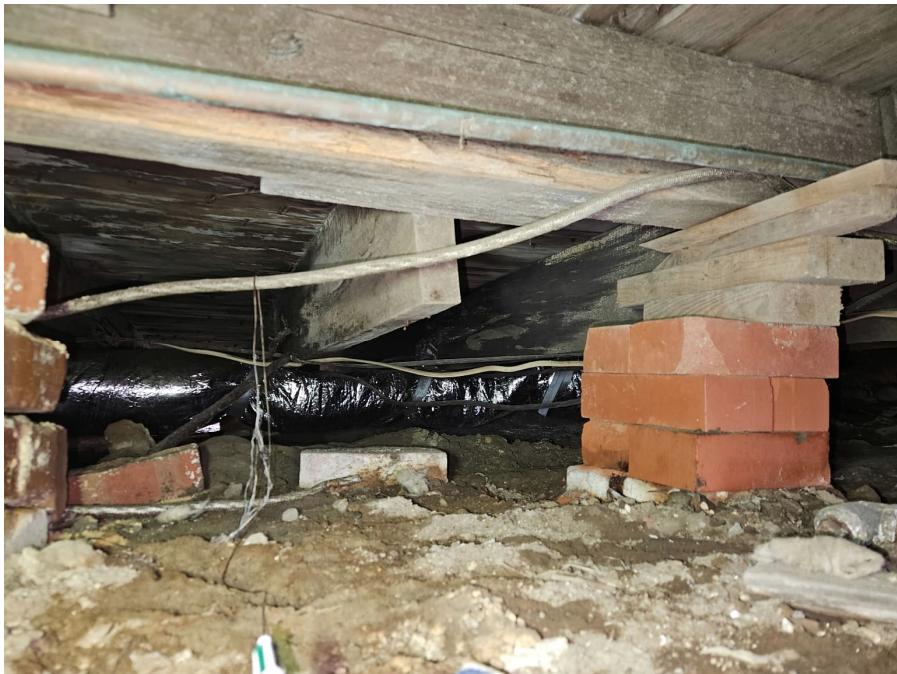
Picture 3 – Inadequate brick pier

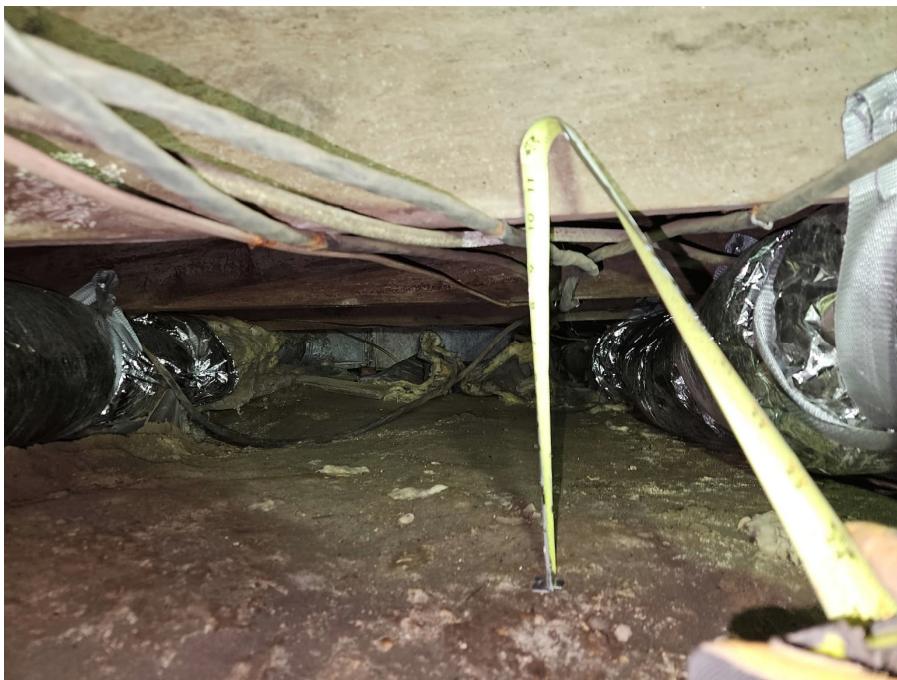
- A significant portion of the crawlspace was unable to be accessed during our site visit due to space constraints (see *picture 4 and the attached repair plan for additional information*).

Picture 4 – Inadequate clearance

- 5) Modern building standards require at least 18" of clearance from top of crawlspace soils to the undersides of joists, and at least 12" of clearance from top of crawlspace soils to the undersides of girders. We recommend removal of soils from the crawlspace as is necessary to achieve minimum clearances to help prevent significant deterioration of wood framing members due to rot. Care should be taken not to undermine foundation elements by removal of soils from the crawlspace.

- a) If excavation is not to be performed, any new framing material should be treated #2 SYP in areas where minimum clearances are not met.
- 6) We strongly advise additional investigation be performed including the select removal of finishes in the portions of the home that are significantly uneven.

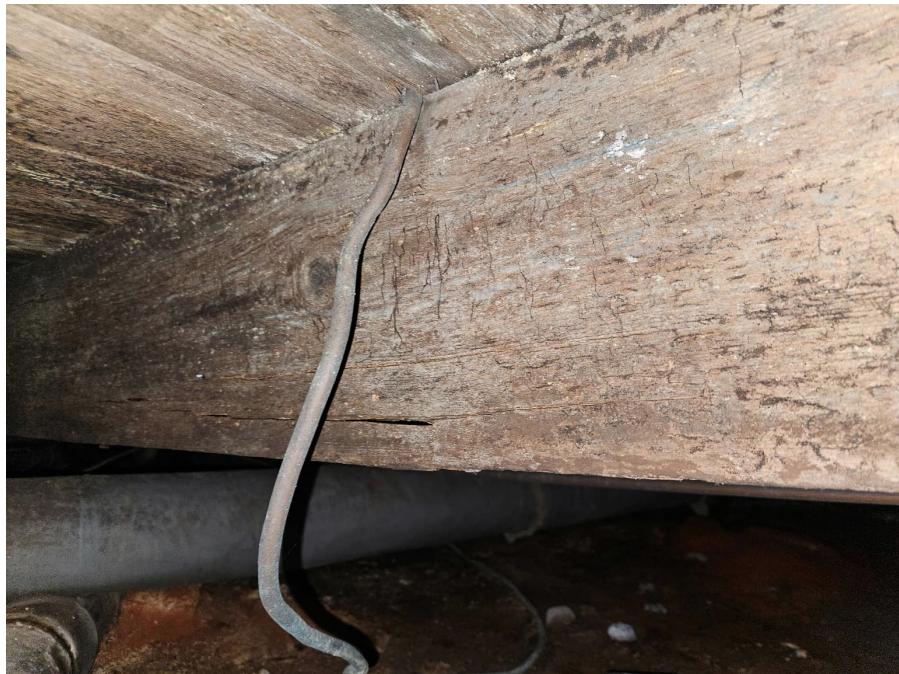
- Limited investigation from the crawlspace revealed the 5th-7th joists from the right were deteriorated (see *pictures 5-6 for examples*).
 - Measurement by laser level indicated the floor joists were sagging by as much as approximately 1 $\frac{3}{8}$ " at midspan.

Picture 5 – Deteriorated joist

- 2) Reinforce the back most girder bay at midspan using an IntelliJack support on a well-compacted 18"x18"x18" gravel footing (see *Detail 2*).
- 3) Reinforce each of the deteriorated joists noted above with an additional ply of full-depth (2x8 minimum) 2x #2 Southern Yellow Pine (SYP), fastened to the side of the deteriorated joists using (3)10d common nails at each end and at 12" on-center staggered top and bottom along the lengths of the joists. Sistered material should span continuously between end supports.

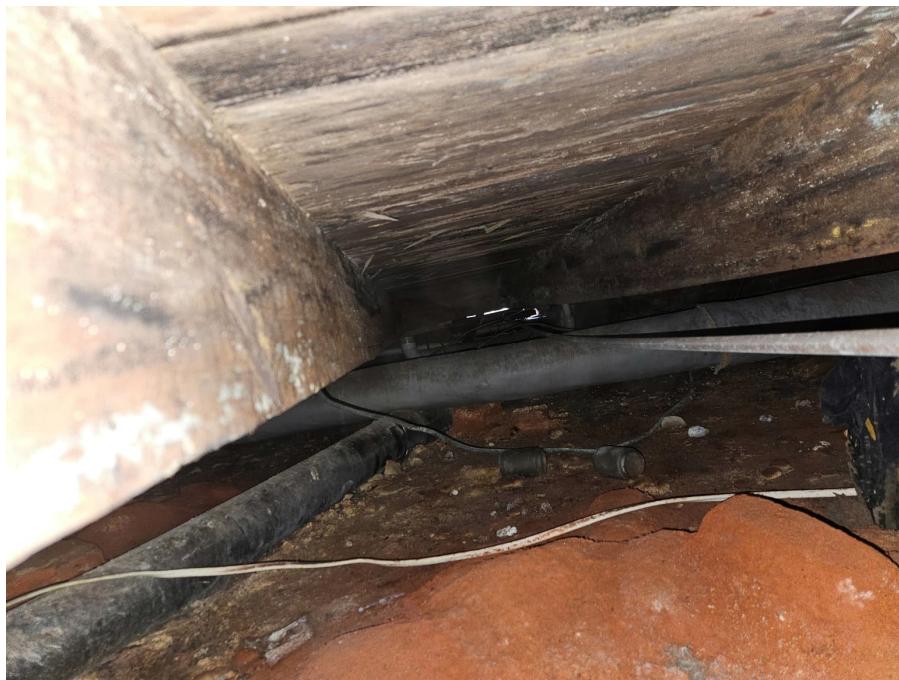
Picture 6 – Deteriorated joist

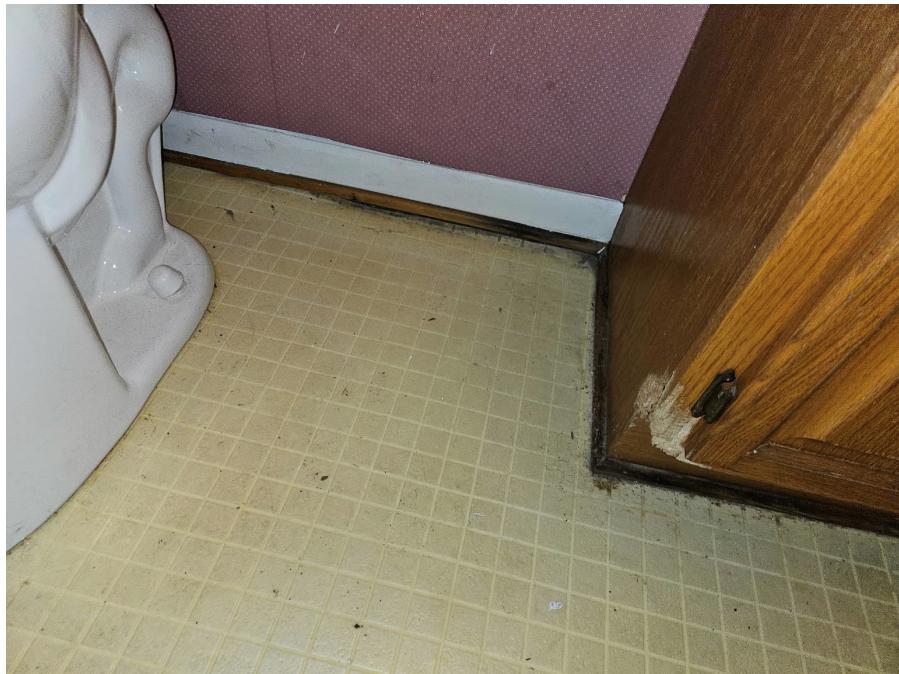
- Significant slopes in the floor were noted near the back bathroom as well as the left side of the home (see *picture 7 for example*).
 - As noted above, the framing beneath these areas was inaccessible at the time of our site visit; however, significant deterioration was visually apparent (see *picture 8*).

Picture 7 – Slope in bathroom

- a) *Additional structural repairs, up-to and potentially including, re-framing may be required. The removal of finishes to expose the existing framing configuration and the extents of deterioration are required in order to facilitate design of the appropriate repairs.*

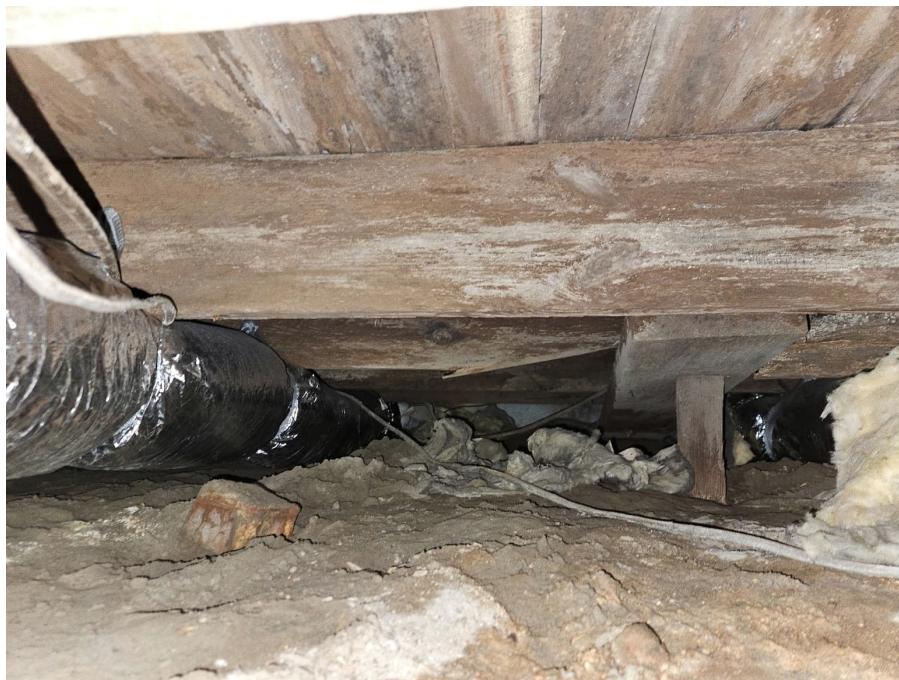
Picture 8 – Deteriorated joists past inadequate clearance
