RE: Asbestos Inspection
995 Bullard Road, Sanford, North Carolina 27332
EI Project No: IHMO230000.27
ReBuild NC Batch ID: APP-12327, INSP-0015269

Per the contract outlined by The North Carolina Office of Recovery and Resiliency (NCORR), The EI Group, Inc. performed a limited asbestos inspection for the residence located at 995 Bullard Road in Sanford, North Carolina. The inspection was performed by Mr. Chris Ciappina (NC Asbestos Inspector #13253) on January 16, 2023 and limited to the residence's accessible interior and exterior.

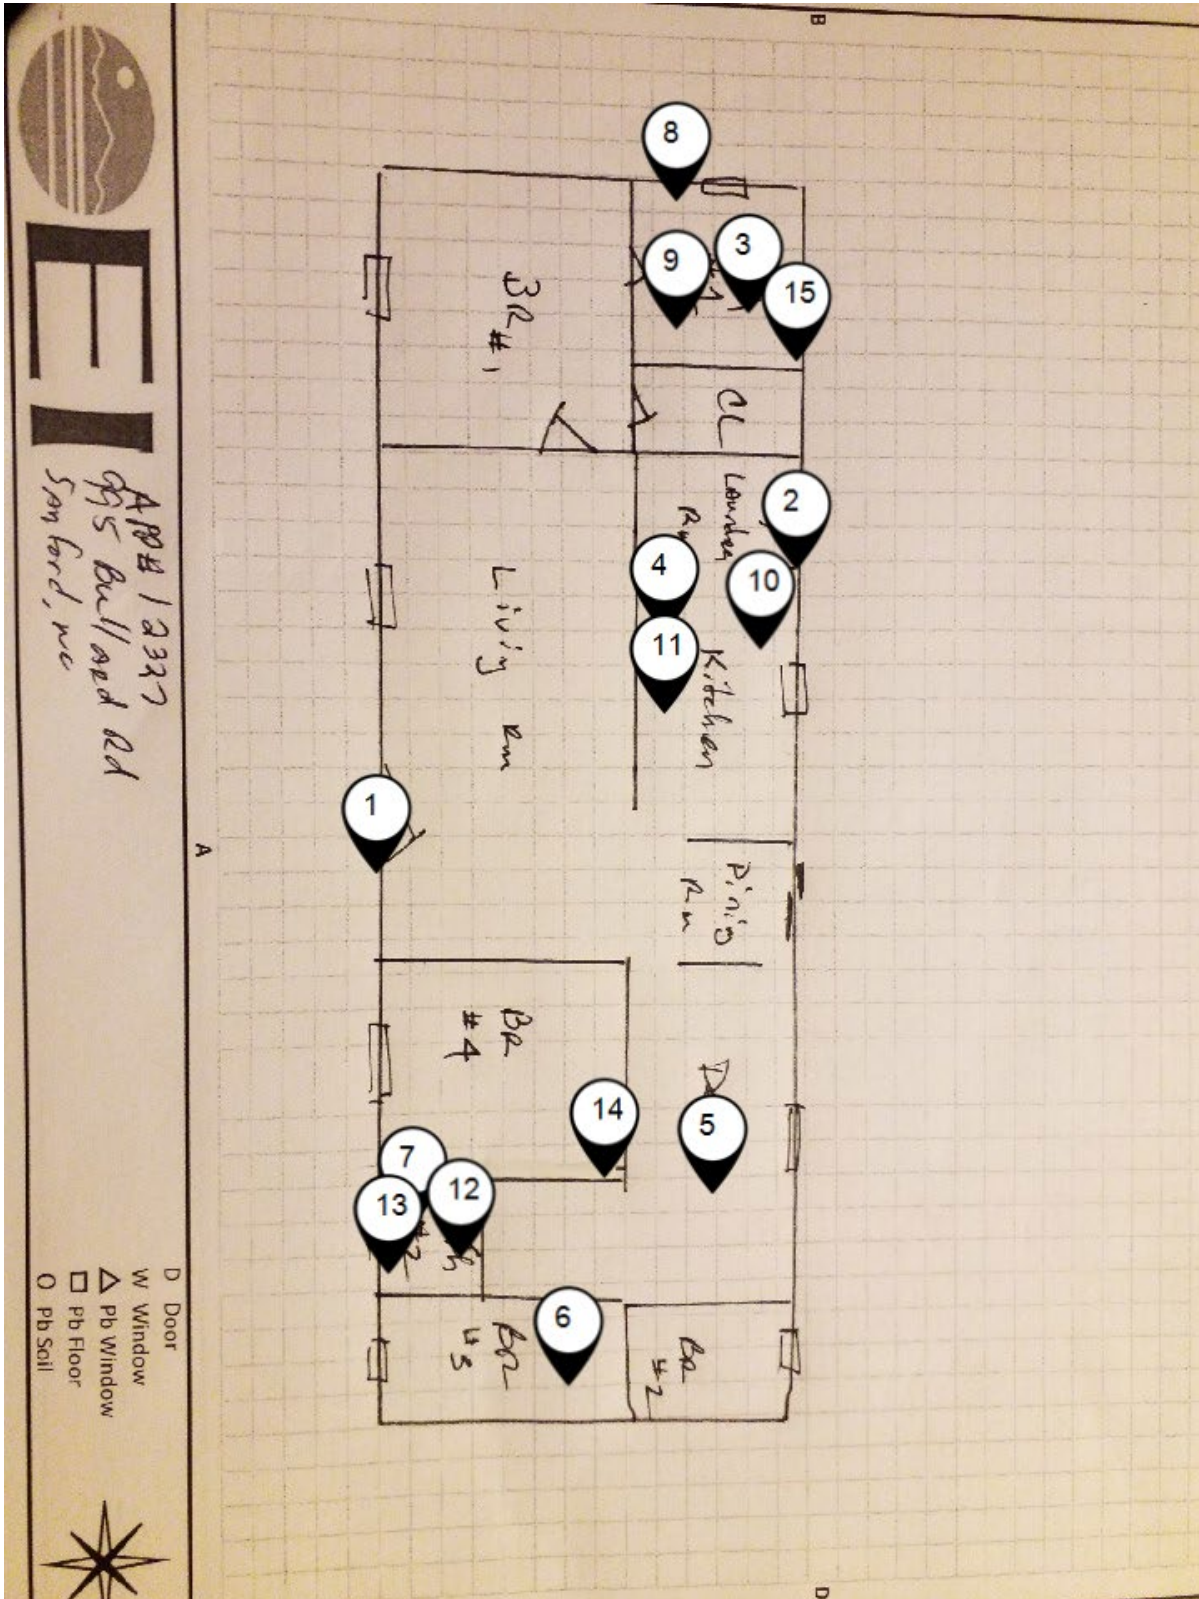
APPENDIX C: SAMPLE LOCATION MAPS

Map ID	Sample ID	Space Name	Material	Lab Result	Analytical Result
1	001A	Exterior	001 - Roofing, Composite Shingle	Tested Negative by Lab (No Asbestos Detected)	N/A
2	001B	Exterior	001 - Roofing, Composite Shingle	Tested Negative by Lab (No Asbestos Detected)	N/A
3	002A	Bathroom 1	002 - Textured Ceiling	Tested Negative by Lab (No Asbestos Detected)	N/A
4	002B	Kitchen	002 - Textured Ceiling	Tested Negative by Lab (No Asbestos Detected)	N/A
5	002C	Den	002 - Textured Ceiling	Tested Negative by Lab (No Asbestos Detected)	N/A
6	002D	Bedroom 3	002 - Textured Ceiling	Tested Negative by Lab (No Asbestos Detected)	N/A
7	002E	Bathroom 2	002 - Textured Ceiling	Tested Negative by Lab (No Asbestos Detected)	N/A
8	003A	Bathroom 1	003 - white and Blue Tile	Tested Negative by Lab (No Asbestos Detected)	N/A
9	003B	Bathroom 1	003 - white and Blue Tile	Tested Negative by Lab (No Asbestos Detected)	N/A
10	004A	Kitchen	004 - White Linoleum	Tested Negative by Lab (No Asbestos Detected)	N/A

11	004B	Kitchen	004 - White Linoleum	Tested Negative by Lab (No Asbestos Detected)	N/A
12	005A	Bathroom 2	005 - 12" x 12" Black Stick-on Tile	Tested Negative by Lab (No Asbestos Detected)	N/A
13	005B	Bathroom 2	005 - 12" x 12" Black Stick-on Tile	Tested Negative by Lab (No Asbestos Detected)	N/A
14	006A	Den	006 - Gypsum Wallboard	Tested Negative by Lab (No Asbestos Detected)	N/A
15	006B	Bathroom 2	006 - Gypsum Wallboard	Tested Negative by Lab (No Asbestos Detected)	N/A

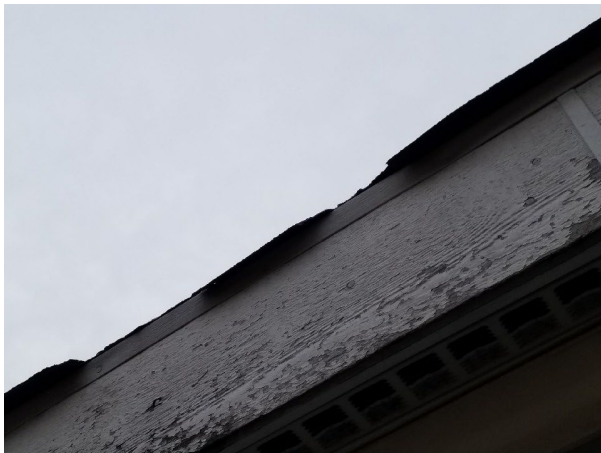
001A, 001 - Roofing, Composite Shingle, Exterior, Main Floor

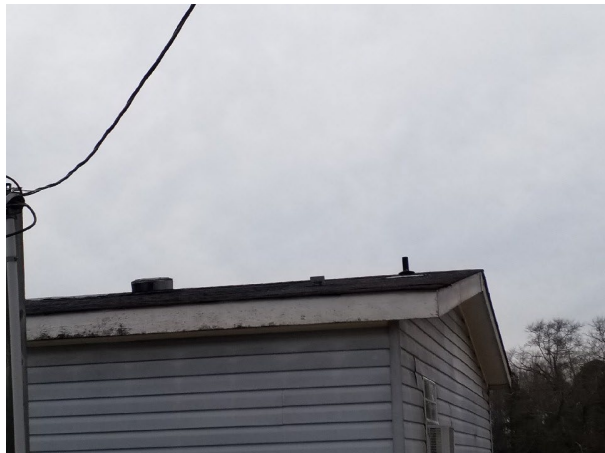
001B, 001 - Roofing, Composite Shingle, Exterior, Main Floor

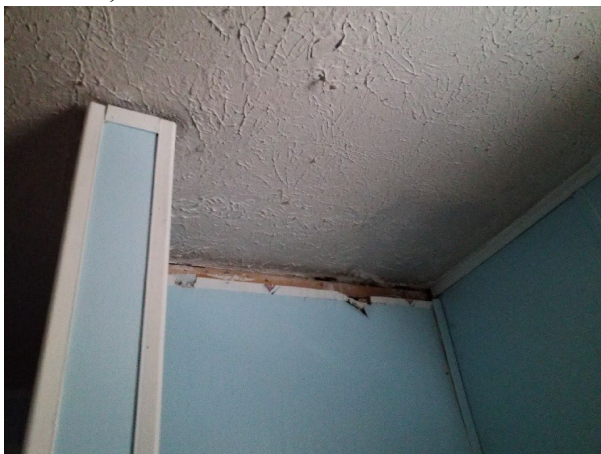
002A, 002 - Textured Ceiling, Bathroom 1, Main Floor

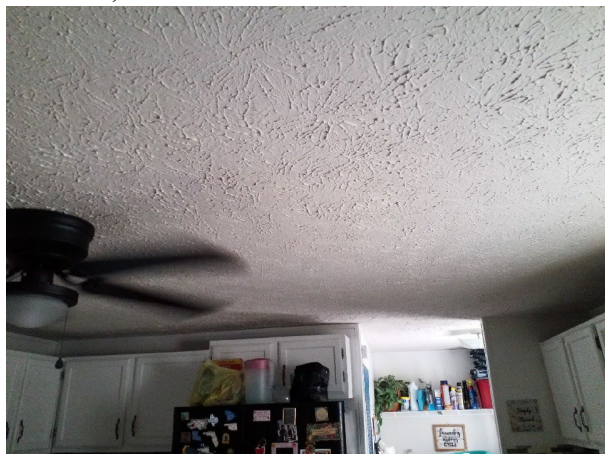
002B, 002 - Textured Ceiling, Kitchen, Main Floor

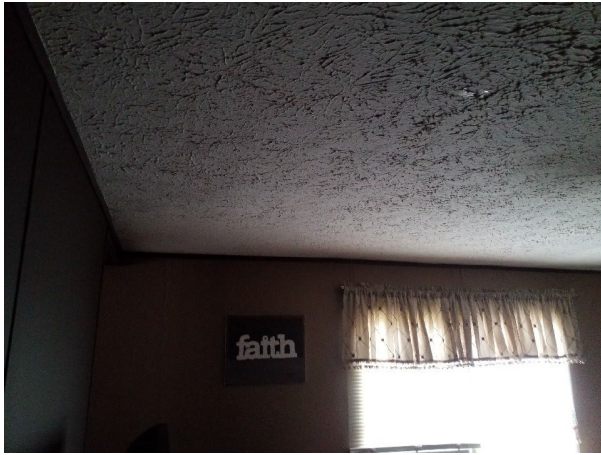
002C, 002 - Textured Ceiling, Den, Main Floor

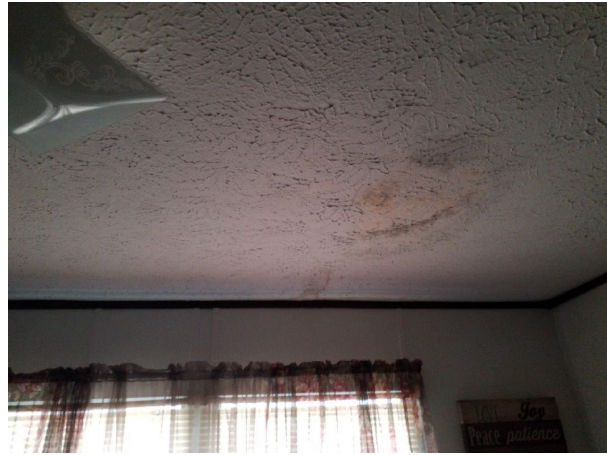
002D, 002 - Textured Ceiling, Bedroom 3, Main Floor

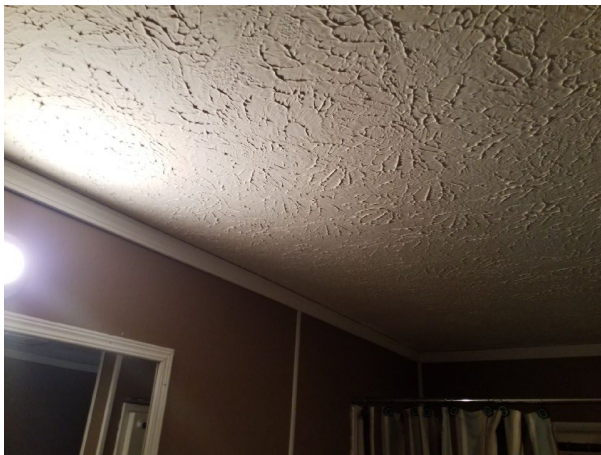
002E, 002 - Textured Ceiling, Bathroom 2, Main Floor

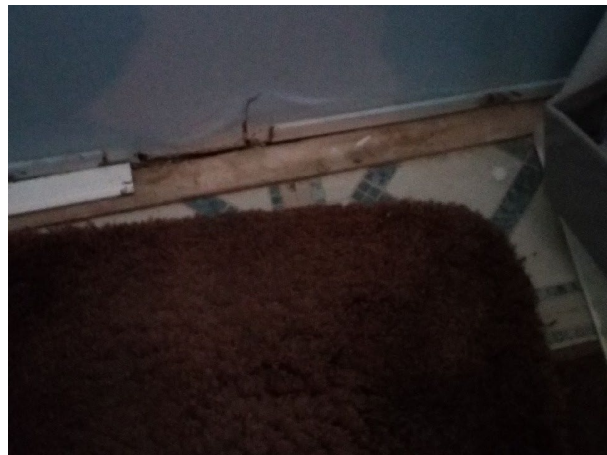
003A, 003 - white and Blue Tile , Bathroom 1, Main Floor

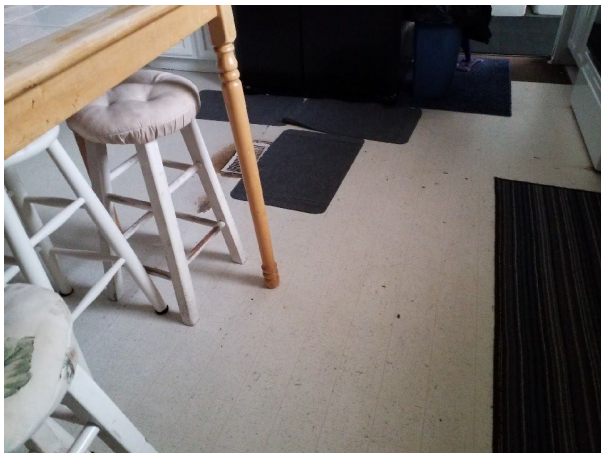
004A, 004 - White Linoleum , Kitchen, Main Floor

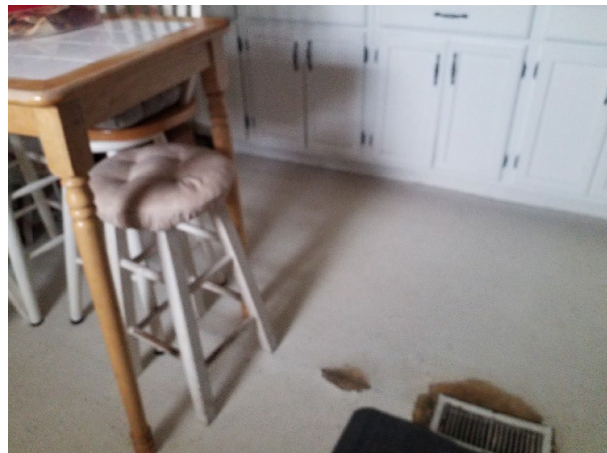
004B, 004 - White Linoleum , Kitchen, Main Floor

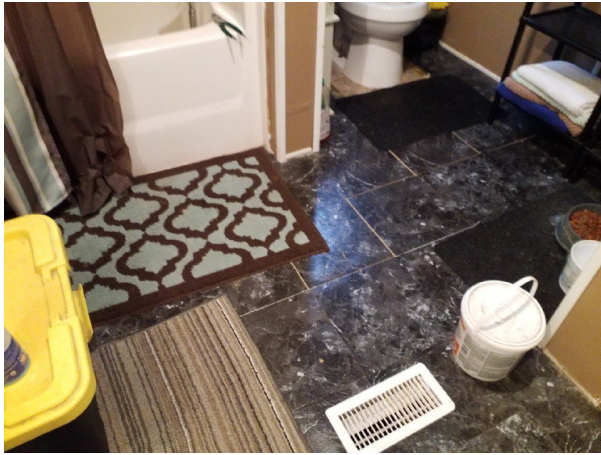
005A, 005 - 12 x 12 Black Stick on Tile , Bathroom 2, Main Floor

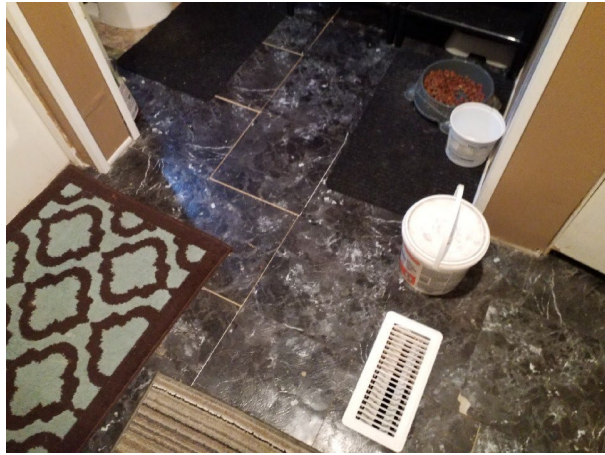
005B, 005 - 12 x 12 Black Stick on Tile , Bathroom 2, Main Floor

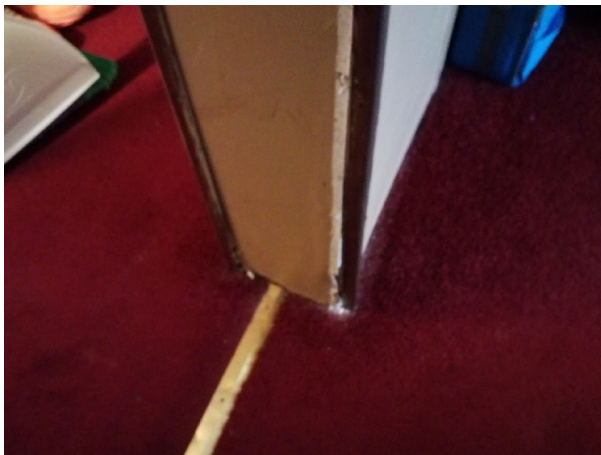
006A, 006 - Gypsum Wallboard, Den, Main Floor

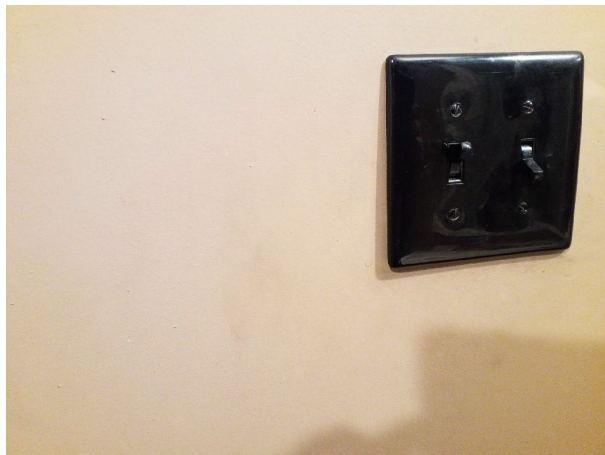
006B, 006 - Gypsum Wallboard, Bathroom 2, Main Floor
