December 09, 2021

ReBuild NC - Package 15
1600 Perimeter Park Drive
Morrisville, North Carolina 27560

RE: Asbestos Inspection
121 Stewart Farm Ln., Spring Lake, North Carolina 28390
ReBuild NC Batch ID: APP-03991

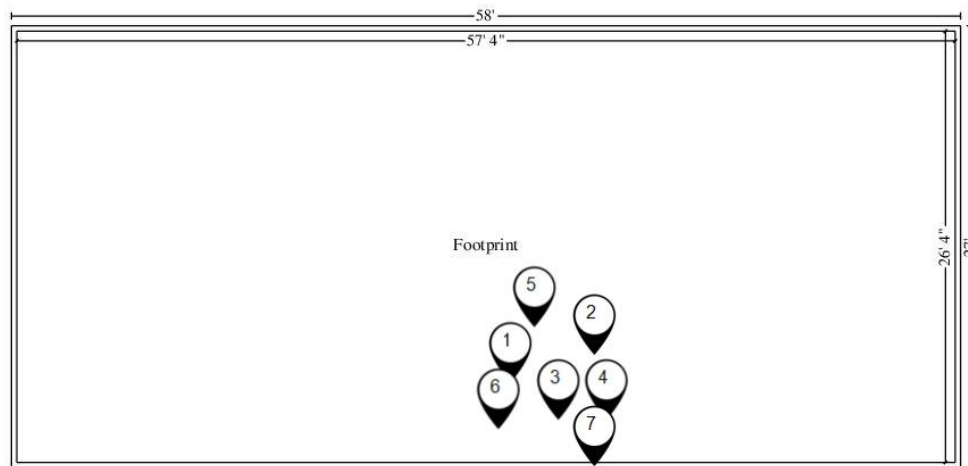
Main Level

Map ID	Sample ID	Space Name	Material	Lab Result	Analytical Result
1	001A	Living Room	001 - Textured Ceiling	Tested Negative by Lab (No Asbestos Detected)	N/A
2	001B	Living Room	001 - Textured Ceiling	Tested Negative by Lab (No Asbestos Detected)	N/A
3	001C	Living Room	001 - Textured Ceiling	Tested Negative by Lab (No Asbestos Detected)	N/A
4	001D	Living Room	001 - Textured Ceiling	Tested Negative by Lab (No Asbestos Detected)	N/A
5	001E	Living Room	001 - Textured Ceiling	Tested Negative by Lab (No Asbestos Detected)	N/A
6	002A	Living Room	002 - Gypsum Wallboard Joint Compound	Tested Negative by Lab (No Asbestos Detected)	N/A
7	002B	Living Room	002 - Gypsum Wallboard Joint Compound	Tested Negative by Lab (No Asbestos Detected)	N/A
