Date: July 19, 2024  
Project: Hoggard Residence  
Address: 209 Holder Rd  
Lillington, NC 27546

### Wood Framing Floor Support Analysis

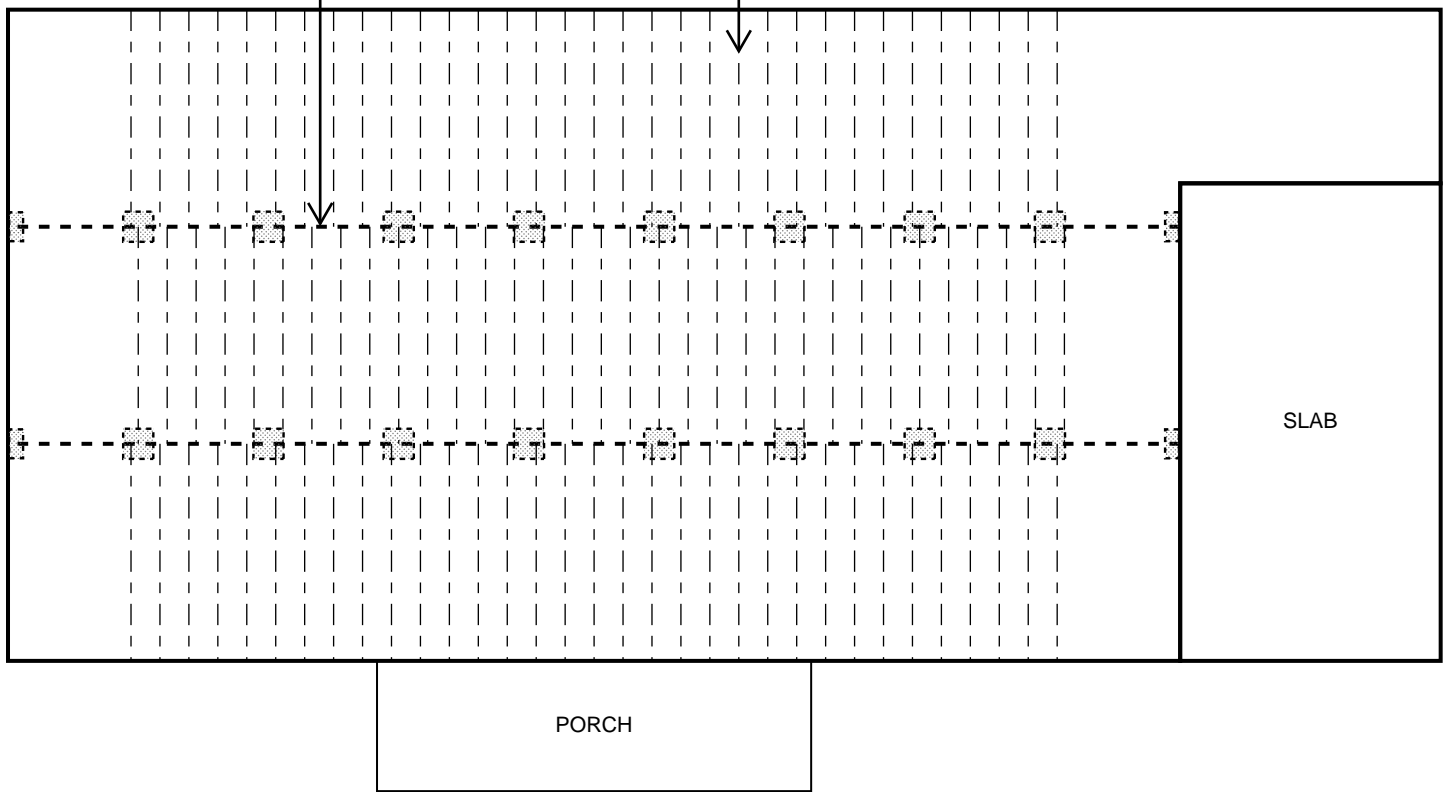
FRONT HOUSE  
FOOTPRINT OF  
RESIDENCE

Replace (Double 2 x 8)  
Damaged/Rotted Main Beam

Sister (2 x 8)  
Damaged Joists.
