Reference: Engineering Services
1604 Brick Mill Road
Coats, NC 27521
TE&D Project No.: 2401-020919

1. Assessment of existing collar ties for vaulted porch roof.

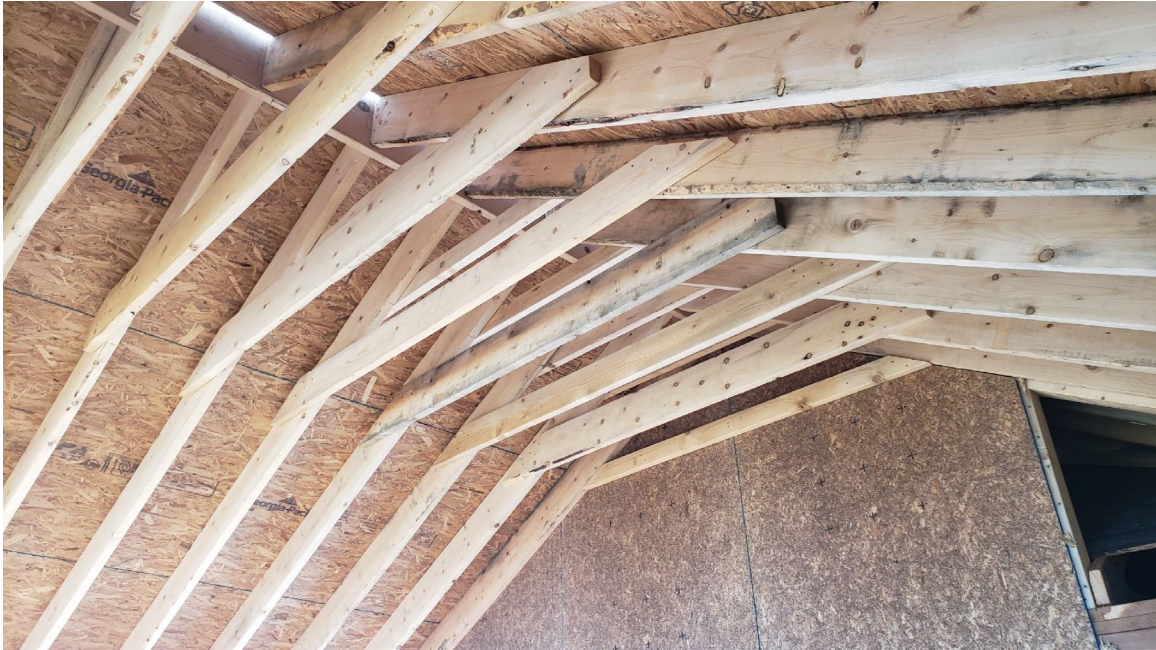
1. We observed the porch roof as consisting of 2 x 8 at 16" o.c. collar ties positioned approximately 1'-8" below the existing ridge. Collar ties were fastened with nails. Based on our observations and analysis, the existing configuration is inadequate to support the anticipated loading conditions. We recommend the following:
 - a. Several collar ties were missing at the front of the porch roof. The 2 x 8 at 16" o.c. collar ties are to extend to the frontmost point of the new ridge (i.e. to the end of the roof overframe). Collar ties are to be positioned 1'-8" below the ridge.
 - b. The method of attachment is inadequate. We recommend fastening each end of the collar ties to the rafters with (4) SDWS screws.

Example of existing collar ties
