## LIMITED STRUCTURAL INSPECTION

671 Prospect Church Rd  
Dunn, NC

September 8, 2025

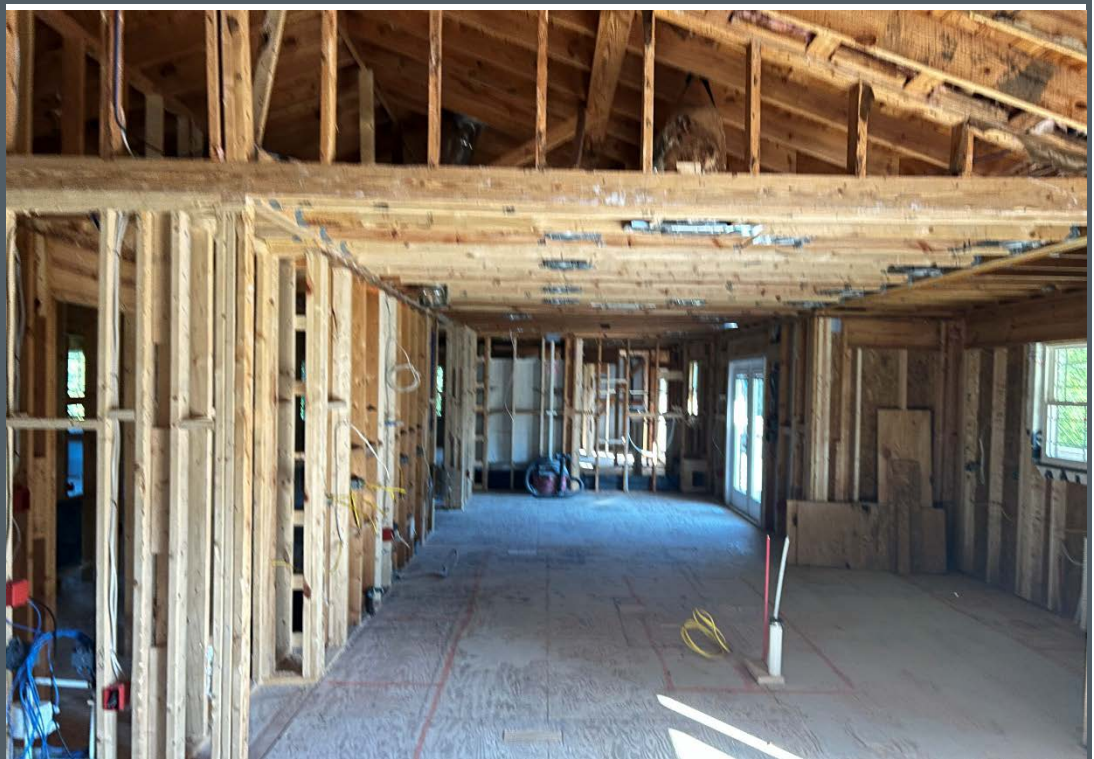
Photo No.  
3

1. A new 3-1.75" x 9.25" LVL beam had been installed above the bedroom area on the left side of the home, and was supporting the ceiling framing.
2. The beam was supported at the left perimeter wall by 4-2 x 4 jack studs. The beam was supported approximately 17'-8" to the right by 5-2 x 4 jack studs, which were supported on a 2- 2 x 10 steel flitch beam with a half-inch steel plate. The beam extended an additional 5'-6" to the right and was supported by an additional two jack studs. Note that the beam only had bearing on the wall plate over approximately half of its cross-section at this bearing point.

3. The plies on the beam were connected via three rows of nails spaced approximately 12 to 16 inches on center. The ceiling joists were connected to the beam via joist hangers.

View of the new LVL beam.

- Connect the plies of the beam together with (2) 5-inch Simpson SDWS screws or equivalent, spaced 16 inches on center.
- Install 30-inch-long Simpson CS 16 straps or equivalent spaced 48 inches on center and connect the ceiling joists on either side of the beam.

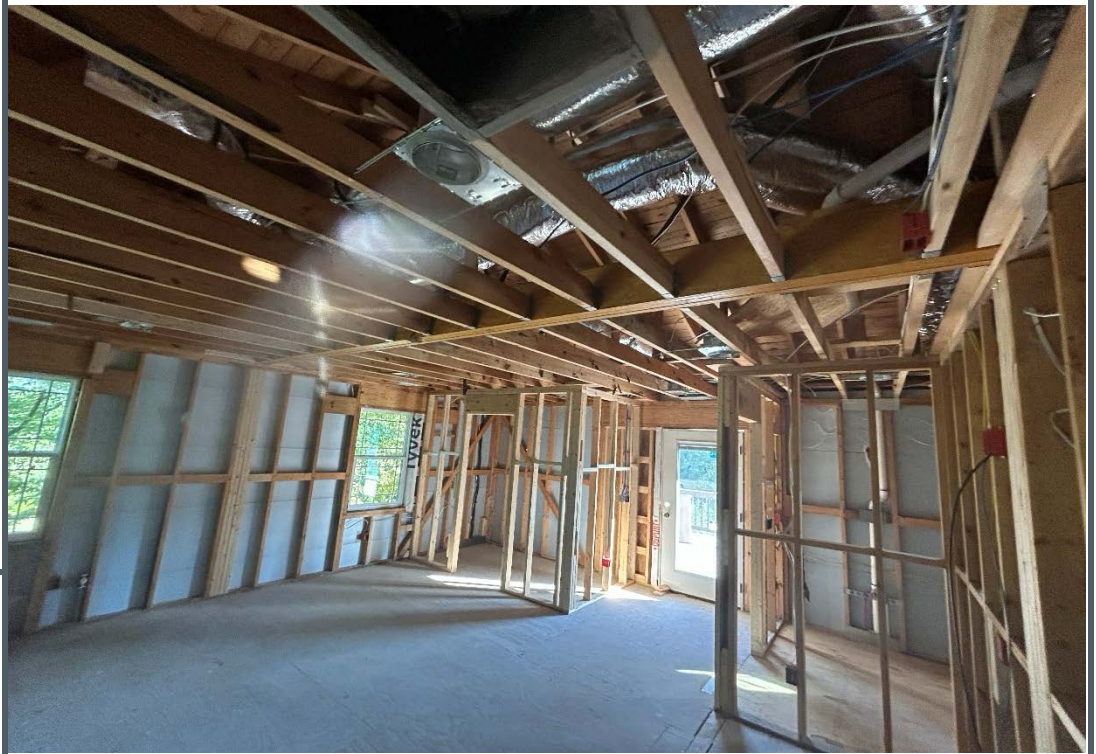
Photo No.  
4

View of the beam bearing.

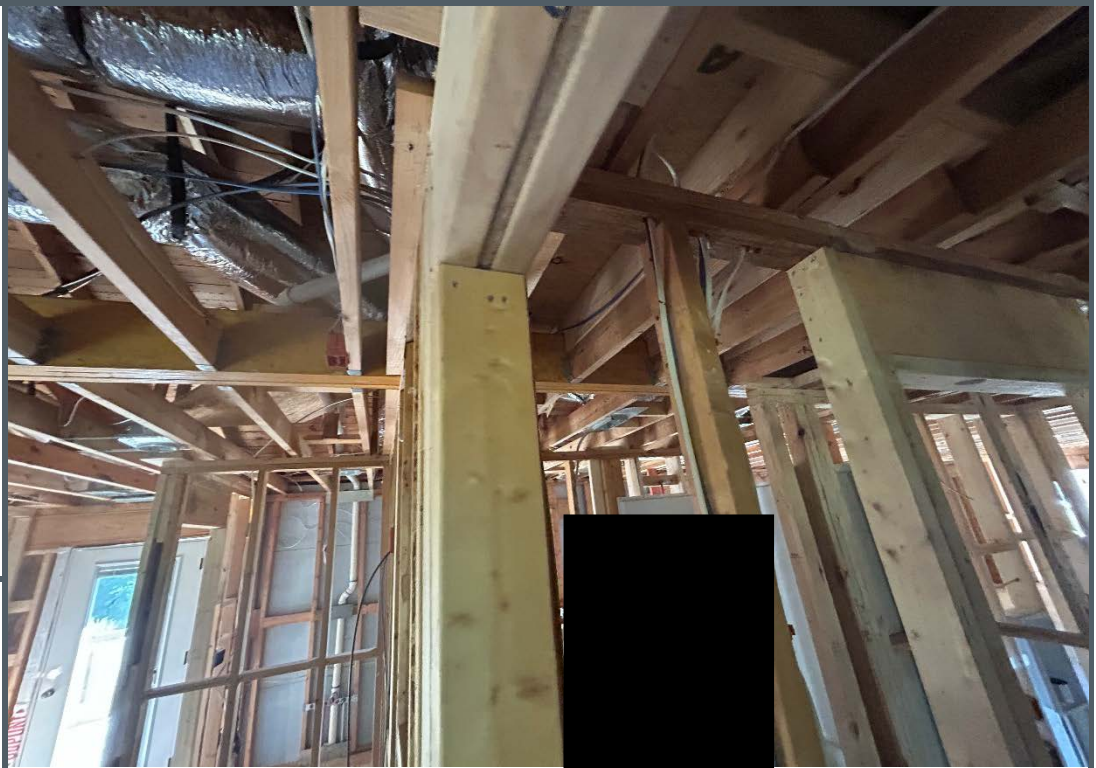
Photo No.  
5

View of the beam bearing.

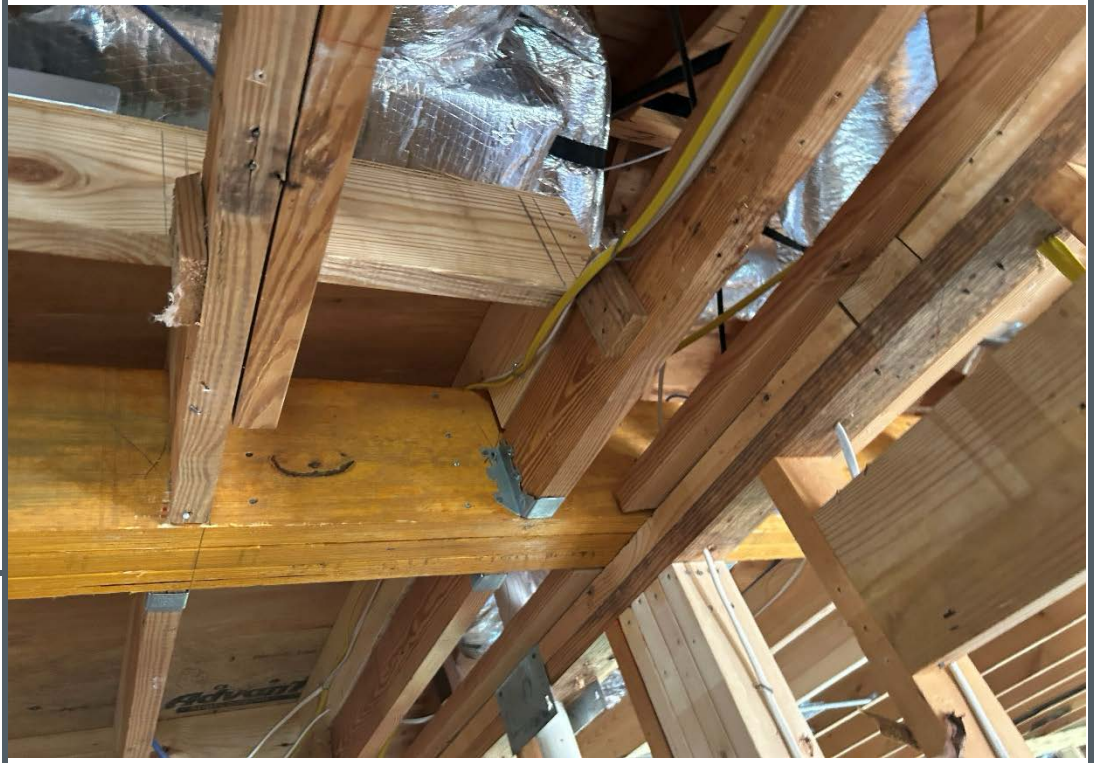
Photo No.  
6

Per our calculations, the 3-1.75 x 9.25" LVL is sufficiently supported by the steel flitch plate beam below and supporting steel columns. The partial bearing area at the second load point is also sufficient. The following repairs are required for the beam assembly.

View of the beam and partial bearing at the wall adjacent to the shower.

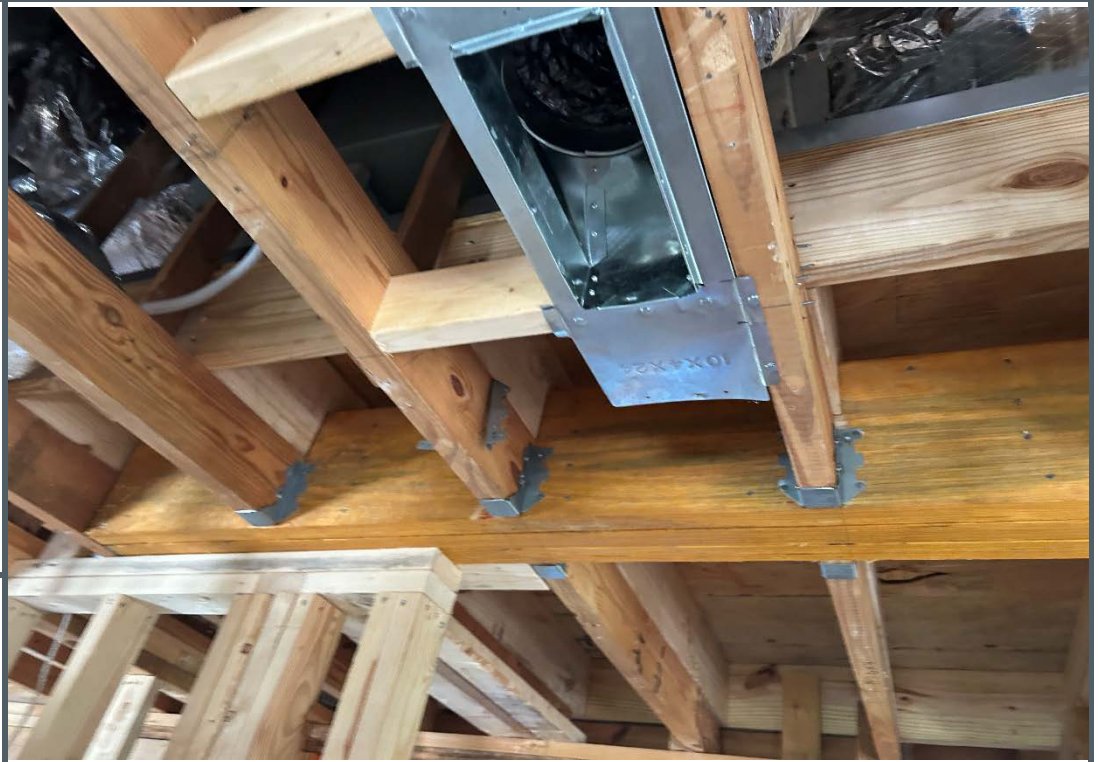
Photo No.  
7

Additional views of the beam.

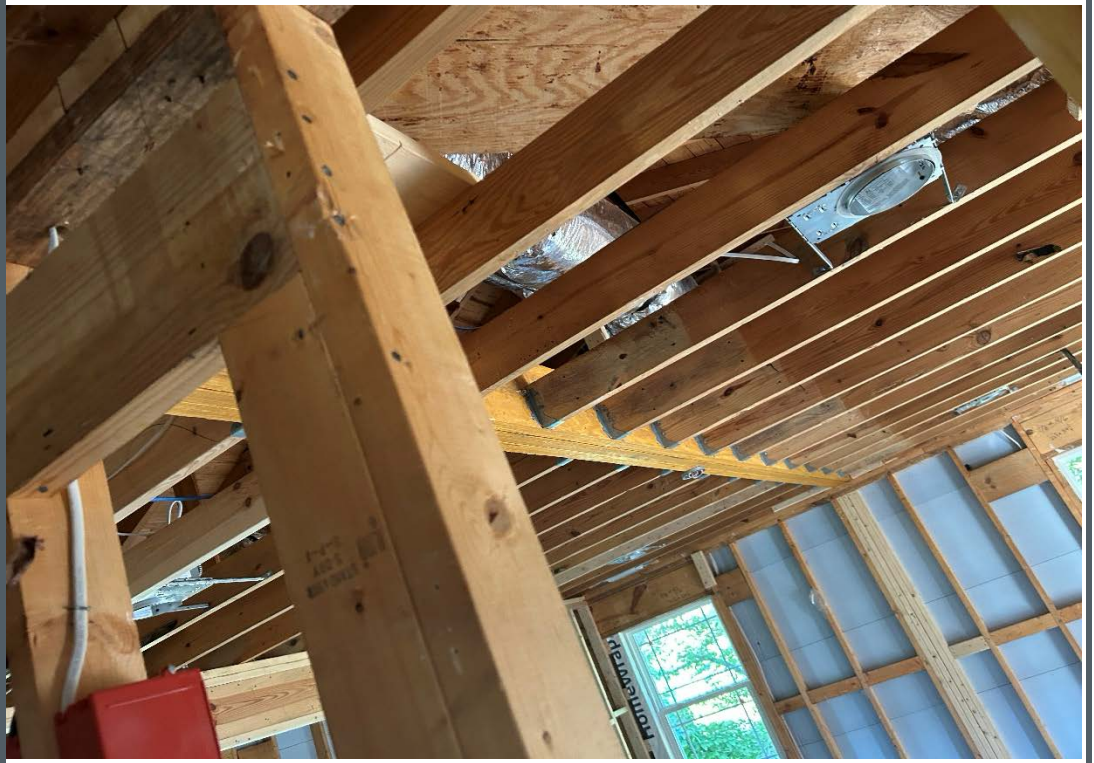
Photo No.  
8

Additional views of the beam.

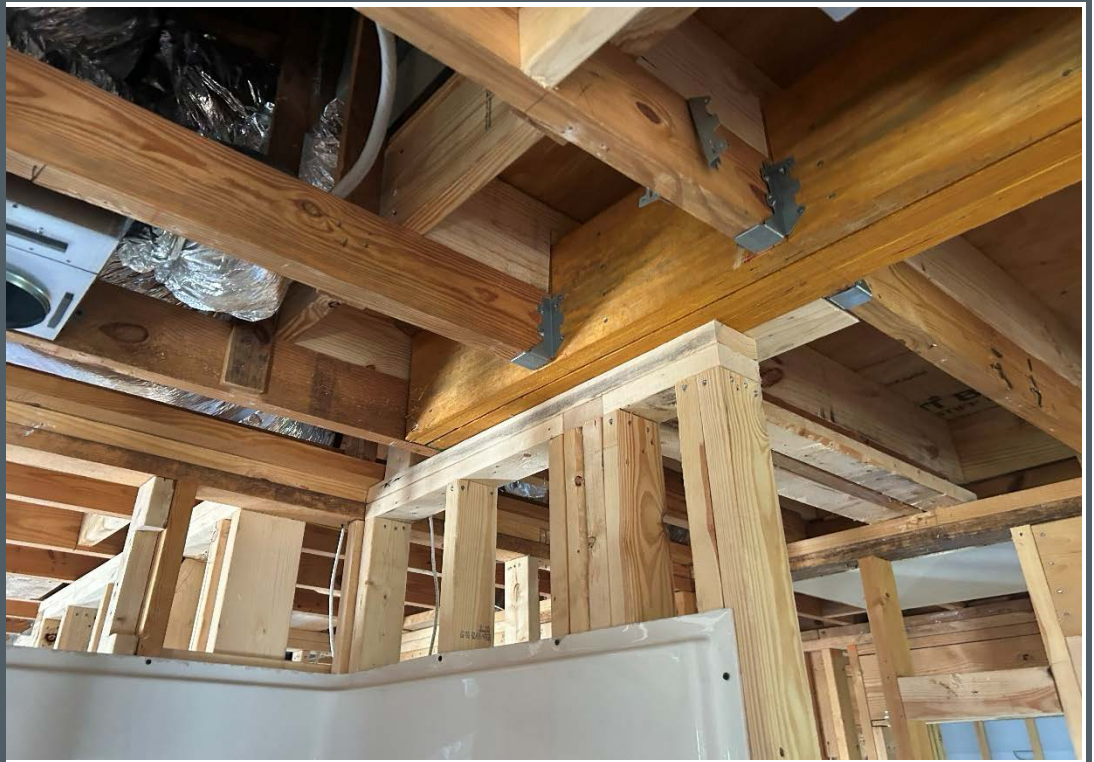
Photo No.  
9

View of partial bearing  
of the beam at the  
wall.
