W. Harrison Welch, PE
Stonewall Structural Engineering, PLLC
9203 Baileywick Rd. #200
Raleigh, NC 27615
(919)407-8663

Re: Review of Proposed Foundation Repairs — 380 Senter Lane, Bunnlevel, NC 28323

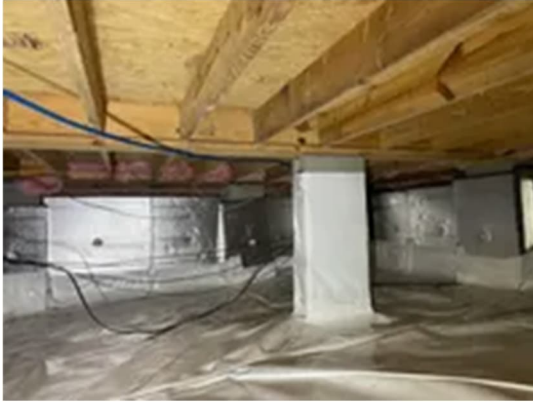
Picture 3 – Existing Foundation System and Typical First Floor Framing

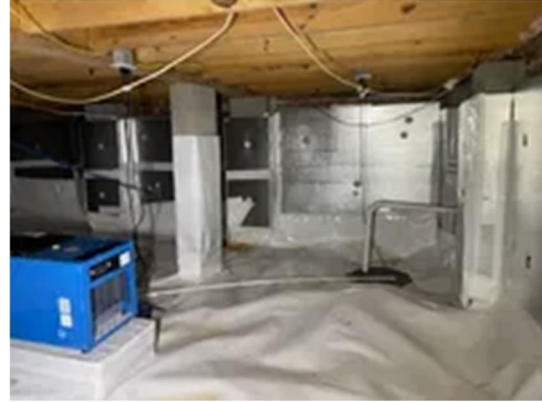
Picture 4 – Existing Crawlspace (Closed Crawlspace System)

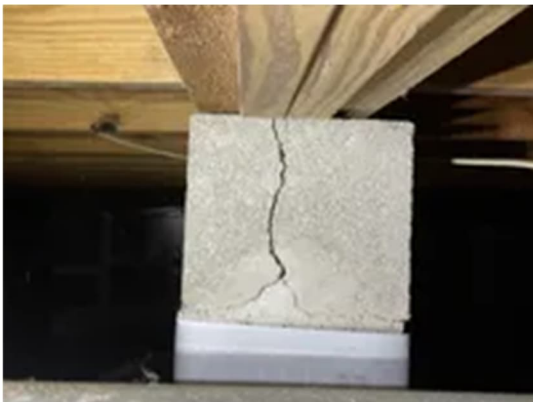
1. One (1) cracked Cement Masonry Unit (CMU) block was reported near the middle of the back girder line (*see picture 5*).
2. One (1) masonry pier was reported to be out of contact with its supported girder (*see picture 6*).

Picture 5 – Cracked CMU Block Supporting Girder

The cracked solid cap of the pier (item #1) is possibly the result of eccentric loading of the CMU pier from the girder above. Additionally, the out-of-contact pier (item #2) is possibly the result of minor interior settlement and is potentially related to the recent installation of the closed crawlspace system. Site drainage improvements and/or moisture control efforts, commonly included with the installation of closed crawlspace systems, can lead to initial structural movement as the moisture levels in the soils supporting a home change, and a relative state of structural equilibrium is reached.

1. Reinforce each girder span adjacent to the cracked CMU pier using an IntelliJack support on a well-compacted 18"x18"x18" gravel footing. Two (2) IntellisJacks required. Jacks should be located within 18" of the cracked pier (*see Drawings 1-2 for details*).

- Each new gravel footing should be located such that the edge of the new footing abuts the existing footing for the cracked pier.
 - If the existing footing projection is found to be larger than 8", then the IntelliJack should be anchored directly to the existing footing and the gravel footing omitted.

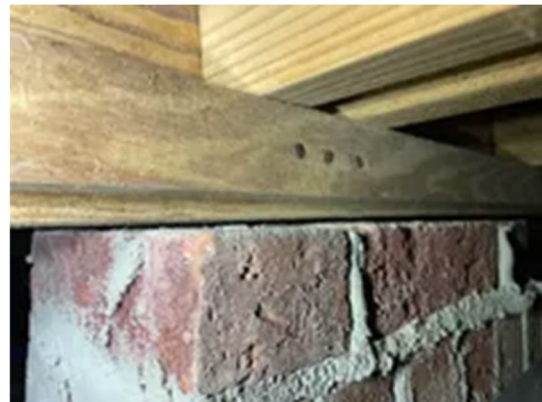
Picture 6 – Out-of-Contact Pier

2. Install tight-fit treated or steel shim material at the out-of-contact pier such that the pier is in contact with the girder.
 - To lessen the likelihood of future differential settlement of the pier, one additional IntelliJack support may be installed at the mid-span of the girder to the left of the out-of-contact pier. The new support should be centered on a well-compacted 18"x18"x18" gravel footing (*see Drawings 1-2 for details*).

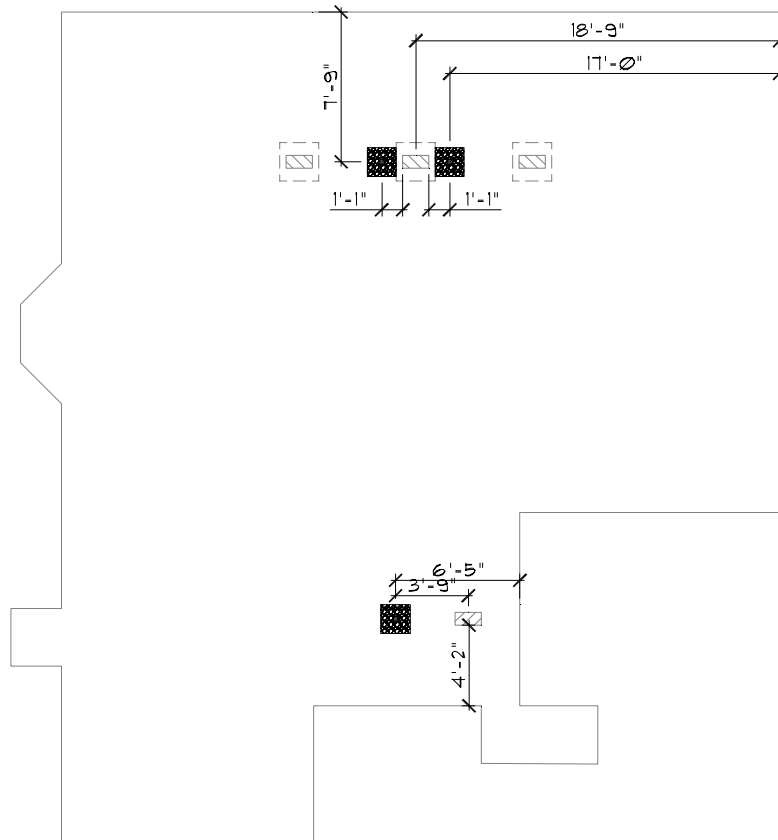
Detail 1 – Interior Pier Stabilization

INTERIOR PIER STABILIZATION SCHEMATIC
SCALE: N.T.S.
