Date: December 5, 2024  
Project: Wilkins Residence  
Address: 1201 Weeks Rd  
Dunn, NC 28334

### Wood Framing Floor Support Analysis

Wilkins Residence  
1201 Weeks Rd  
Dunn, NC 28334

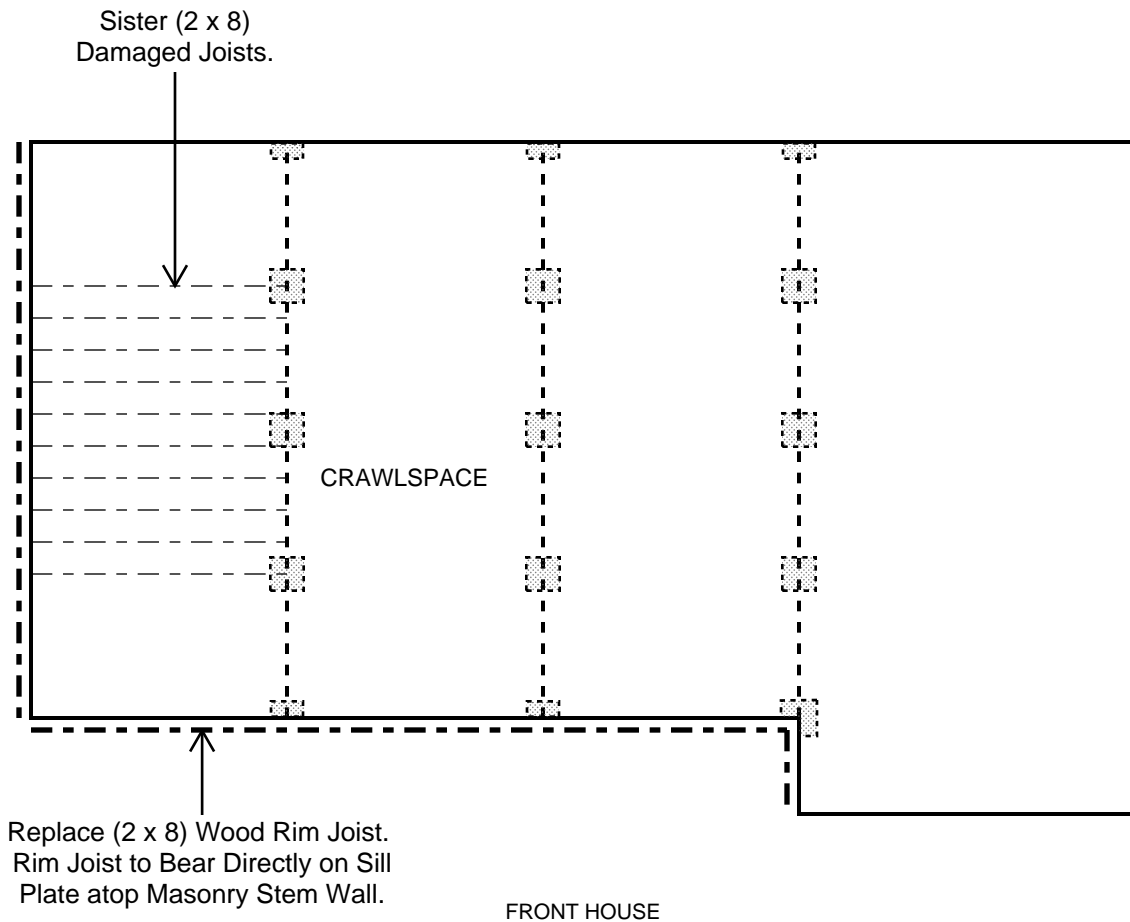
**REPAIR PLAN**

This report is prepared for Southeast Foundation Repair (contractor) by FDN Engineering (engineer). Wood framing repairs and/or replacements on the first floor are proposed for installation at the above referenced project. Existing floor framing is damaged or rotten. The improved wood support system is intended to provide a long-term, structurally safe floor structure. Load requirements for the floor components were calculated at areas shown on the repair plan. Engineer performed design for this project - see page 2 for engineering notes and results. See page 3 for wood framing details. See page 4 for a repair plan of the wood framing on the structure.

11. New framing replacements do not change the load path of the existing structure.
12. Where sistering floor joists, sister with a like size/type wood member. Fasten sister joist to existing with (2) 10d x 3-in nails in each row. #12 structural screws x 3-in may be used instead of nails. End two rows spaced 6" apart & 16" o.c. in between. Sister joist to bear on support at each end (same support location and type as existing joist).

1. Residential construction, one-story.
2. Layout of wood framing repairs and/or replacements on first floor.
3. Install per local Building Code.
4. See page 2 for notes, sizes, and specs.
5. Notify engineer if design assumptions are discovered inaccurate.
