Re: Structural Observation — 106 Micahs Way North, Spring Lake, NC 28390

First Floor Framing Stabilization

Tar Heel Basement Systems
106 Micahs Way North
Spring Lake, NC 28390

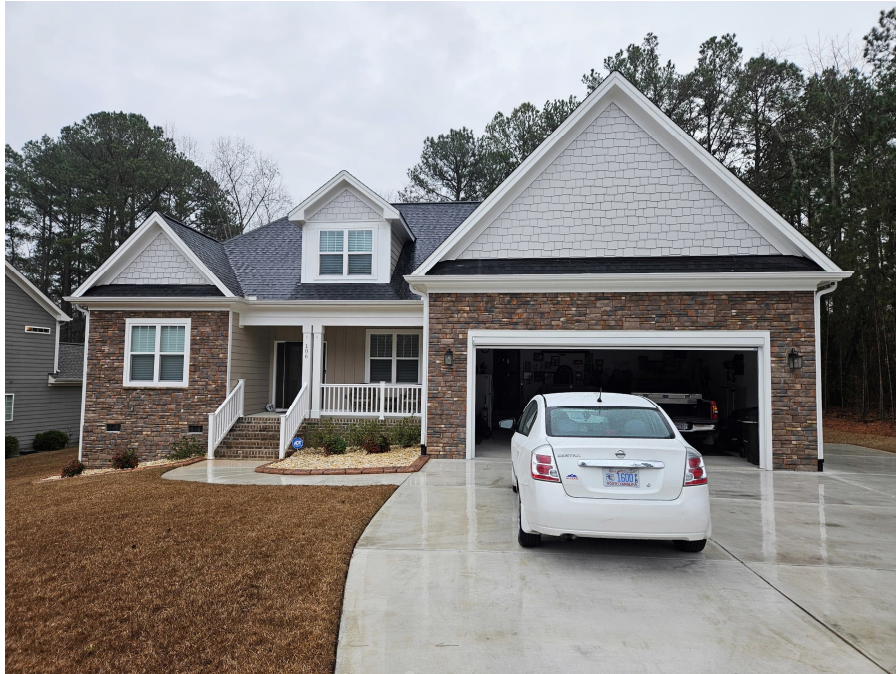
Picture 1 – 106 Micahs Way North, Spring Lake, NC 28390

At your request, on January 6, 2025 we performed a review of the structural plan proposed by *Tar Heel Basement Systems* for the first-floor framing stabilization work at the Spring Lake residence noted above. The structure is a conventionally framed, detached, single family residence with raised first floor framing over a pier/girder foundation system with perimeter masonry foundation walls (see *picture 1*).

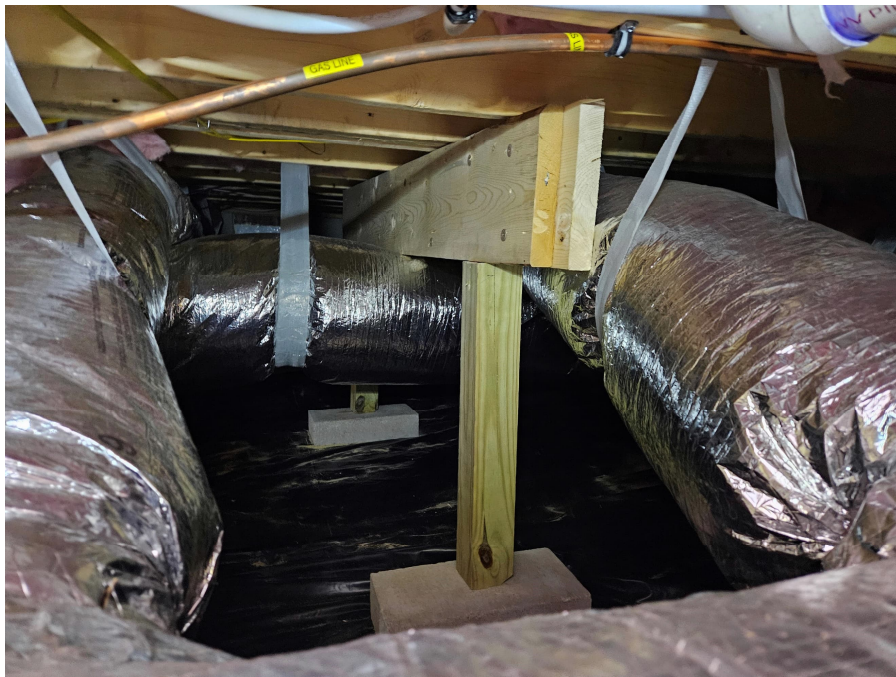
- Between the 2nd and 3rd girder lines from the right, a supplemental dropped girder had been installed. (see *picture 2*).
 - This girder did not appear to be installed to prevent rotation of the girder or appear to have a proper foundation element.

Picture 2 – Example of haphazard support

- 1) Reinforce the second girder line from the right foundation wall using an IntelliJack support on a well-compacted 18"x18"x18" gravel footing. Jacks should be located within the middle 1/3 of each girder span and at the approximate locations shown in the attached repair schematic (*see detail 1*).
- 2) Replace the above noted supplemental girder with a new S4x7.7 dropped girder within the middle 1/3 of the joist span. Support the replacement girder using IntelliJack supports on well-compacted 18"x18"x18" gravel footings spaced no more than 6'-6" apart (*see detail 1*).

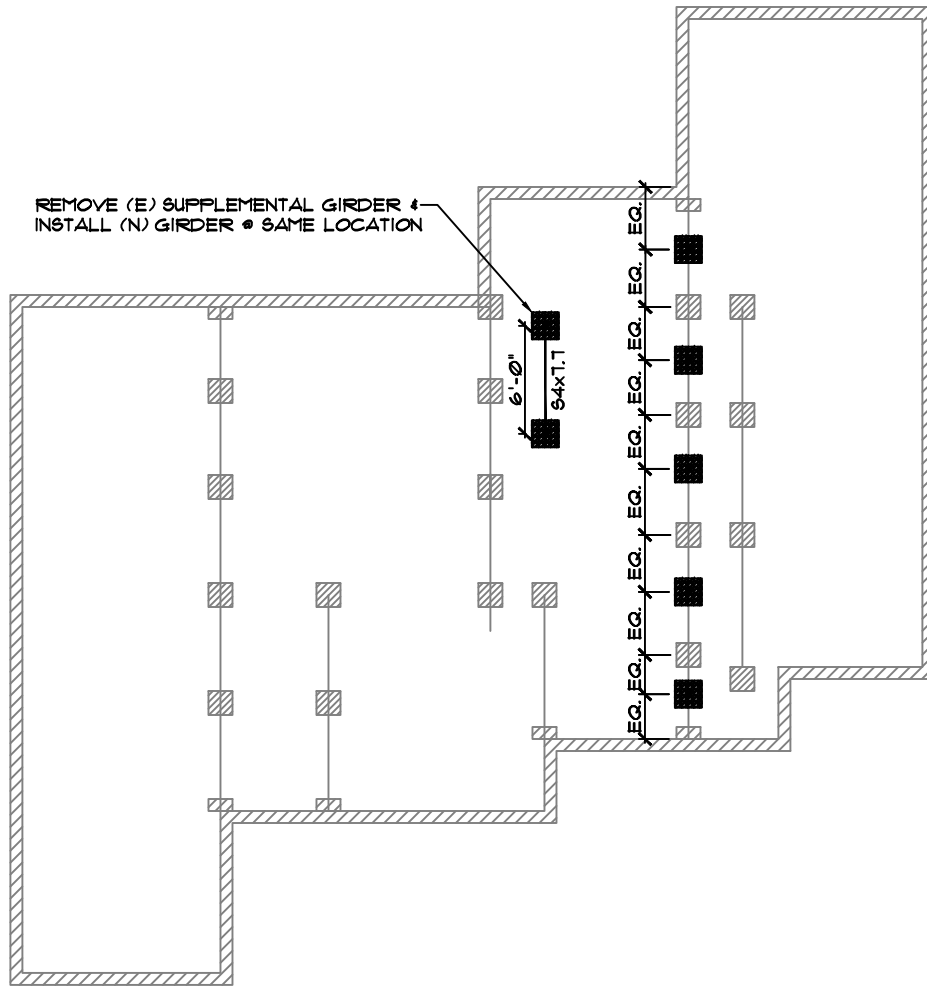
SCALE:	NTS	JOB #:	
DRAWN BY:	DLH		25-1012
DATE:	2025.01.07	SHEET #:	SK1

- Uneven floors were reported on the right side of the home in the primary bedroom/bathroom.
 - Measurement by laser level indicated that the 2nd girder line from the right was down as much as approximately ¼" relative to the 3rd girder line from the right. Additionally, this girder was measured to sag as much as approximately ¼" at mid-span between masonry piers.
 - Measurement by laser level indicated that the back end of the second girder line from the right was down by as much as approximately ½" relative to the right foundation wall.
