Matthew C. Murphy, PE, CWI, PE
Stonewall Structural Engineering, PLLC
9203 Baileywick Rd. #200
Raleigh, NC 27615
(919)407-8663

Re: Review of Proposed 1st Floor Framing Repairs — 678 Raven Rock Road, Lillington, NC 27546

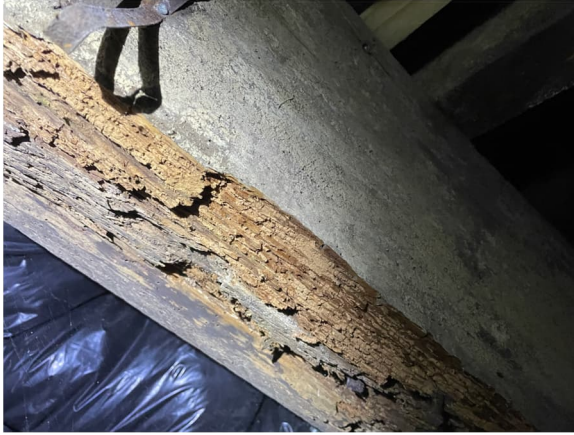
1. Along the back girder line, the 2nd girder span from the left was reported to be deteriorated (see picture 3).
2. Joists along the aforementioned girder span in the back joist bay were also reported to be deteriorated (see picture 4).

Picture 3 – Deteriorated girder

The deteriorated floor framing is the result of prolonged exposure to excess moisture in the crawlspace combined with potential wood destroying insect activity. It should be noted that detailed information for the attic framing and the layout of interior walls was not provided. As such, the attic framing of the home has been assumed to have a front-to-back orientation and be lapped over a load bearing wall that transfers to the subject deteriorated girder span proposed for replacement. Similarly, the existing floor joists have been assumed to carry typical floor loads only.

1. The deteriorated girder span is proposed to be removed and replaced.
2. The deteriorated joists are proposed to be reinforced with an additional full depth continuous ply of 2x #2 Southern Yellow Pine (SYP) material.

1. Remove and replace the above-noted deteriorated girder using full depth treated (3) 2x #2 SYP material with continuous span between existing masonry girder support piers.
 - a. Reinforce the midspan of the new girder using an IntelliJack support on a well-compacted 18"x18"x18" gravel footing (*See Detail 1*).
2. Reinforce each of the deteriorated joists noted above with an additional full depth ply of 2x #2 Southern Yellow Pine (SYP), fastened to the side of the deteriorated joists using (3) 10d common nails at each end and at 12" on center staggered top and bottom along the lengths of the joists. Sistered material should span continuously between end supports.

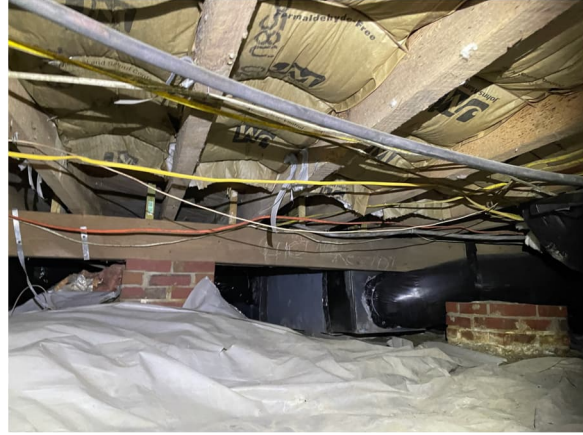
Picture 4 – Deteriorated joists
