W. Harrison Welch , PE  
Stonewall Structural Engineering, PLLC  
2 N Front St 8th Floor  
Wilmington, NC 28401  
(910)444-0208

Re: Structural Observation — 7232 Elliot Bridge Road, Spring Lake NC 28390

PICTURE ADDENDUM

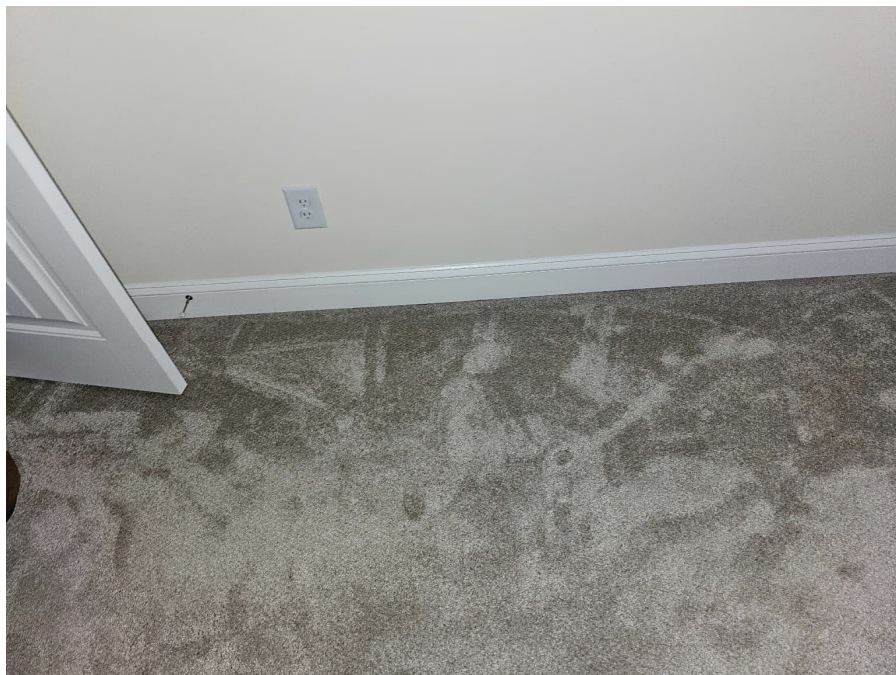
- Creaking floors were noted in the primary bedroom (*see picture 2*) and living room (*see picture 3*).
  - Measurement by laser level indicated that the back girder line was down as much as approximately  $\frac{1}{2}$ " and  $\frac{3}{4}$ " relative to the front girder line and back foundation wall, respectively.
  - Additional measurements indicated that the joists in the middle joist bay were sagging by as much as approximately  $\frac{1}{2}$ " at mid-span.

*Picture 2 – Area of creaking floors in the primary bedroom*

- 1) To reinforce the living room and bedroom floor framing, install a supplemental S4x7.7 dropped girder within the middle  $\frac{1}{3}$  of the joists. The new girders should span from the locations shown in the attached repair schematic over IntelliJack supports on well-compacted 18"x18"x18" gravel footings spaced no more than 6'-0" apart.
  - a) The ends of the girder may cantilever up to 2'-0" over the ends of the support.
  - b) If the creaking floors are caused by missed subfloor fasteners, further engineering may be required to reinforce the subfloor.

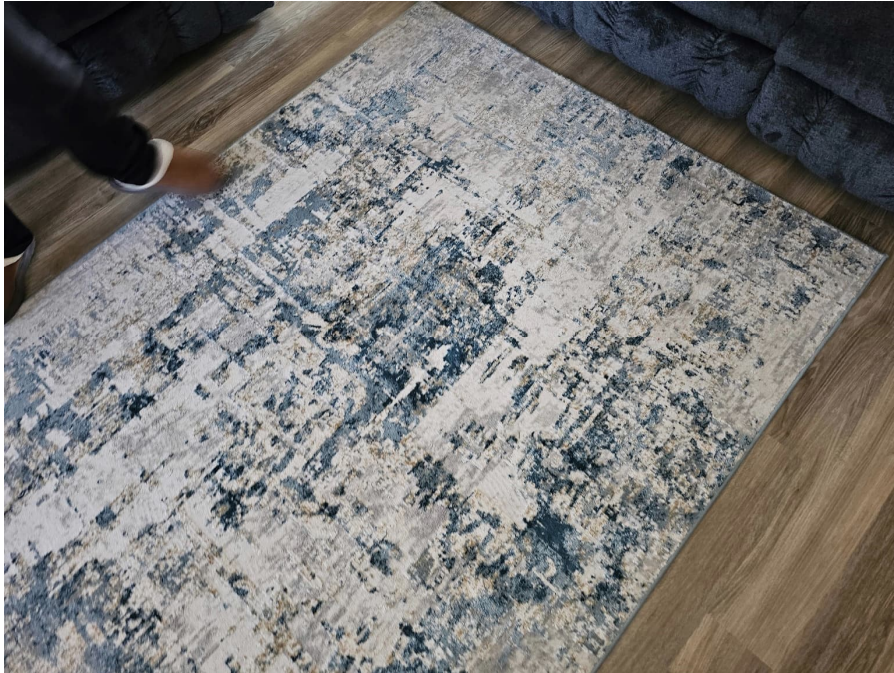
*Picture 3 – Area of creaking floors in the living room*
