Matthew C. Murphy, PE, CWI
Stonewall Structural Engineering, PLLC
2 N Front St 8th Floor
Wilmington, NC 28401
(910)444-0208

Re: Structural Observation — 4254 US-301, Dunn NC 28334

First Floor Framing Reinforcement

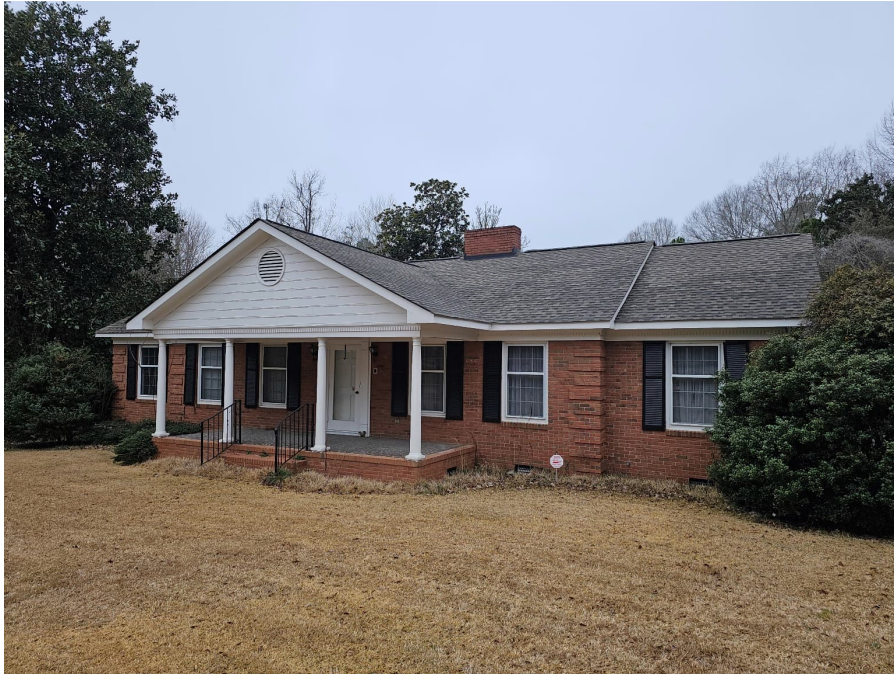
Picture 1 – 4254 US-301, Dunn NC 28334

At your request, on February 6, 2025 we performed an on-site visual inspection and review of the structural plan proposed by *Tar Heel Basement Systems* for the first-floor framing reinforcement work at the Dunn residence noted above. The structure is a conventionally framed, detached, single family residence with raised first-floor framing over a pier/girder foundation system with perimeter masonry foundation walls (*see picture 1*).

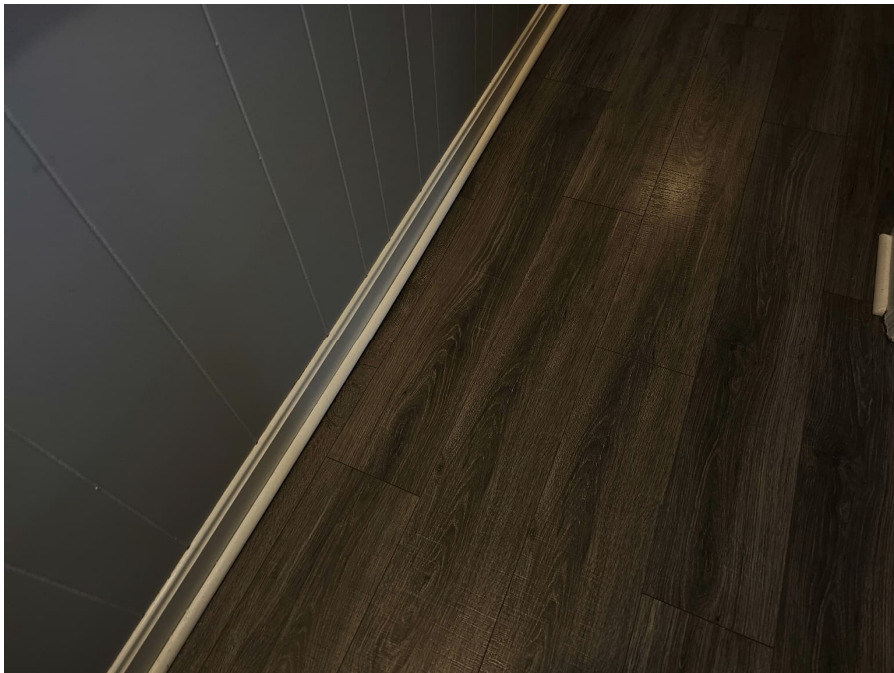
- Uneven floors were noted along the front wall of the left hallway (*see picture 2*).
 - Measurement by laser level indicated that the low spot in the hallway was down by as much as approximately 1" relative to both the front left corner of the hallway and the back wall of the hallway.
 - Measurements from within the crawlspace found that the 4th girder span from the left was down towards the left by as much as approximately ¼". Additionally, the 3rd girder span from the left was found to have as much as approximately ¼" sag.
 - Investigation from within the crawlspace found that a section of joists in the front joist bay approximately 18' from the left foundation and continuing to the right by 7' were deteriorated (*see pictures 3-4*).

Picture 2 – A low spot in the front hallway wall

- 1) Reinforce each of the above noted dropped and/or sagging girder spans using an IntelliJack support on a well-compacted 18"x18"x18" gravel footing (*see Detail 1*). Jacks should be located within the middle 1/3 of each girder span and at the approximate locations shown in the attached repair schematic.

- 2) To reinforce the floors under the front hallway, install a supplemental S4x7.7 dropped girder near the location of the front hallway wall. The new girder should span from the locations noted in the attached repair schematic, within the middle 1/3 of the front joist bay, over IntelliJack supports on well-compacted 18"x18"x18" gravel footings spaced no more than 6'-6" apart (*see Detail 1*).

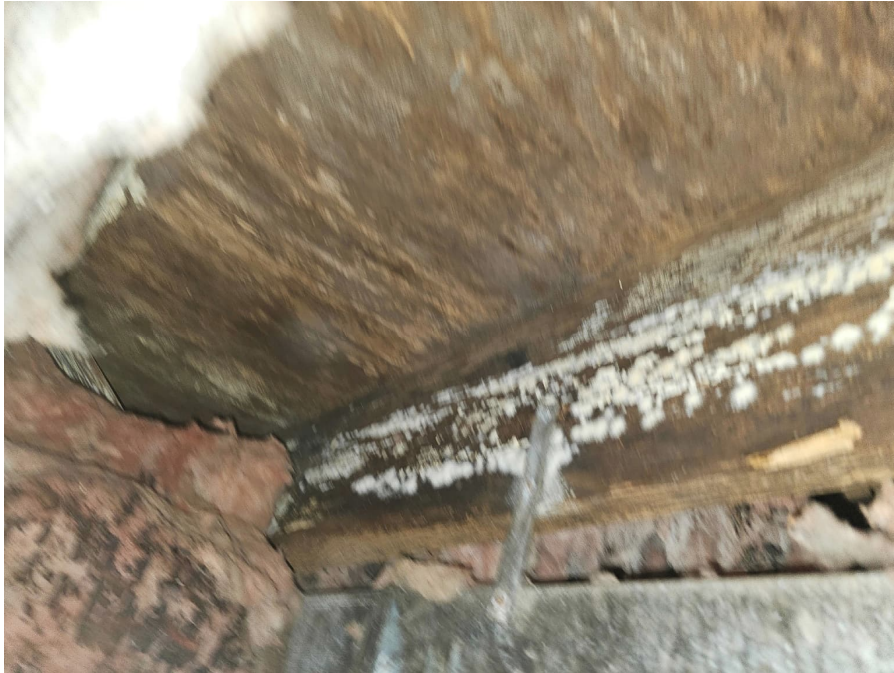
Picture 3 – Example of deteriorated joist

- a) Additionally, reinforce each of the deteriorated joists noted above with an additional full depth ply of 2x #2 Southern Yellow Pine (SYP), fastened to the side of the deteriorated joists using (3)10d common nails at each end and at 12" on center staggered top and bottom along the lengths of the joists. Sistered material should span continuously between end supports.

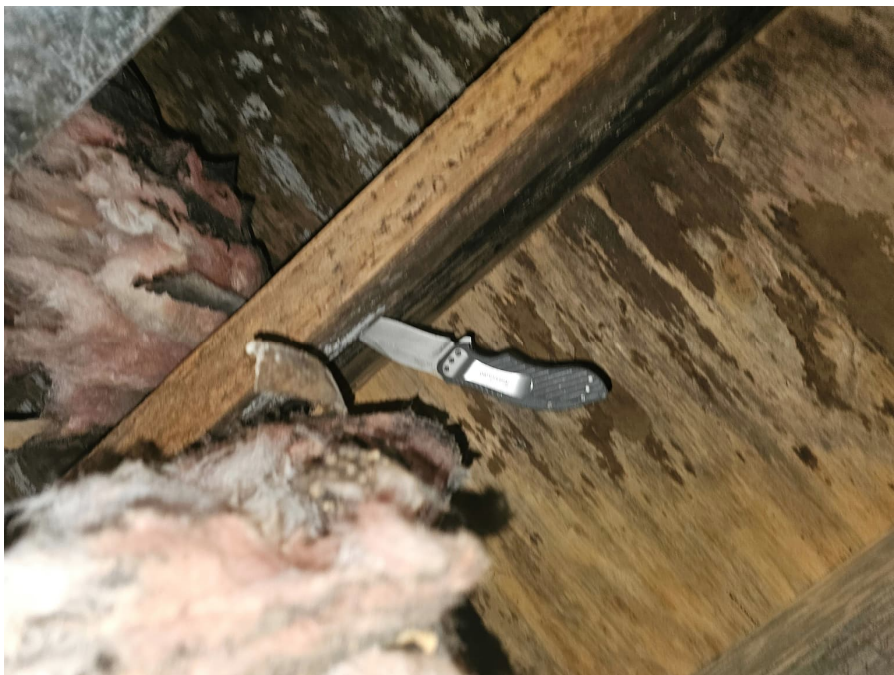
Picture 4 – Example of deteriorated joist
