Re: Structural Observation — 913 South 13<sup>th</sup> Street, Erwin, NC 28339

Living Room Framing Repair Plan

Tar Heel Basement Systems  
 913 S 13th St.  
 Erwin, NC 28339

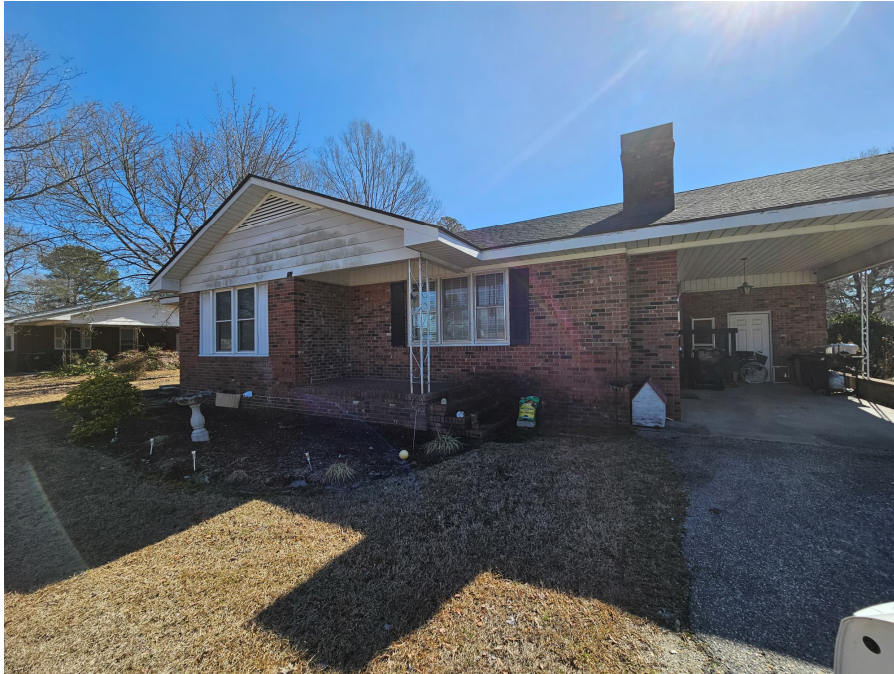
*Picture 1 – 913 South 13<sup>th</sup> Street, Erwin, NC 28339*

At your request, on February 14, 2025 we performed an on-site visual inspection and review of the structural plan proposed by *Tar Heel Basement Systems* for the first-floor framing repair work in the front-right living room at the Erwin residence noted above. The structure is a conventionally framed, detached, single family residence with raised first-floor framing over a pier/girder foundation system with perimeter masonry foundation walls (*see picture 1*).

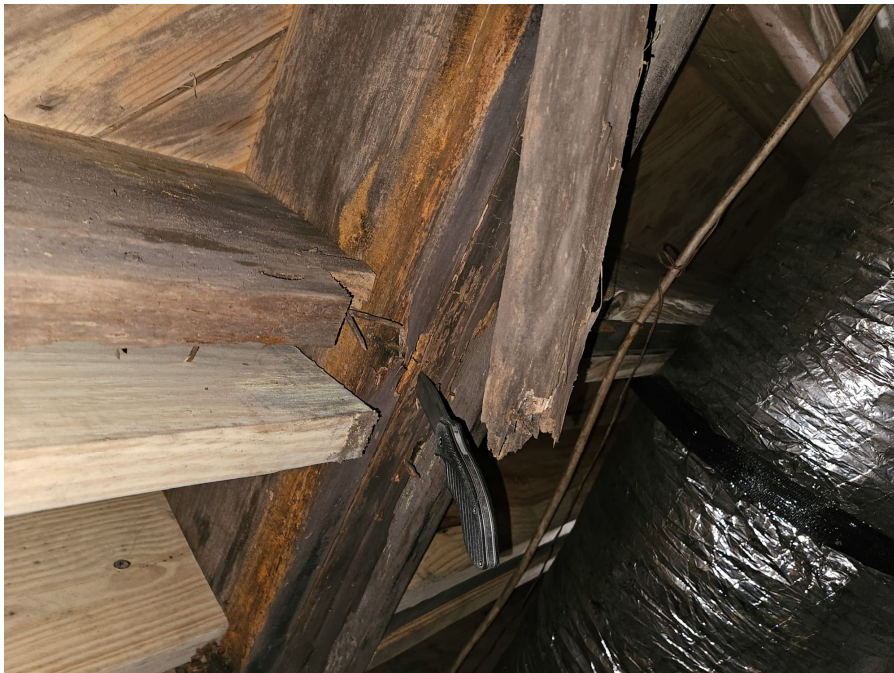
- Signs of moisture damage were noted throughout the first-floor framing system, particularly in the living room. Thorough probing indicated that the following framing members at the living room were deteriorated beyond salvageable limits:
  - The girder and ledger strip at 3<sup>rd</sup> span from the right along the front girder (*see picture 2*).
  - The leftmost (7) joists (*see picture 3 for example and attached repair schematic for reference*).
    - Most of these joists were noted to be improperly reinforced with non-continuous sister plies (*see picture 4 for example*).
  - Additional sections of the sill plate, rim band, and joists in the middle joist bay were deteriorated and/or cracked.

*Picture 2 – Deteriorated girder and ledger strip*

- 1) Remove the above-noted significantly deteriorated portion of the girder and replace using a new (3)2x10 #2 Southern Yellow Pine (SYP) material with continuous span between existing masonry girder support piers.

- a) Fasten joists to the sides of the new girder using Simpson face hangers.
- 2) Reinforce each of the deteriorated joists noted above with an additional full depth ply of 2x #2 SYP, fastened to the side of the deteriorated joists using (3)10d common nails at each end and at 12" on center staggered top and bottom along the lengths of the joists. Sistered material should span continuously between end supports.

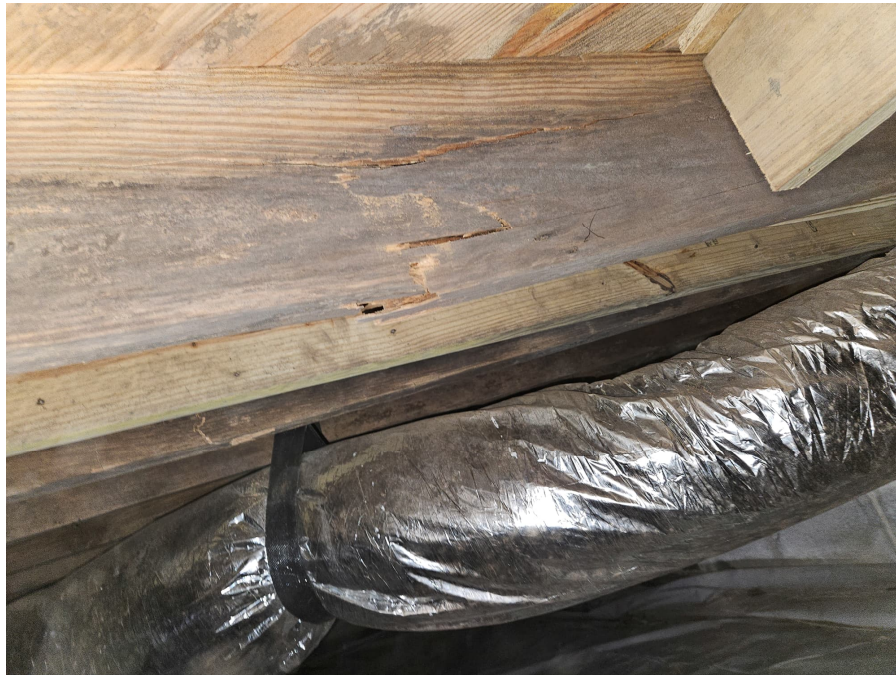
*Picture 3 – Deteriorated joist*

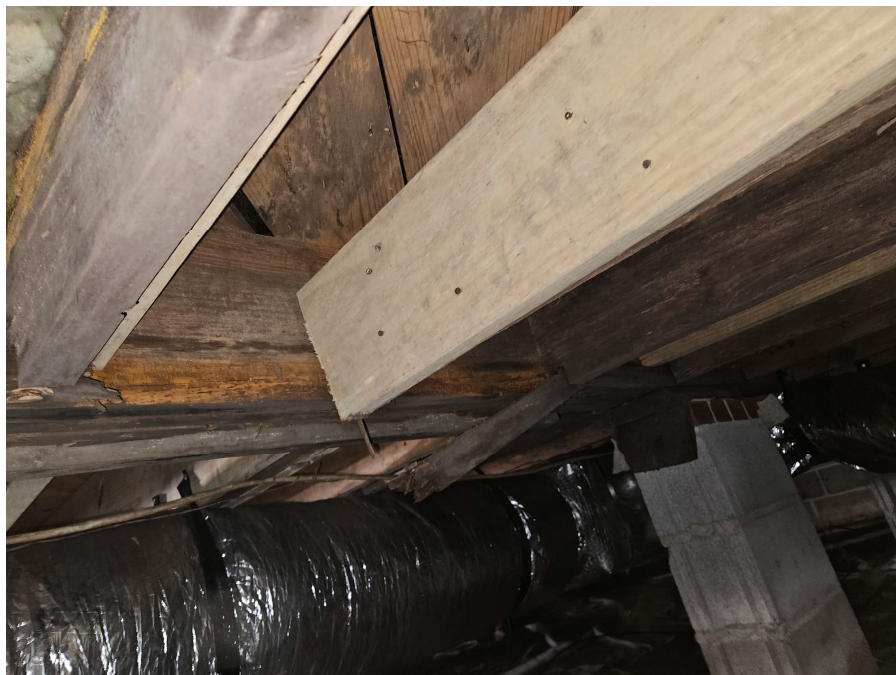
*Picture 4 – Improperly reinforced joist*
