GILES FLYTHE
ENGINEERS

March 5, 2025 – *Revised from February 5, 2025*

Re: Limited Structural Inspection
140 Tylerstone Drive
Fuquay-Varina, NC

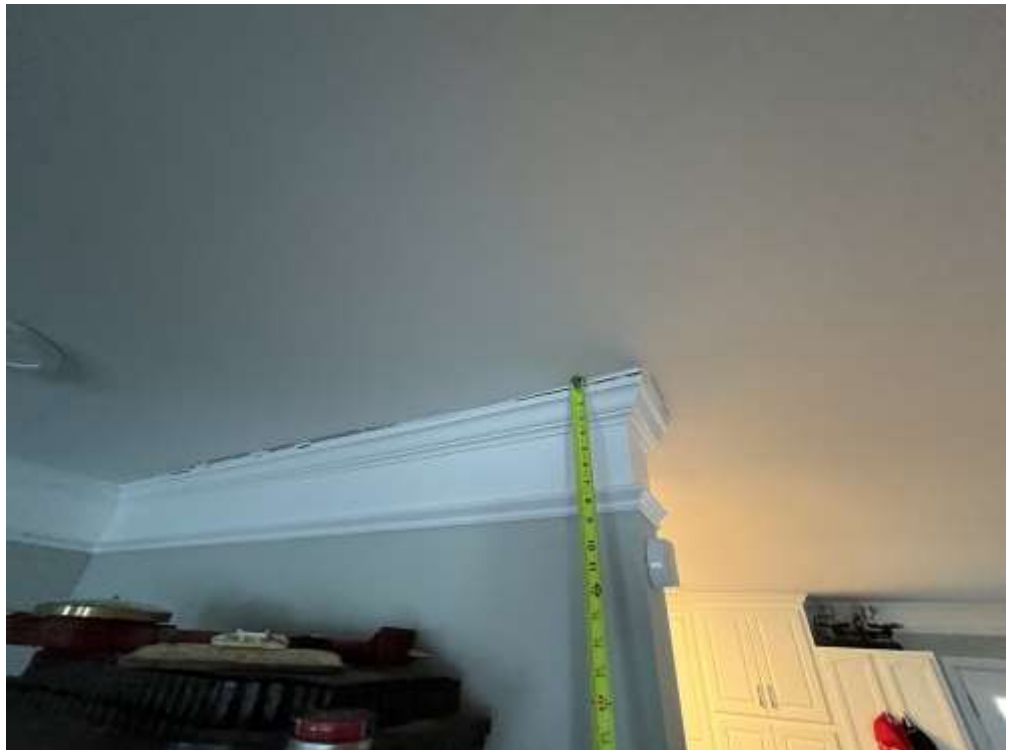
Photo No.
2

1. Separation (up to 1/4" wide) was observed between the ceiling and the crown molding in the front kitchen wall spanning left to right located approximately 13'-0" from the rear exterior wall and 23'-0" from the right garage wall. Floor slope was not observed at this location.
2. Separation (up to 1/8" wide) was observed in the finish flooring spanning front to rear located approximately 28'-0" from the right garage wall.
3. Multiple additional minor separations (up to 1/16" wide) were observed between the crown molding and the ceiling throughout the home. Multiple minor drywall cracks (less than 1/16" wide) were observed in the wall finish materials throughout the home.

Typical view of crown molding separation.

5. *If additional stiffness in the floor system at the interior wall to ceiling separation noted above (Observation #1) is desired, the double joist below this location may be fully sistered (bearing point to bearing point) with an equivalently sized member fastened with (3) 4.5" Simpson SDS screws (or approved equivalent) staggered at 16" on-center. Ensure a snug condition against the subfloor/double joist and proper bearing at the ends.*

6. *If additional stiffness in the floor system at the interior wall to ceiling separation noted above (Observation #1) is desired, we recommend installing a steel post with an ICC-ES evaluation report (IntelliJack or approved equivalent) at the midspan of the double joist below this location. The steel post should bear on a minimum 24"x24"x12" concrete footing and be positively fastened to the framing and the footing.*

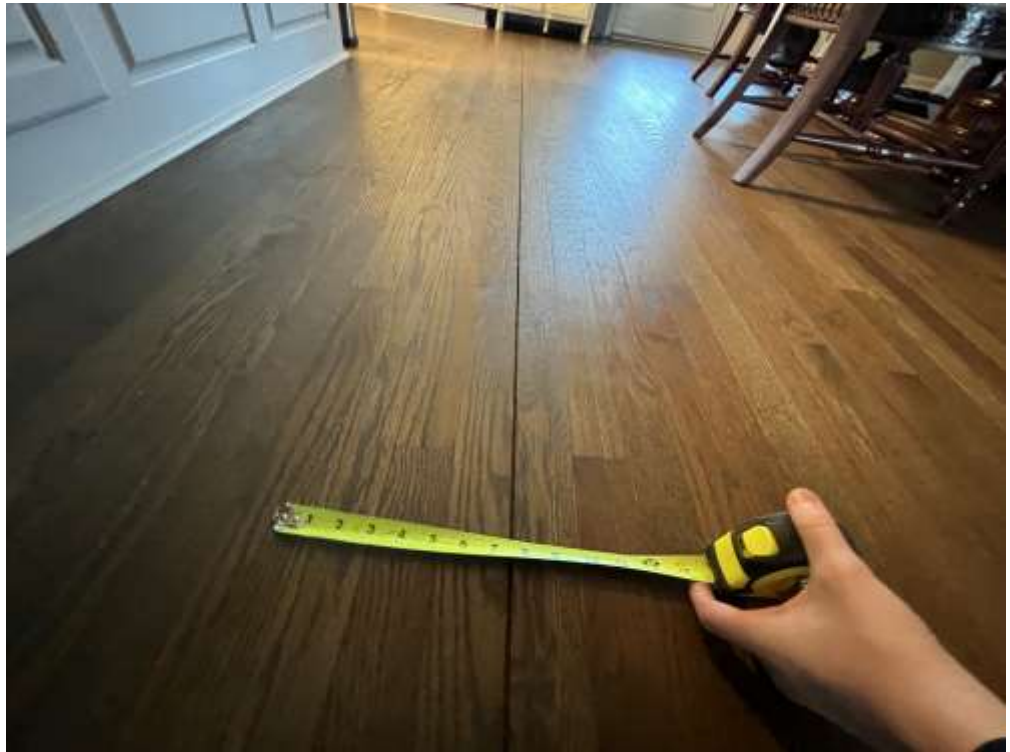
Photo No.
3

View of finish flooring separation.

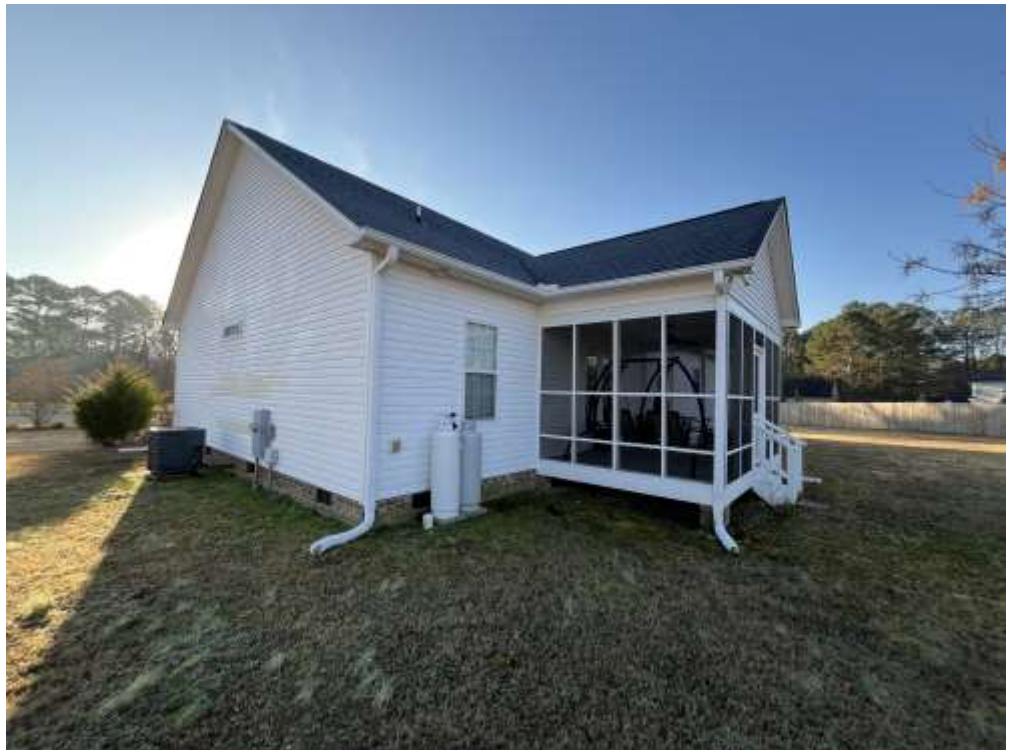
Photo No.
4

4. Gutters and downspouts (with leaders) were noted installed on the home. Grade was noted with a relatively neutral slope along the perimeter walls of the home.

Typical view of exterior drainage.

4. We recommend ensuring that stormwater drains positively away from the home to minimize the risk of future water infiltration. This can be accomplished by ensuring gutters, downspouts, and leaders remain clear of debris and properly functioning. Also, creating a positive grade, where possible, away from the perimeter of the home will aid in the stormwater evacuation.

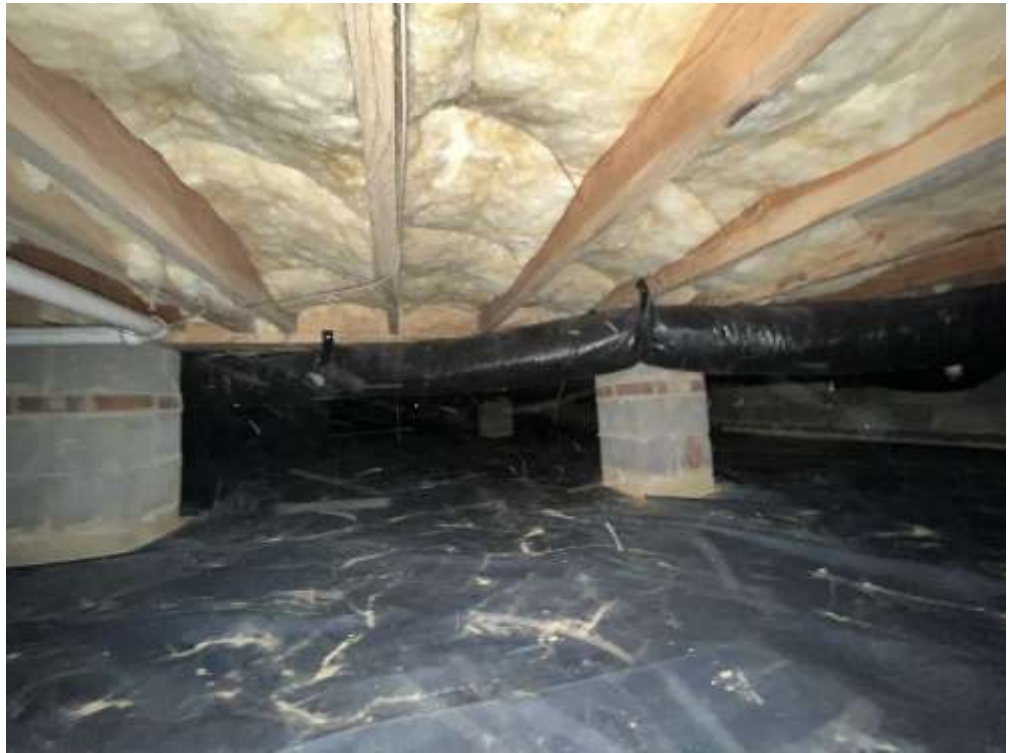
Photo No.
5

5. The floor framing was noted to consist of 2x10 floor joists spaced at 16" on-center spanning left to right supported by 4-2x10 flush girders bearing on masonry piers typically spaced approximately 9'-0" apart.

Typical view of crawl
space
framing/foundation
components.

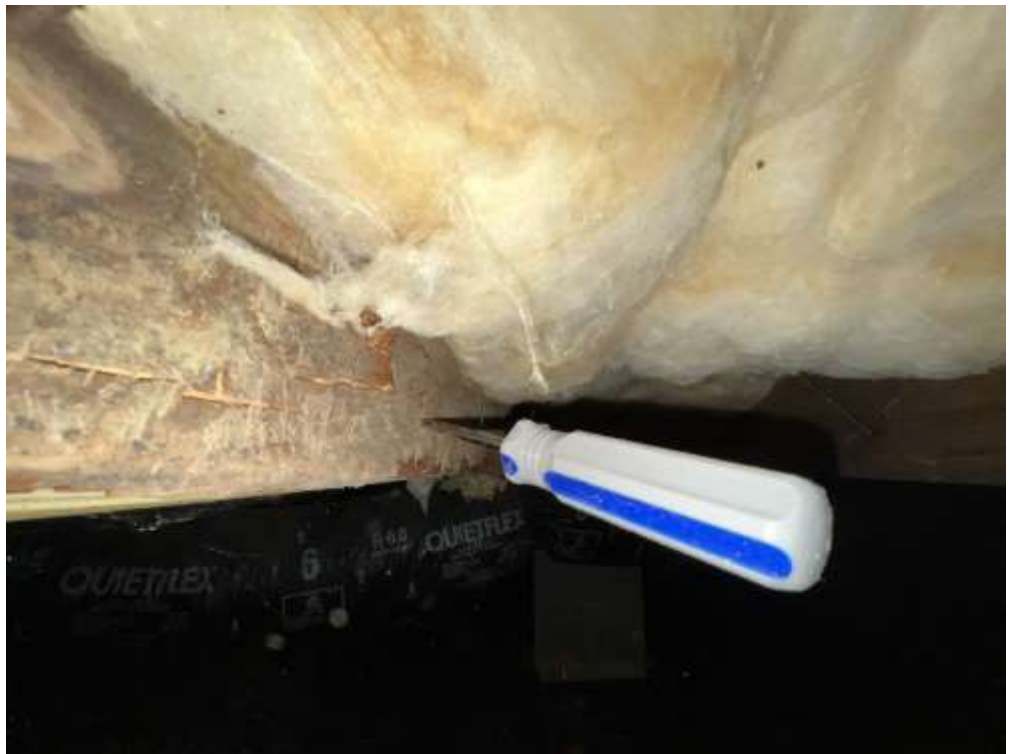
Photo No.
6

6. Damage was observed to the floor joists at the front-left corner of the crawl space beginning approximately 18'-0" from the front wall and extending to the front wall, and beginning approximately 23'-0" from the right garage wall and extending to the right garage wall.

The interior wall/floor separations and the damaged/flared floor framing components noted above (Observations #1-3 and 6-8) are likely the result of prolonged elevated moisture levels in the crawl space. It appeared that there were previously greatly elevated moisture levels in the crawl space that have since been reduced, which can often result in deflection of the framing components. The moisture content of the floor framing noted in the crawl space at the time of the inspection was considered acceptable; however, moisture levels of the framing can fluctuate based on weather conditions and seasonal changes in humidity. Prolonged elevated moisture content of the framing can lead to excessive deflection and structural damage. We recommend monitoring the moisture content of the crawl space framing throughout the seasons. The damaged and flared floor framing noted above are considered structural concerns and we have provided recommendations below to address the issues. *We have also provided recommendations below if additional stiffness in the floor system is desired.*

Typical view of
damaged floor joists.

- b) This will likely require cutting back the floor joists to replace the damaged flush girders. We recommend fully sistering (bearing point to bearing point) the damaged floor joists noted above (Observation #6) and any joists cut back with new equivalently sized members, attached with (3) 10d common nails at 16" on-center. Ensure a snug condition against the subfloor/damaged members and proper bearing at the ends.

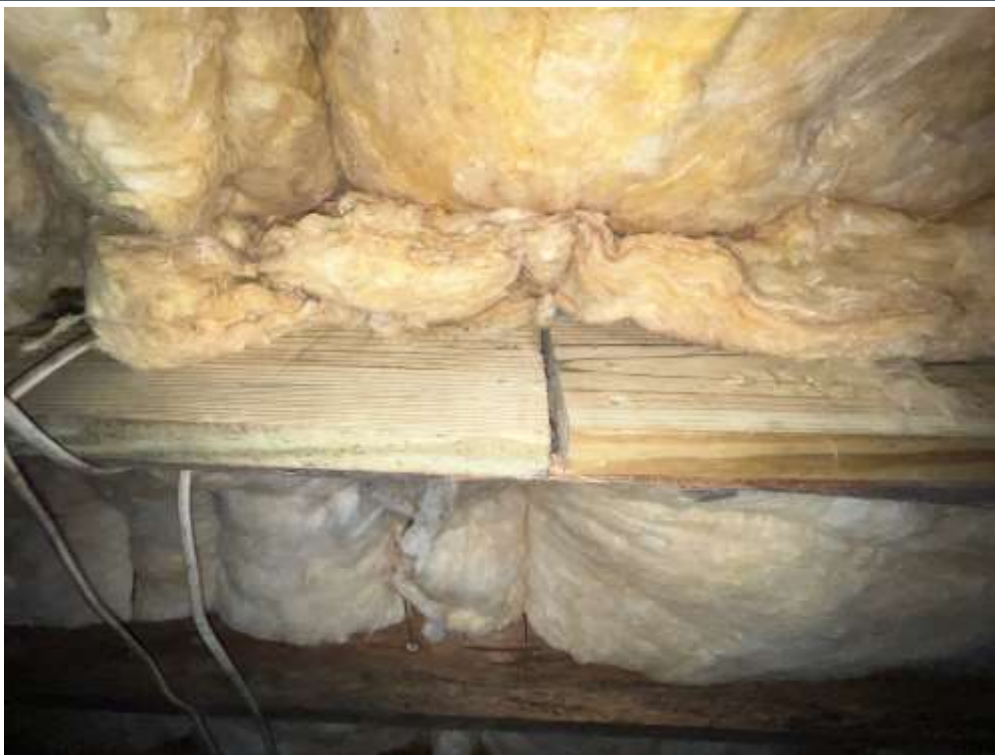
Photo No.
7

Typical view of partially
sistered member repairs.

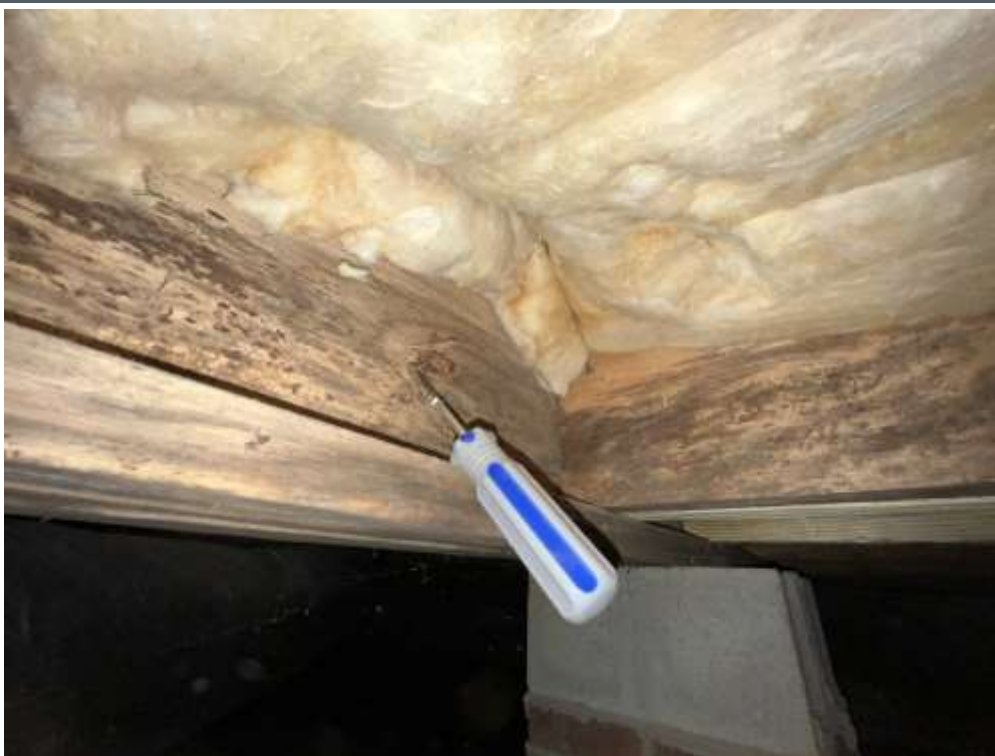
Photo No.
8

7. Damage was observed to the front (2) spans of the (2) flush girders located approximately 23'-0" and 11'-0" from the right garage wall.
8. Flared framing (with separation between plies up to 1/4" wide) was observed as follows:

View of damaged floor
girders.

1. We recommend fully replacing the damaged flush girder sections noted above (Observation #7) with new 4-2x10 girders spanning a maximum of 5'-0" between the new/existing piers. Appropriate flashing should be installed between the girders and the piers or the new girders should be pressure treated. We recommend fastening the girder plies together from both sides with minimum (3) 6" Simpson SDWS screws staggered at 16" on-center, for a net 8" on-center spacing. Install flat pressure-treated blocking (min. 3/4" thick) and/or flat metal shims as required to provide full-width, uniform bearing of the new girders onto the new/existing block piers (angled shims are not acceptable).

- a) This will require the installation of new mortared and fully grouted 8"x16" CMU block piers installed at the midspan of the girders to achieve a maximum girder span of 5'-0" between the load bearing points. The new piers should bear on minimum 24"x24"x12" concrete footings with minimum (3) #4 reinforcement bars equally spaced each way in the bottom of the footings.

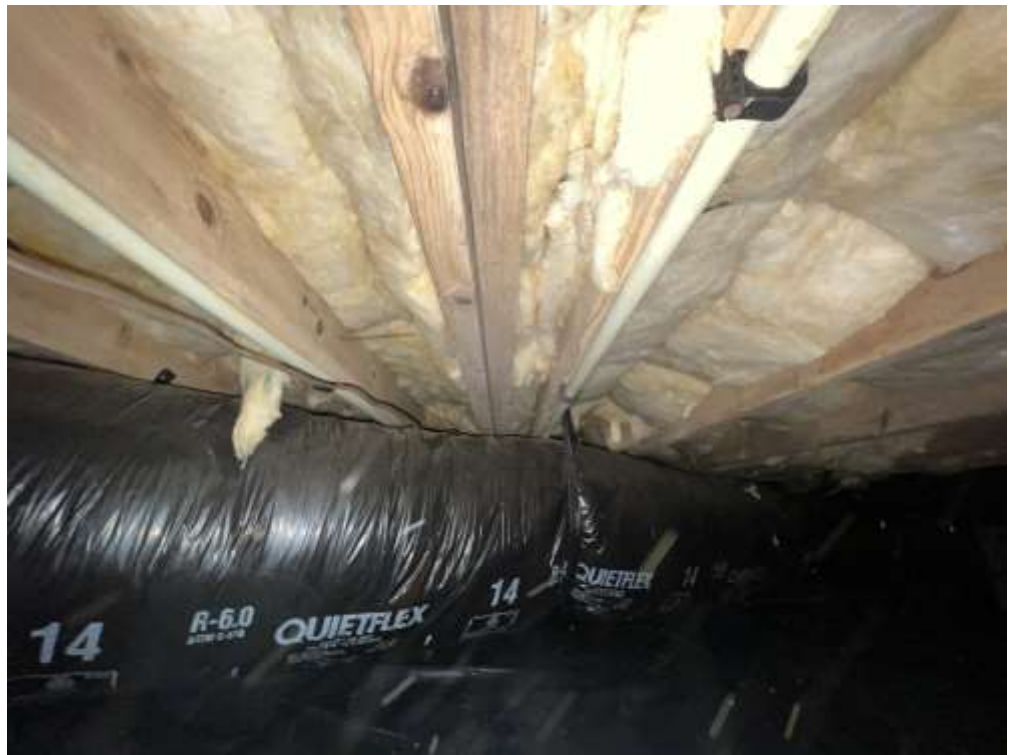
Photo No.
9

- a. Flaring was observed in the double joist spanning from the left crawl space wall to the right crawl space wall located approximately 13'-0" from the rear foundation wall.

- c. Flaring was observed in the double joist spanning left to right at the left of the crawl space located approximately 6'-0" from the rear foundation wall.

View of flared double joist.

2. We recommend temporarily clamping the plies of the flared framing noted above (Observation #8) to bring them into full contact (to the greatest extent practical without damaging the members) and positively re-attaching the plies with (3) Simpson SDS screws (or approved equivalent) of sufficient length to penetrate all plies. The screws should be staggered at 16" on-center, alternating sides.

- a) Alternatively, the flared framing plies may be reconnected with (2) staggered rows of 5/8" diameter through bolts (with nuts and washers), installed at 16" on-center (one every 8") along the top and bottom edges of the member. Maintain a minimum 2-1/2" edge distance between bolts and the edge of the wood member(s). Take care to not over-tighten the bolts and crush the wood fibers.

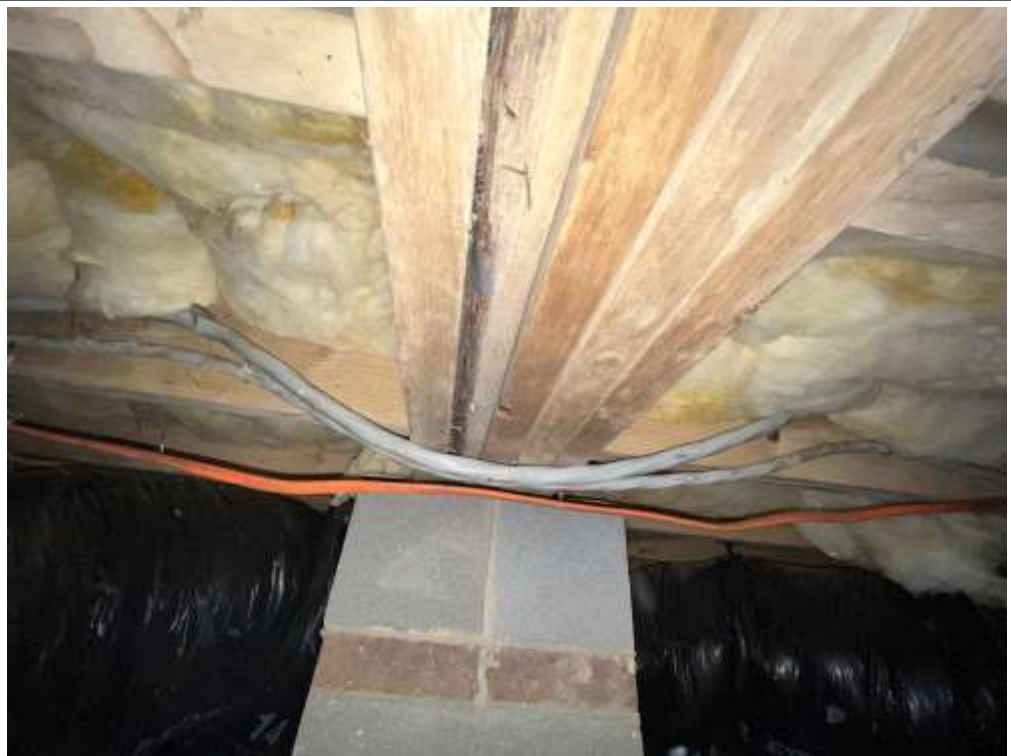
Photo No.
10

- b. Flaring was observed in the girder spanning front to rear located approximately 23'-0" from the right garage wall and 13'-0" from the rear foundation wall.

View of a flared girder.
