W. Harrison Welch, PE Stonewall Structural Engineering, PLLC 9203 Baileywick Rd. #200 Raleigh, NC 27615 (919)407-8663

Re: Review of Proposed Floor Framing Repairs — 18 Pineridge Cove, Sanford, NC 27332

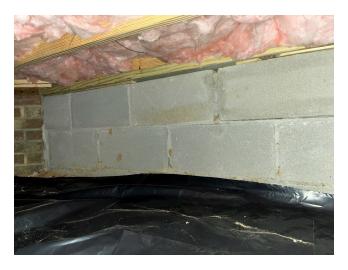
Picture 3 – Typical Floor Framing in Addition

- 1. Uneven floors at the sill plate for the addition of up to 1/8".
- 2. Sill plate out of contact with the foundation wall and not anchored (see picture 3).

The uneven floors could be the result of out of level construction. Additionally, the sill plate should be anchored per the requirements of the 2018 edition of the *North Carolina Residential Building Code*.

- 1. Remove the approximate 11' section of rim band at the area of uneven floors and replace with full depth treated 2x #2 Southern Yellow Pine (SYP) tight fit beneath the floor sheathing.
- 2. Remove the above-noted sections of sill plate at the uneven floors and replace using treated 2x # 2 SYP material and fasten with $\frac{1}{2}$ "Ø J-bolts at 6' on center max spacing and 12" from sill plate ends and breaks with at least (2) bolts installed per sill plate segment.
 - a. Bolts should be embedded at least 7" into the top course of the wall.
