Re: Structural Observation — *174 Nature Trail Road, Dunn, NC 28334*

First Floor Framing Repair

Nathan Seeley
174 Nature Trail Rd
Dunn, NC 28334

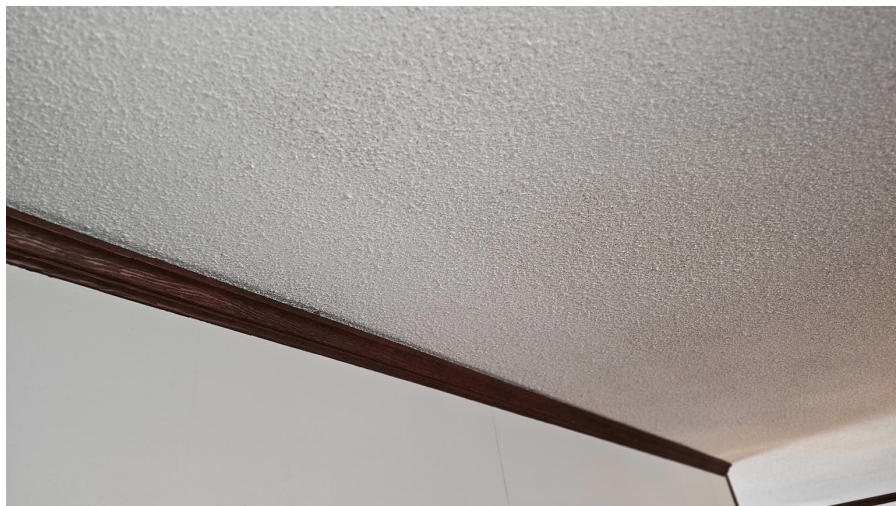
- Trim separation was noted along the front wall of the kitchen (*see picture 2*).
 - Investigation from within the crawlspace revealed that the left (2) spans of the rear girder and (5) joists starting 8' from the left foundation wall, extending to the right, were deteriorated beyond the salvageable limits (*see pictures 3-4*).
- Soft and bouncy floors were noted in the living room.
 - Investigation from within the crawlspace revealed that the left (2) spans of the front girder and (5) joists starting 16' from the left foundation wall, extending to the right, were deteriorated beyond the salvageable limits (*see pictures 5-6 for examples*).
 - Further investigation revealed that the leftmost 20' of joists in the middle joist bay were deteriorated beyond the salvageable limits.

Picture 2 – A view of trim separation in the kitchen.

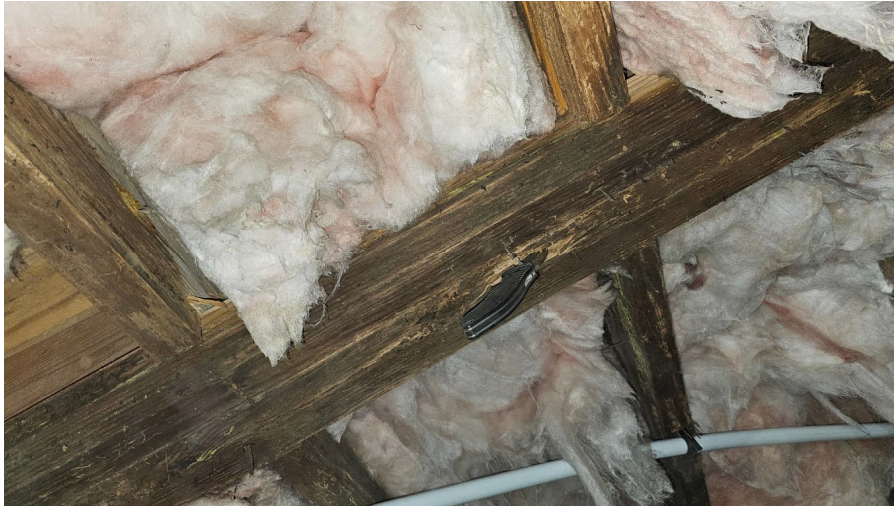
Picture 3 – Example of a deteriorated girder

- 1) Reinforce each of the deteriorated joists noted above with an additional full depth ply of 2x #2 Southern Yellow Pine (SYP), fastened to the side of the deteriorated joists using (3)10d common nails at each end and at 12" on center staggered top and bottom along the lengths of the joists. Sistered material should span continuously between end supports.
- 2) Remove the above-noted significantly deteriorated portions of the girders and replace using full depth treated (3)2x10 #2 SYP (rear girder) or (2)2x10 #2 SYP (front girder) material with continuous span between existing masonry girder support piers.
 - a) Reinforce each girder bay using an IntelliJack support on a well-compacted 18"x18"x18" gravel footing. Jacks should be located within the middle 1/3 of each girder span and at the approximate locations shown in the attached repair schematic (*see detail 1*).

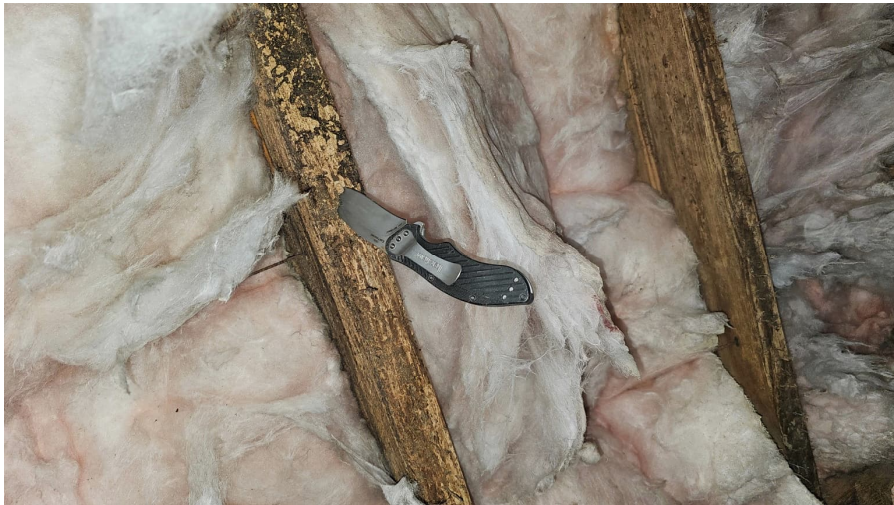
Picture 4 – An example of a deteriorated joist

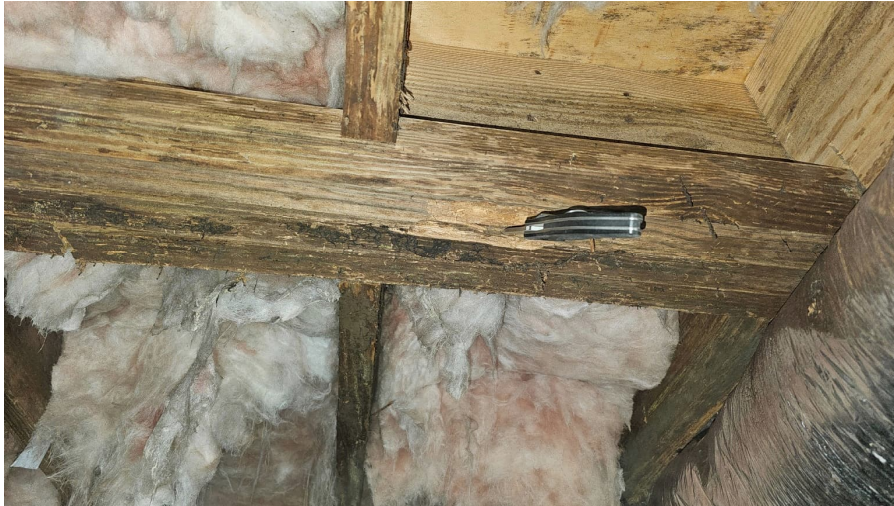
Picture 5 – An example of a deteriorated girder.

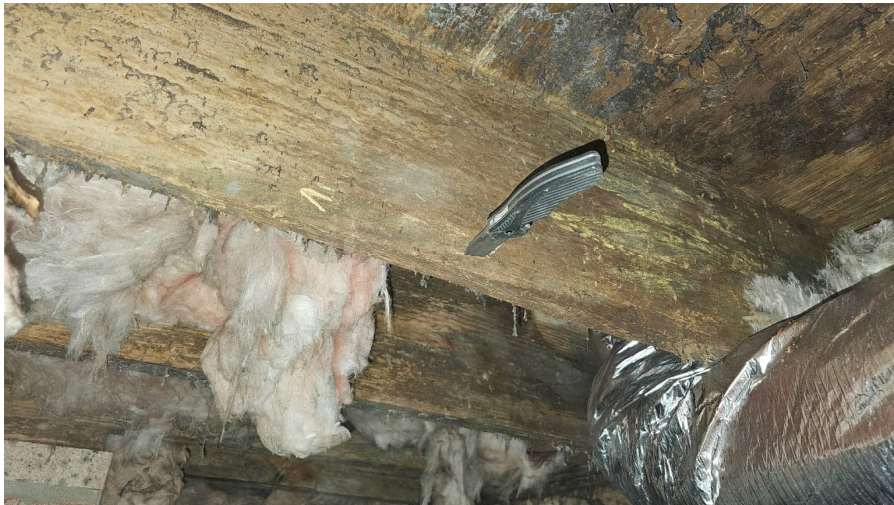
Picture 6 – An example of a deteriorated joist
