RE: Existing Condition Report
Sollinger-Agnew Residence
515 Bumpas Creek Access
Dunn, NC 28334

Site Description and Project Narrative

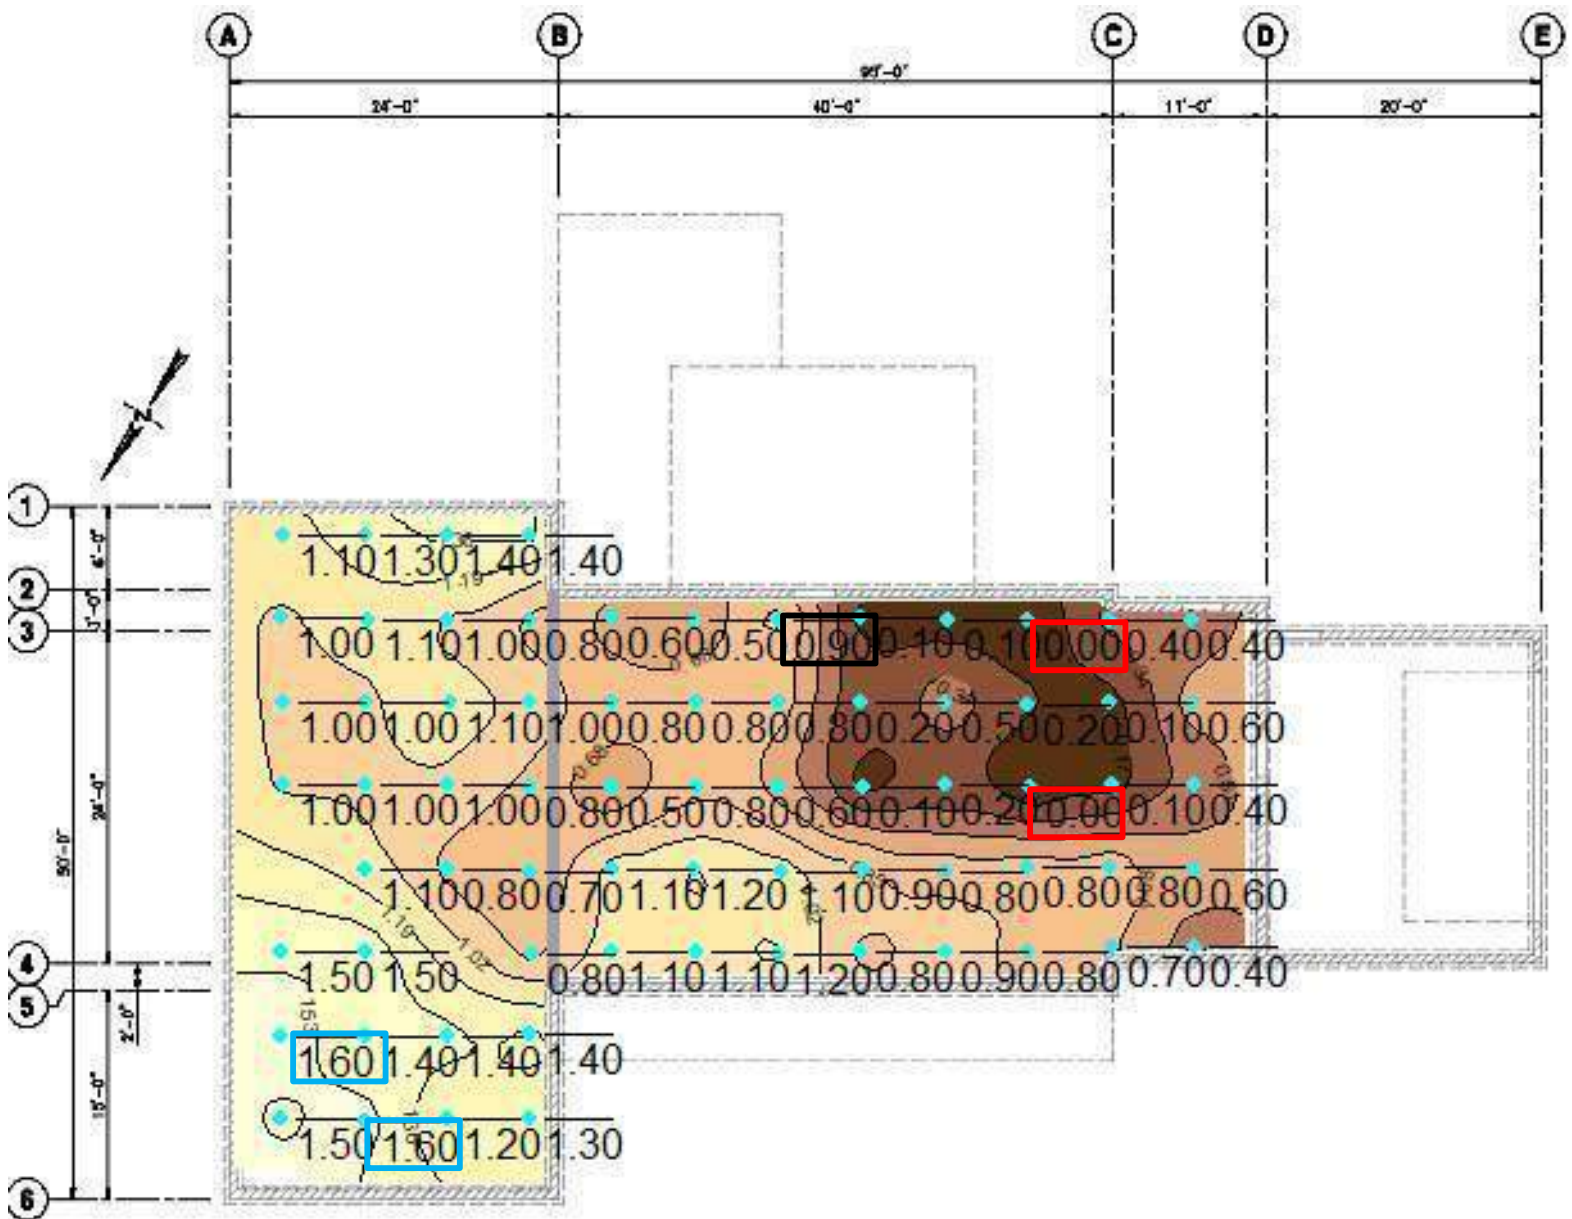
<p style="text-align: center;">2D TOPOGRAPHIC MAP</p>	<p>PROJECT NUMBER: RBC25-016</p>
---	--	--------------------------------------

A Zip Level Survey was performed on the interior of the subject property, using the front door as the bench mark or starting point; designated as "0.9" on the floor plan. Measurements of the floor elevation were made in tenths of an inch. The high point was 1.6" and the low point was 0.0". The maximum difference in the floor readings was 1.6 inches. As can be seen on the topographic map, the most significant settlement is indicated by dark brown contours surrounding the area.

Starting Point: 0.9
 Highest Point: 1.6"
 Lowest Point: 0.0"
