## LIMITED STRUCTURAL INSPECTION

49 James Allen Lane  
Dunn, NC

August 22, 2025

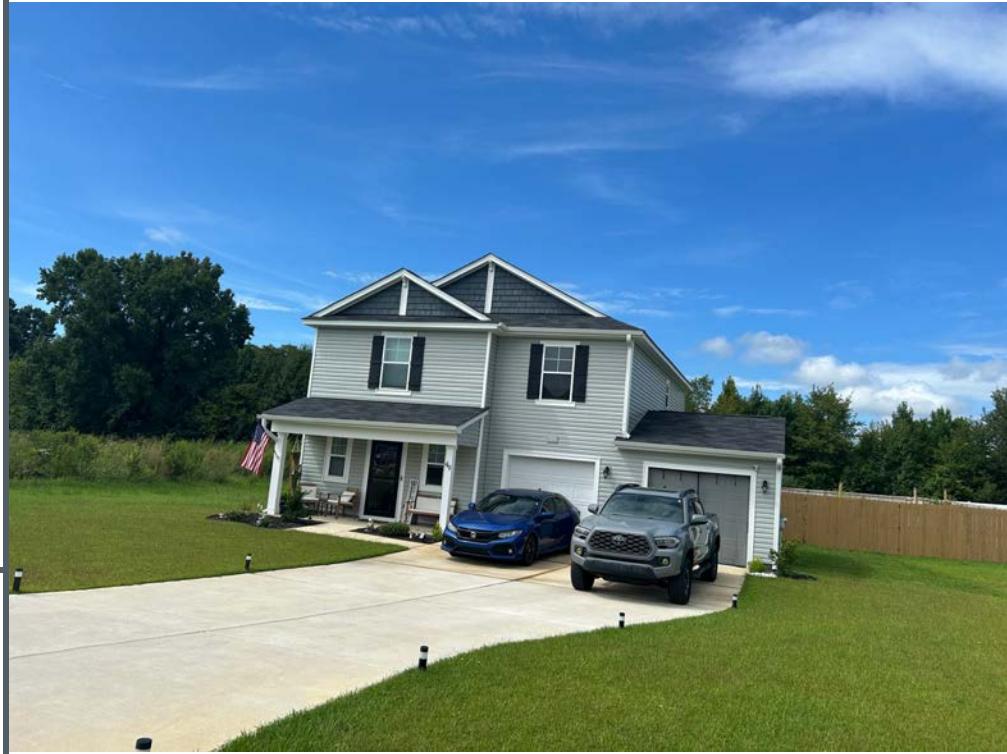
View of the home.

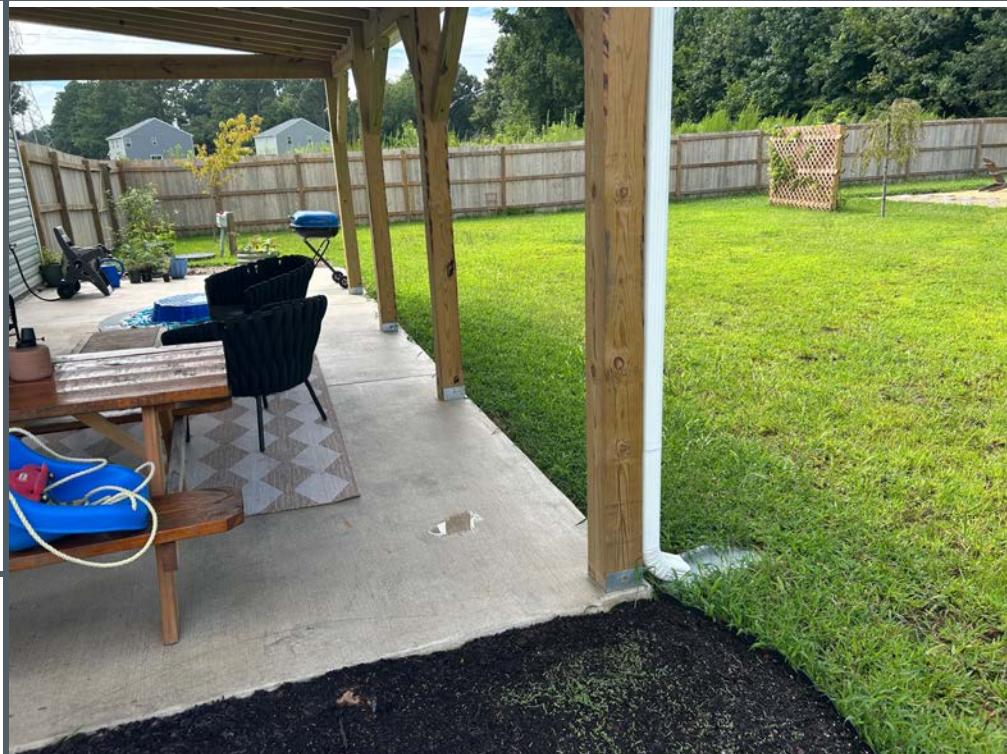
1

View of the porch.

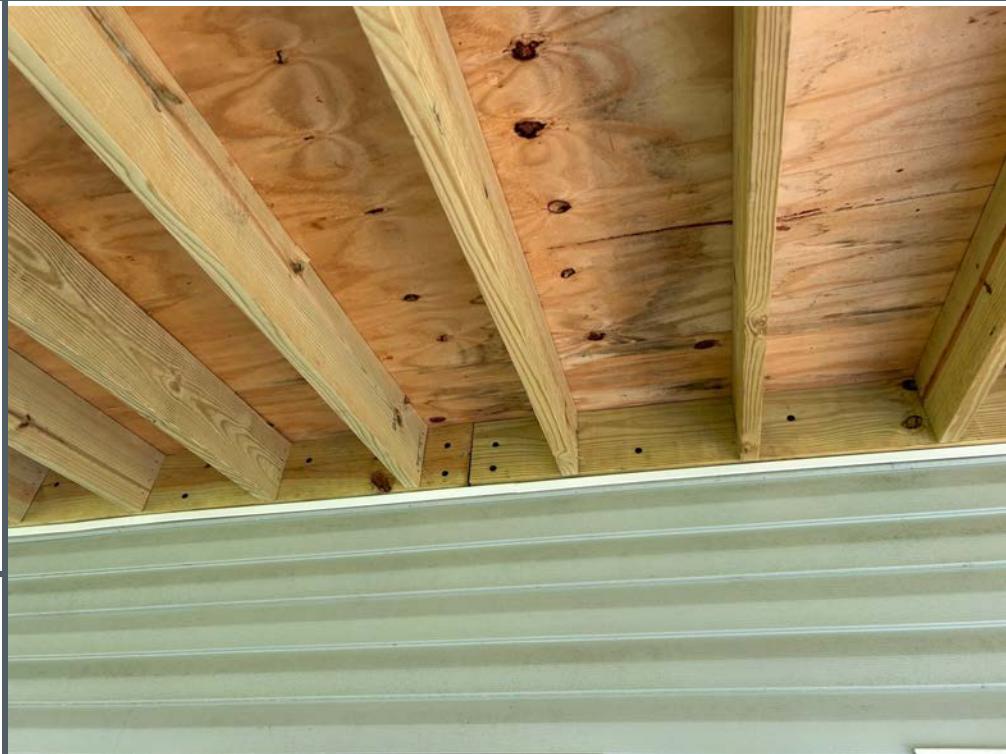
2. The roof framing is comprised of 2 x 8 rafters, spanning approximately 12 feet and supported by a 2x ledger board, which is screwed to the rear wall of the home. The screw spacing appeared to be somewhat inconsistent. But generally appeared to be targeted at 24 inches on center staggered.

View of the rafters and roof sheathing.

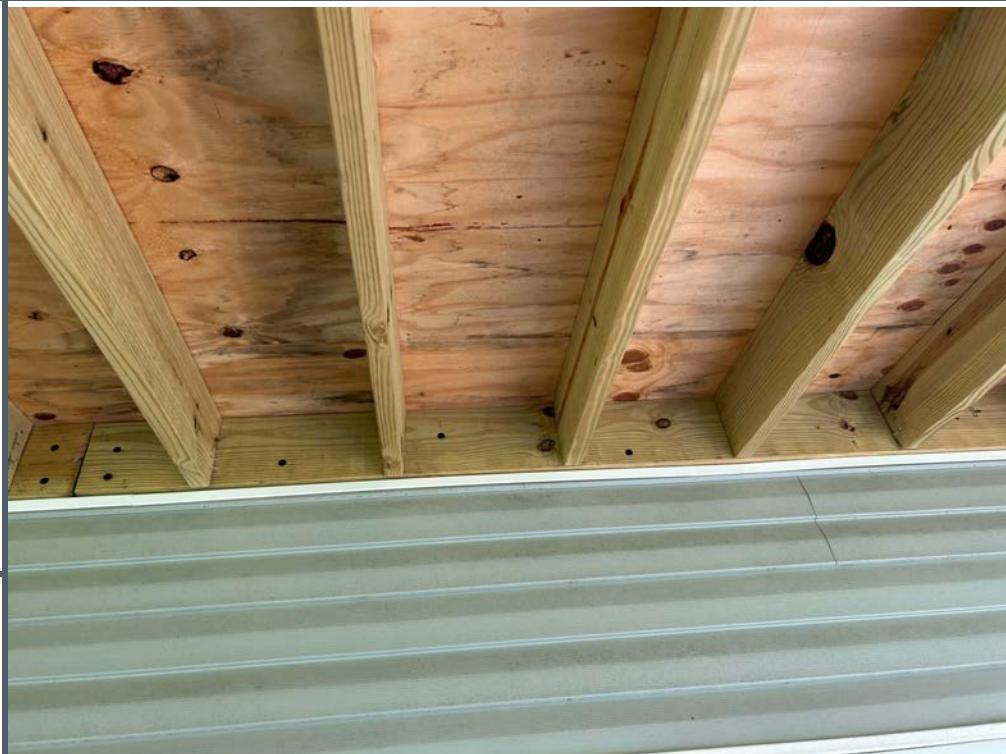
**Photo No.**  
**3**

View of the rafters and roof sheathing.

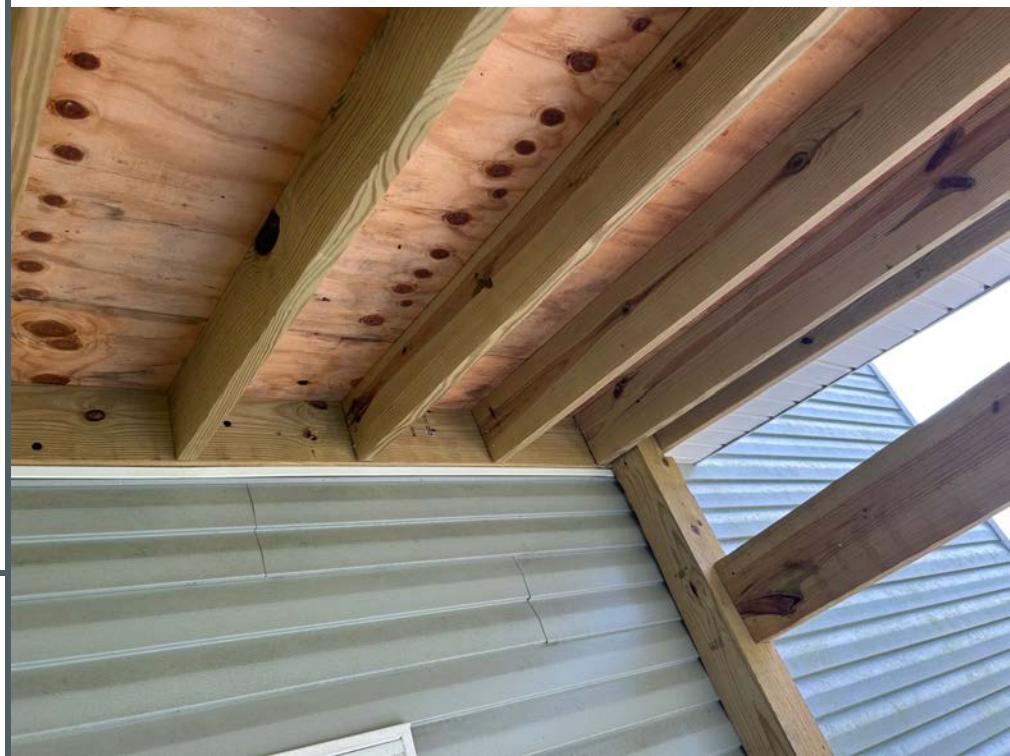
**Photo No.**  
**4**

View of the ledger connection at the house.

1. We recommend undermining the slab below the three posts without footings and installing 16 x 16 x 8" thick concrete footings. The new concrete shall be packed and tied to the underside of the slab.
2. We recommend installing additional structural screws (Simpson SDWS 4" or similar) to connect the ledger board supporting the roof against the wall of the house. Additional screws shall be installed to achieve a minimum of two screws at 24 inches on center.
3. We recommend installing Simpson L 50 clip angles to connect the rafters to the ledger board at the rear wall.

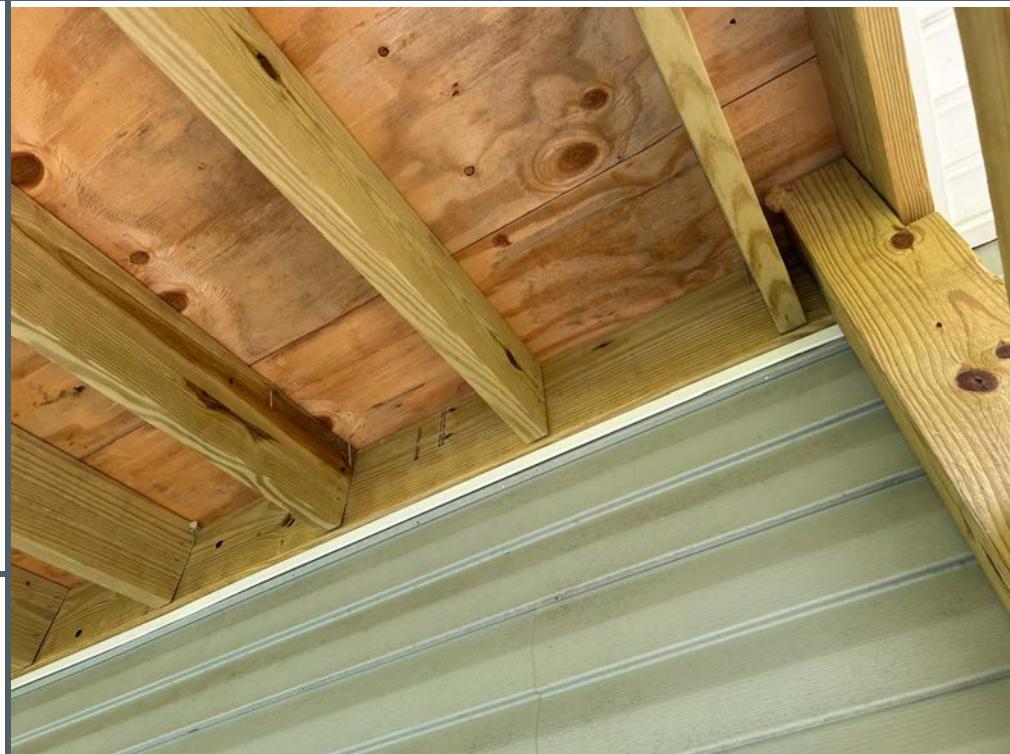
**Photo No.**  
**5**

View of the ledger connection at the house.

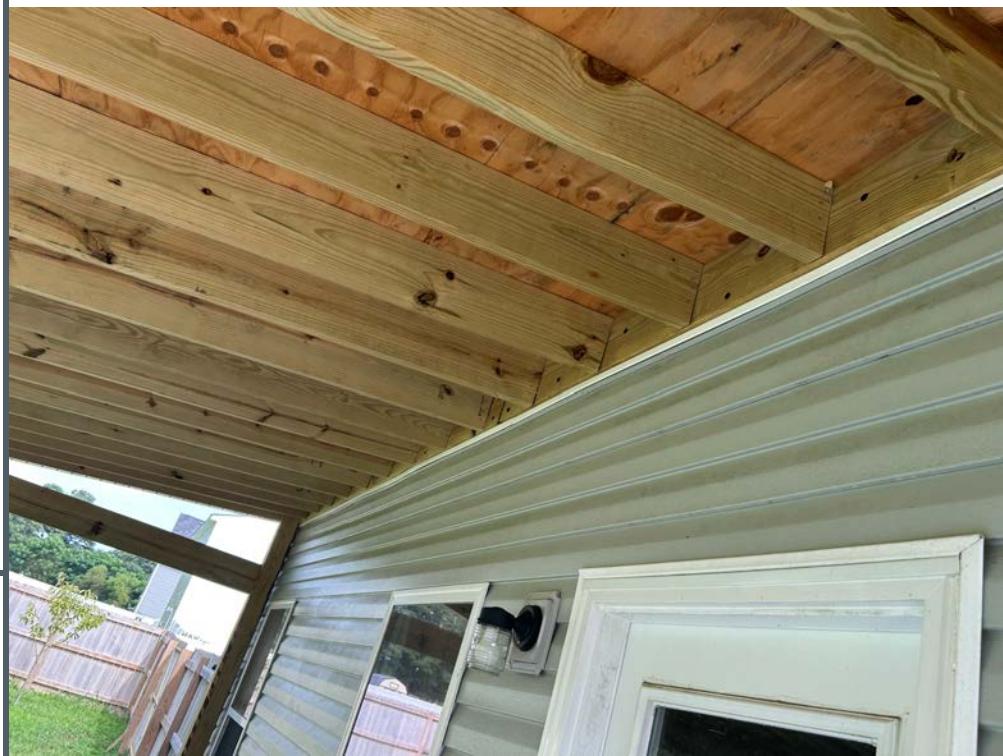
**Photo No.**  
**6**

View of the rafter framing.

4. We recommend installing a new 2 x 6 ledger strip below the over-notched rafters. The new ledger strip shall be bevel cut to provide continuous bearing to the underside of the rafters and be connected to the existing 2 x 10 band with two rows of #8 screws at 16 inches on center.
