STRUCTURAL DESIGN LETTER – WALL REMOVAL

643 Wheeler Road
Angier, NC

May 19, 2025

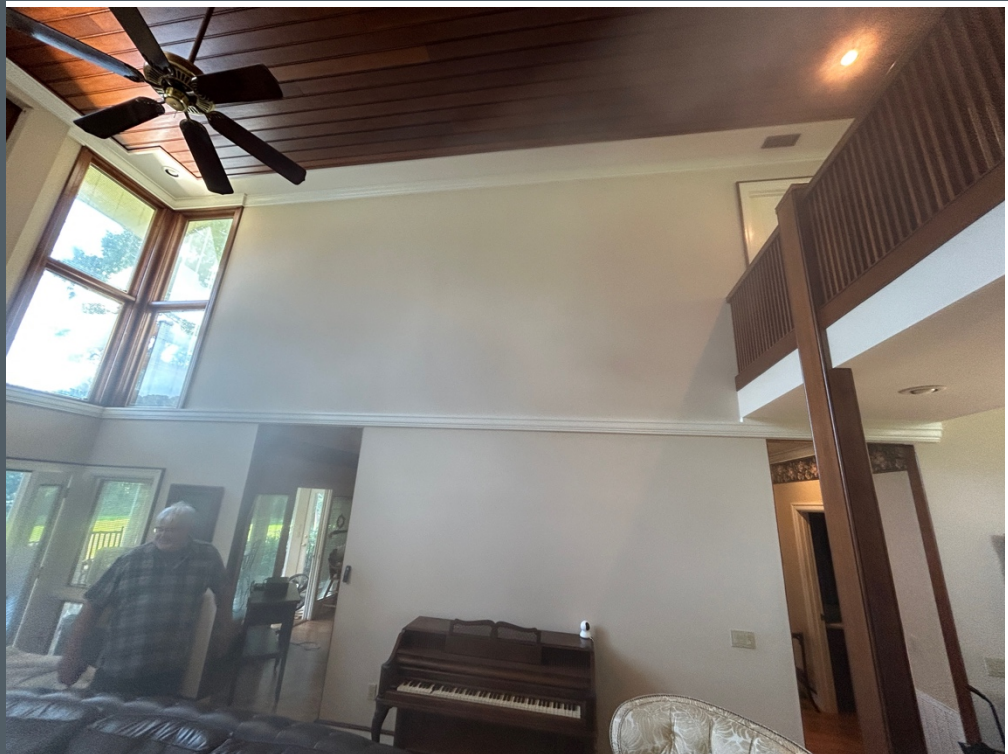
Photo No.
3

View of the subject wall.

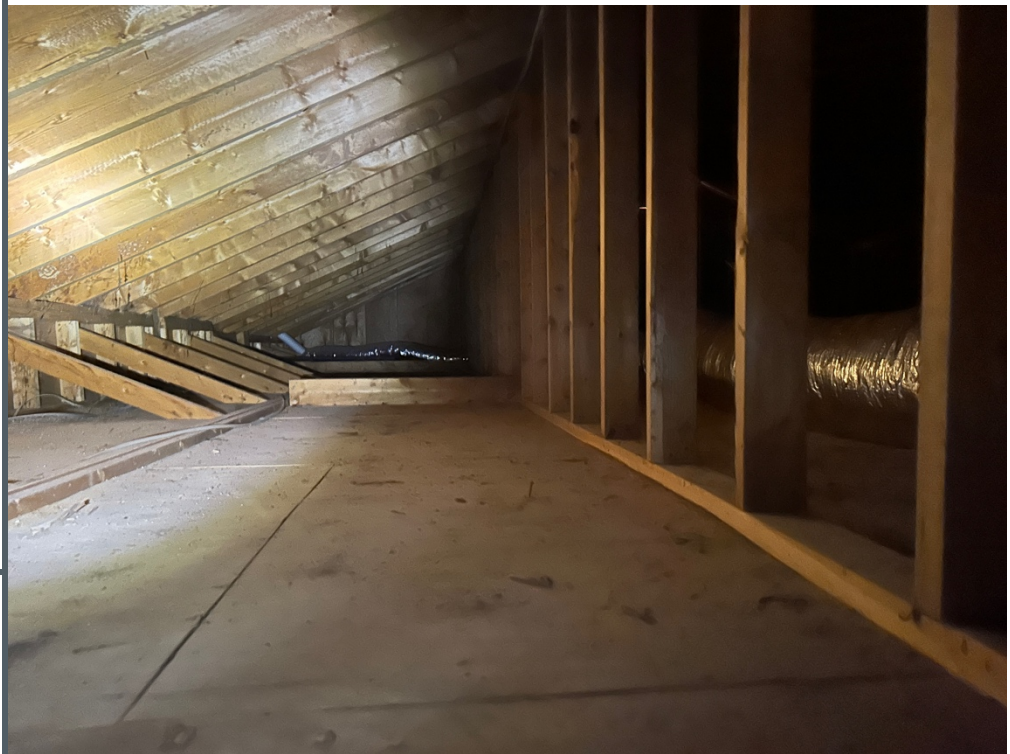
Photo No.
5

View of floor framing.
