Matthew C. Murphy, PE
Stonewall Structural Engineering, PLLC
9203 Baileywick Rd. #200
Raleigh, NC 27615
(919)407-8663

Re: Review of Proposed First-Floor Framing Reinforcement — 25 Dinghy Drive, Sanford, NC 27332

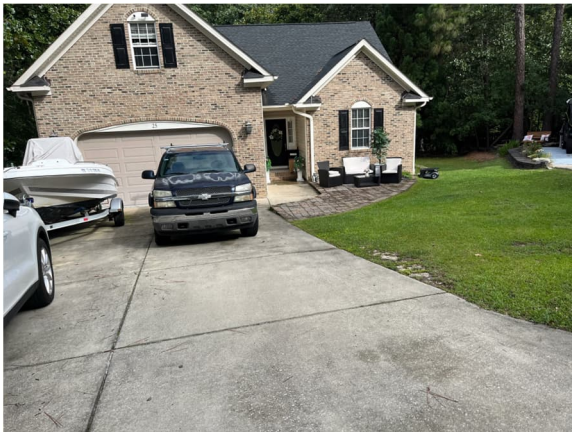
Picture 1 – Front of Home
(25 Dinghy Drive, Sanford, NC 27332)

Based on the information provided by Tar Heel Basement Systems, we understand the subject structure to be a conventionally framed, detached, single-family residence with raised first-floor framing over a pier/girder foundation system with perimeter masonry foundation walls (see pictures 1-2). Indicators such as "left," "right," "front," and "back" are referenced as viewing the front of the home.

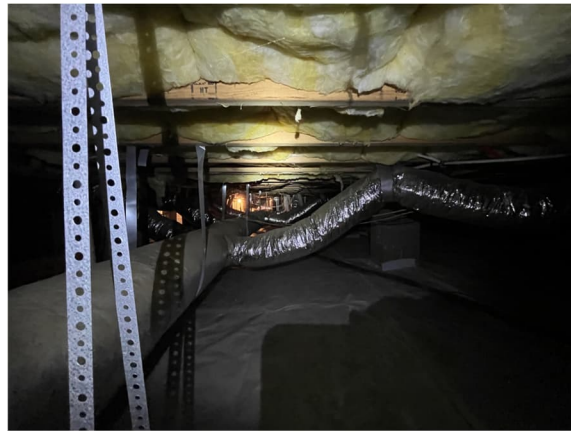
Picture 2 – Typical crawlspace conditions and
first-floor framing

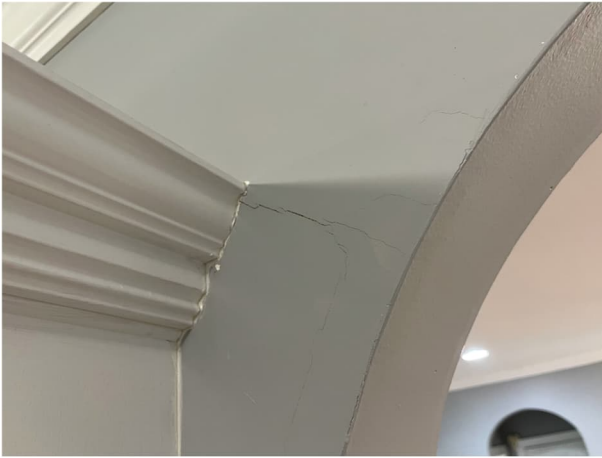
1. Drywall cracks and uneven floors were reported near the middle of the home.
 - a. It was reported that the joists in the middle joist bay were sagging.

Picture 5 – Drywall cracks

The observed sagging floor framing is possibly the result of prolonged exposure to high moisture levels within the crawlspace. As the moisture content of wood increases, its strength decreases, which can result in excessive deflection (i.e. sagging) when loaded.

1. Install the proposed supplemental S4x7.7 dropped girder within the middle $\frac{1}{3}$ of the joists. The new girder should span across the locations shown in the attached repair schematic (see *Detail 1*) over IntelliJack supports on well-compacted 18"x18"x18" gravel footings spaced no more than 6'-6" apart (see *Detail 2*).
 - a. The supplemental dropped girder may be comprised of multiple segments provided splices between adjoining segments are located over supports.
 - b. Where feasible/practical, the ends of the new supplemental girder are recommended to start/stop under walls such that the changes in floor stiffness are less noticeable.

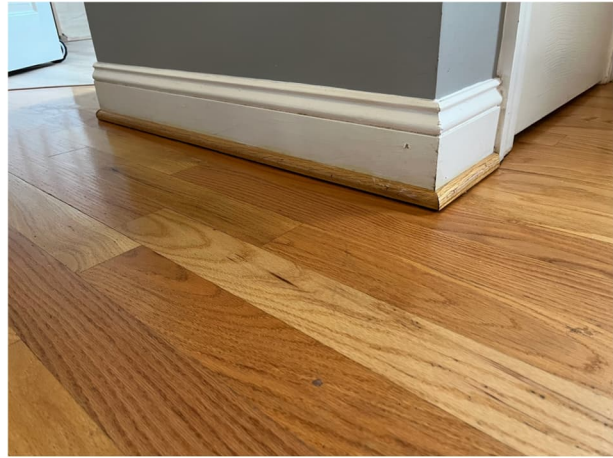
Picture 6 – Uneven floors
