Matthew C. Murphy, PE  
Stonewall Structural Engineering, PLLC  
9203 Baileywick Rd. #200  
Raleigh, NC 27615  
(919) 407-8663

Clint Weirich  
Tar Heel Basement Systems  
8005 Knightdale Blvd.  
Knightdale, NC 27545

Re: Review of Proposed First-Floor Framing Reinforcement — 1963 Temple Road, Bunnlevel, NC 28323

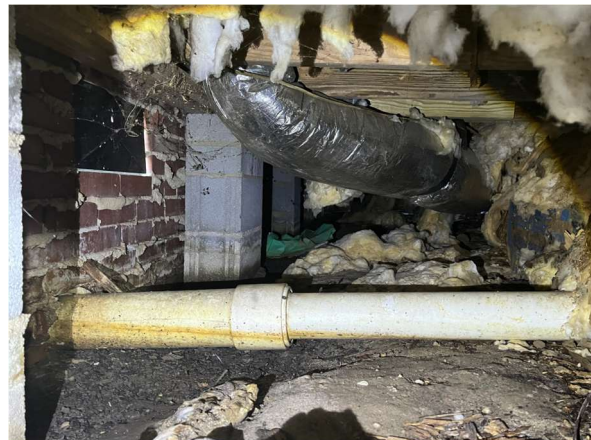
Based on the information provided by Tar Heel Basement Systems, we understand the subject structure to be a conventionally framed, detached, single-family residence with raised first floor framing over a pier/curtain wall foundation system (*see pictures 1-2*). Indicators such as “left,” “right,” “front,” and “back” are referenced as viewing the front of the home.

*Picture 2 – Typical crawlspace conditions and first-floor framing*

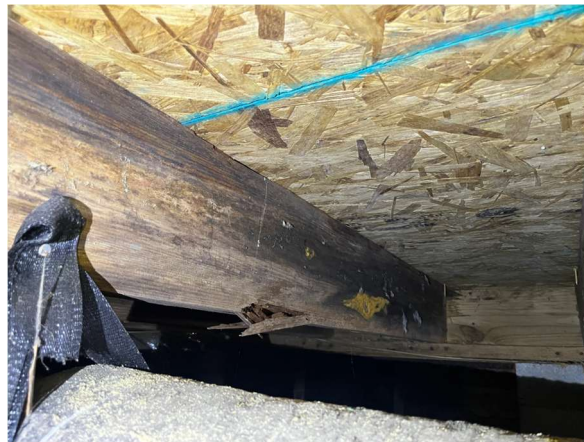
1. Uneven floors were reported in the front-left section of the home.
  - a. Reported measurements indicated that the floors in the area were down by as much as approximately  $\frac{1}{2}$ " relative to the back-right corner.
  - b. Reported investigation from within the crawlspace indicated that (2) joists in the front-left joist bay, located approximately 6'-0" from the left foundation, wall were cracked (see picture 3).

*Picture 3 – Example of a cracked joist*

The observed cracked floor joist is possibly the result of prolonged exposure to high moisture levels within the crawlspace. As the moisture content of wood increases, its strength decreases, which can result in excessive deflection (i.e. sagging) when loaded. This increase in deflection can lead to framing members cracking.

1. Reinforce the reported cracked joists with an additional ply of full depth treated 2x #2 Southern Yellow Pine (SYP). Sistered material should be continuous between end supports.

1. Reinforce each of the deteriorated joists noted above with an additional full depth ply of 2x #2 Southern Yellow Pine (SYP), fastened to the side of the deteriorated joists using (3)10d common nails at each end and at 12" on-center staggered top and bottom along the lengths of the joists. Sistered material should span continuously between end supports.

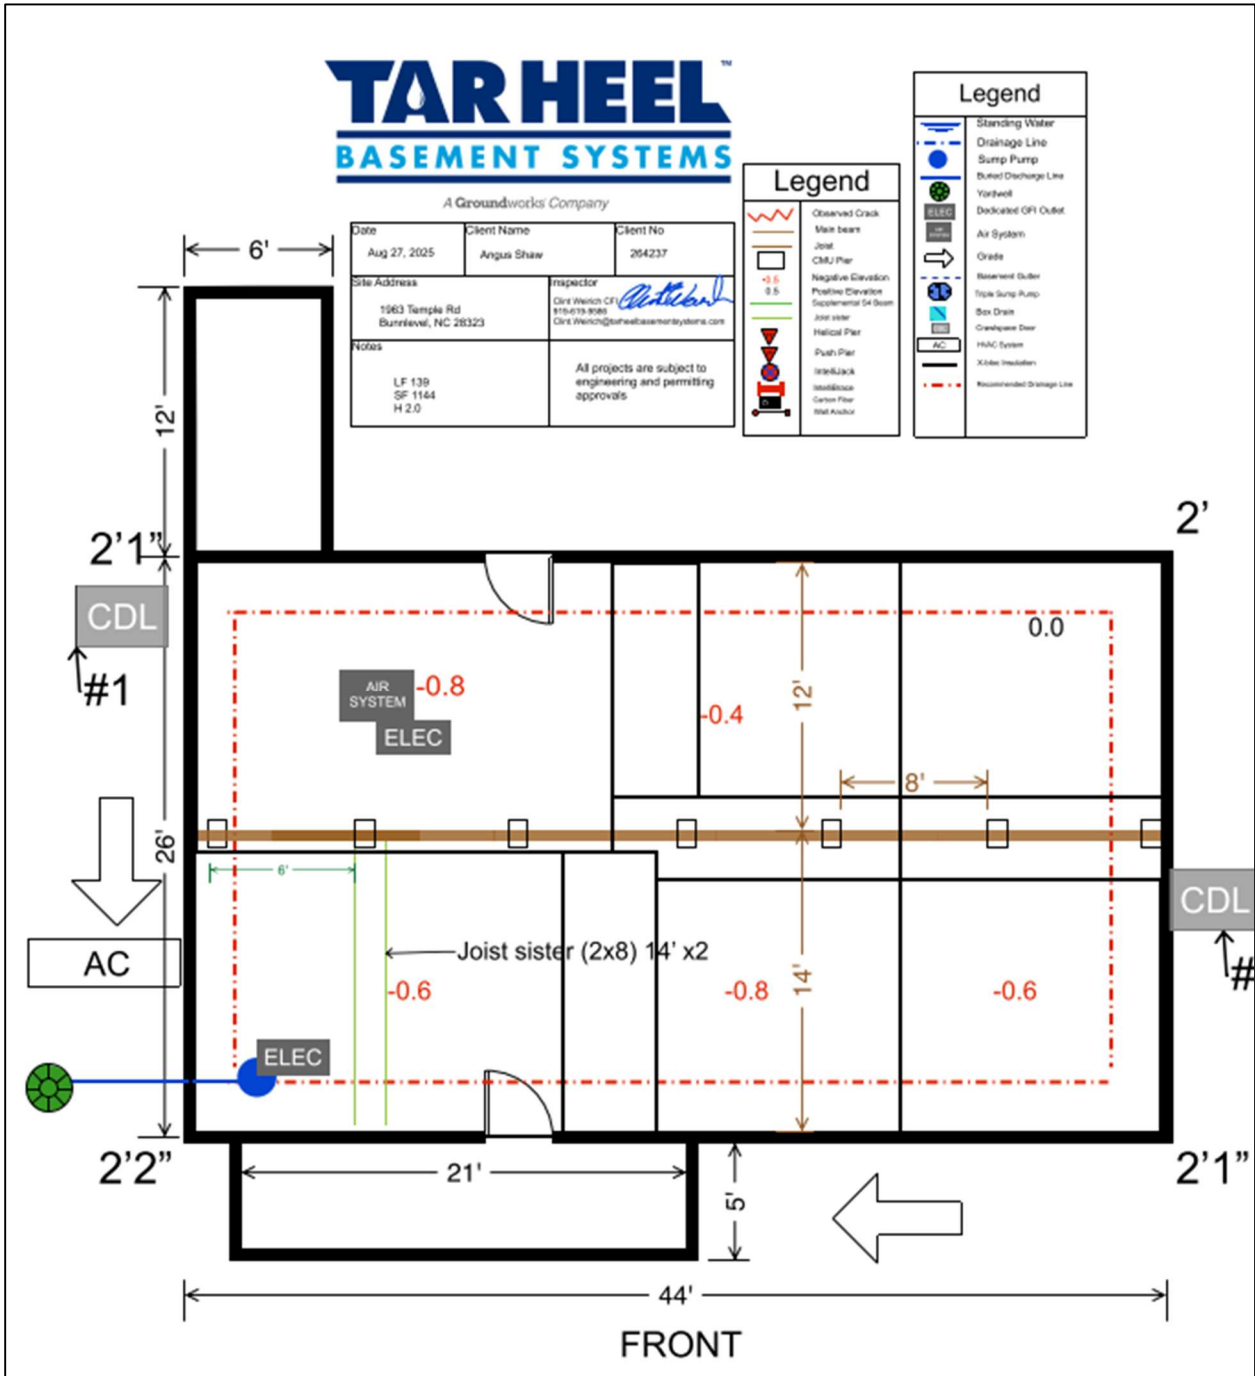
Detail 1 – Repair Schematic  
(Provided by Tar Heel Basement Systems)
