## LIMITED STRUCTURAL INSPECTION

206 Olde Ferry Lane  
Dunn, NC

September 15, 2025

NEW ELEVATOR - STRUCTURAL  
MODIFICATIONS

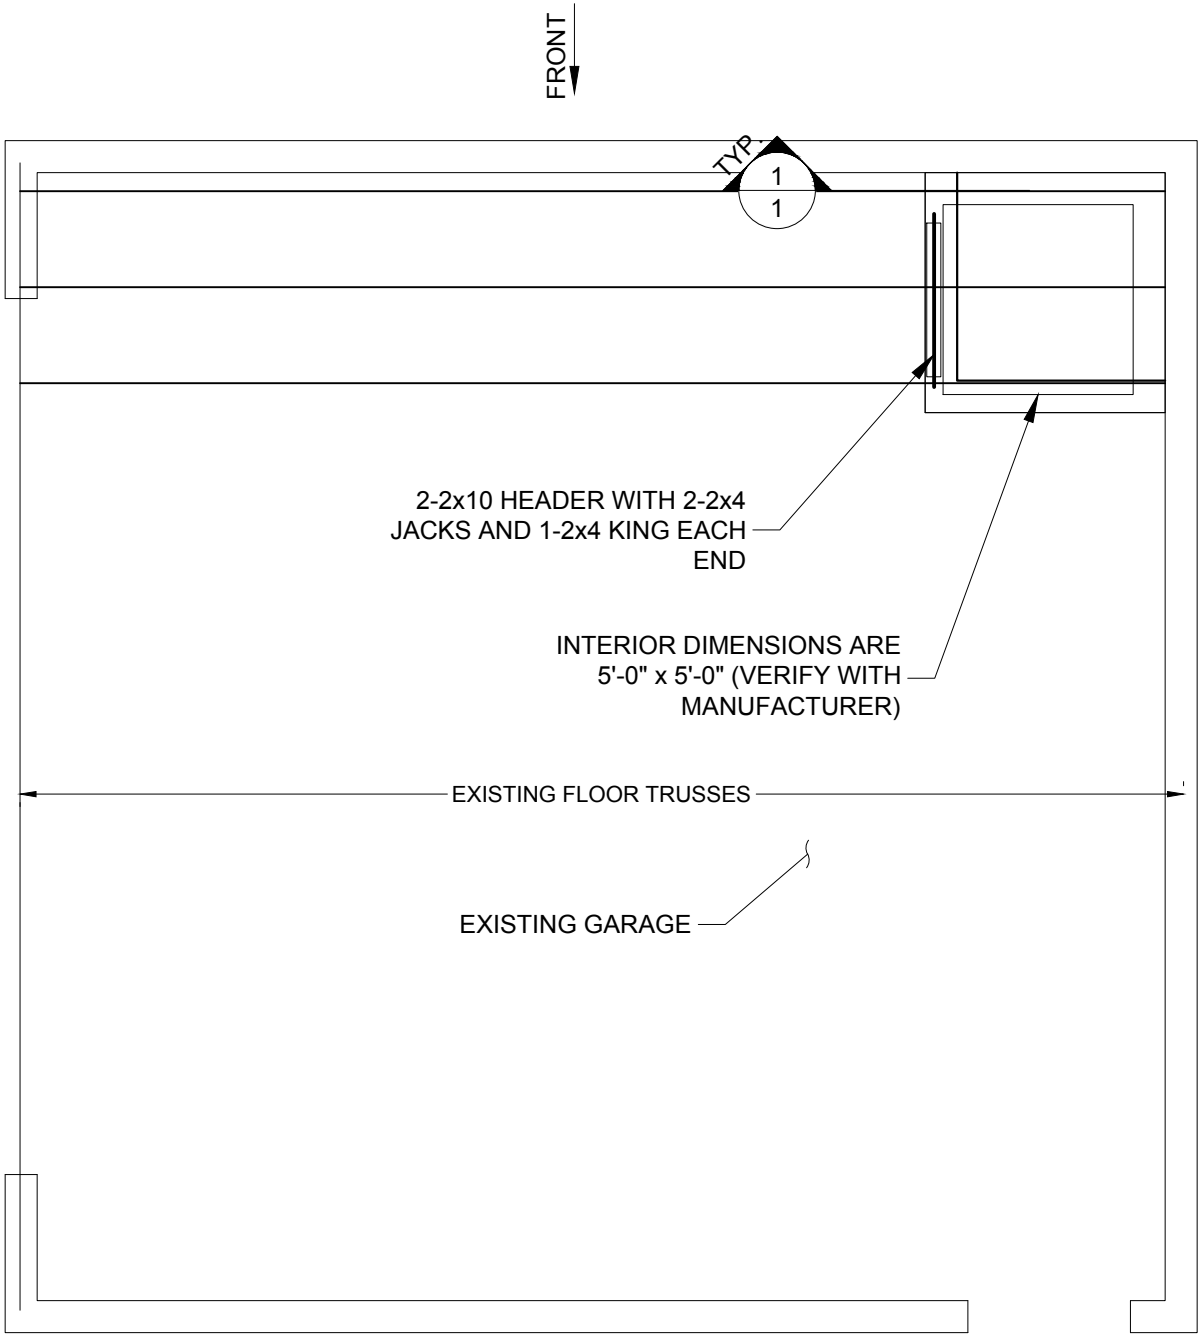
PLAN VIEW OF GARAGE

1. The subject elevator was to be located in the front left corner of the front garage.
2. The first floor framing was comprised of 18 inch deep open web wood trusses, spanning left to right.
3. The ceiling and roof framing above appeared to be comprised of attic roof trusses.
4. Per review of literature provided for the elevator to be installed, a new traction style elevator with the counterweight system was to be installed. The elevator pit was to be designed to support a 5100 pound impact load per our understanding.

1. We recommend saw cutting the existing concrete slab to install a new 8 inch thick concrete slab for the elevator pit.
  - a) Per our understanding, the elevator pit is to be placed approximately 10 inches below the top surface of the slab.

- b) The slab should be undermined, on the interior sides to install a new minimum 8 inch thick concrete or grouted CMU stem wall.
  - c) Provide number four bars, spaced 16 inches on center each way, in the base of the elevator pit.

2. We recommend a waterproofing/vapor barrier system being installed on the inside of the elevator pit to help prevent water infiltration. Note that due to the elevator pit being a low point in the grade, the installation of a drain may not be effective.

3. The existing web trusses shall be temporarily shored, and cut off at the penetration through the floor. Provide 2x blocking at the end of the trusses install 7/16 inch OSB gussets on each side of the trusses extending back into the truss span a minimum 24 inches.

4. The modified trusses shall bear on a new minimum 2 x 4 wall with a single 2x4 bottom plate and 2 – 2 x 4 top plates. Provide vertical two – 2 x 12 studs for the elevator tracks for the

5. Provide a new 2 – 2 x 10 header at the elevator door opening.

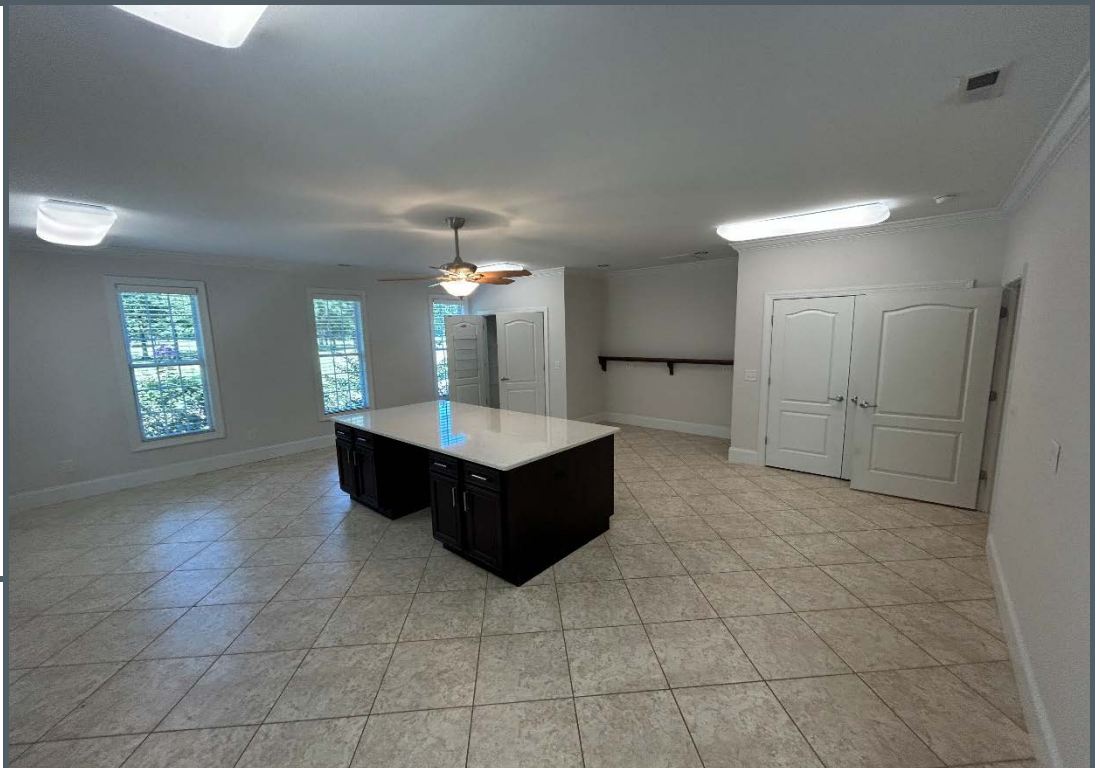
Photo No.  
3

View of the subject room where the elevator is to be installed.

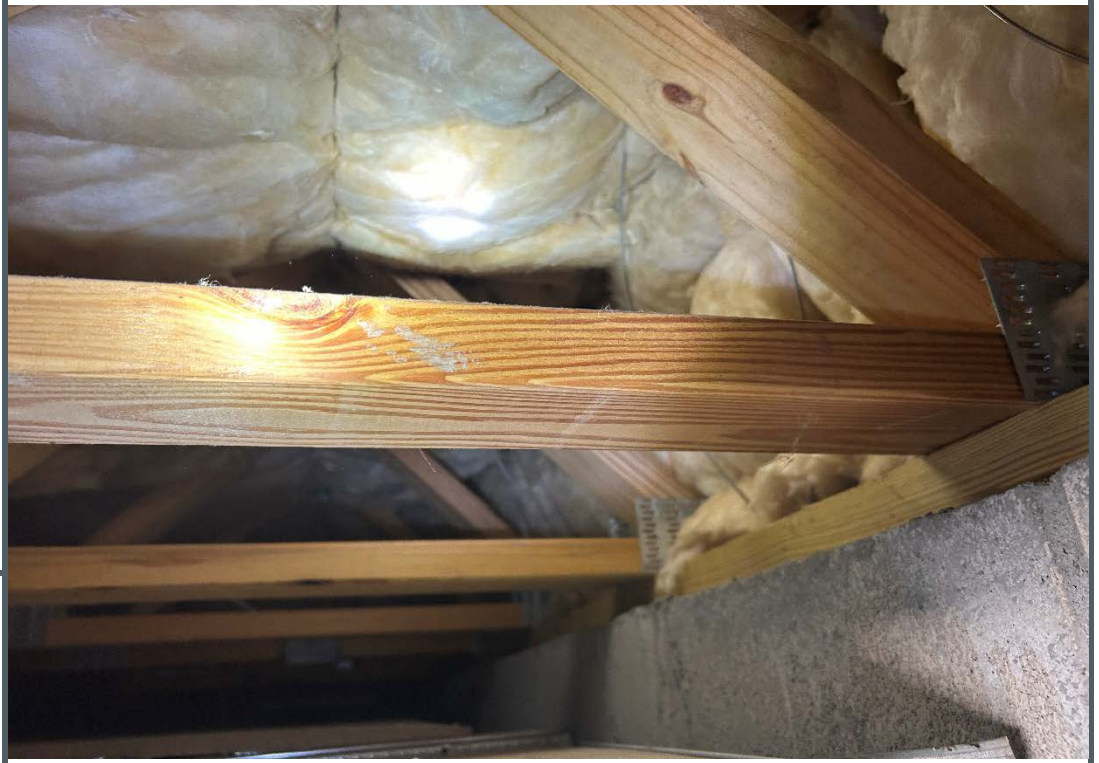
Photo No.  
7

View of the floor trusses to be cut for the new elevator opening.

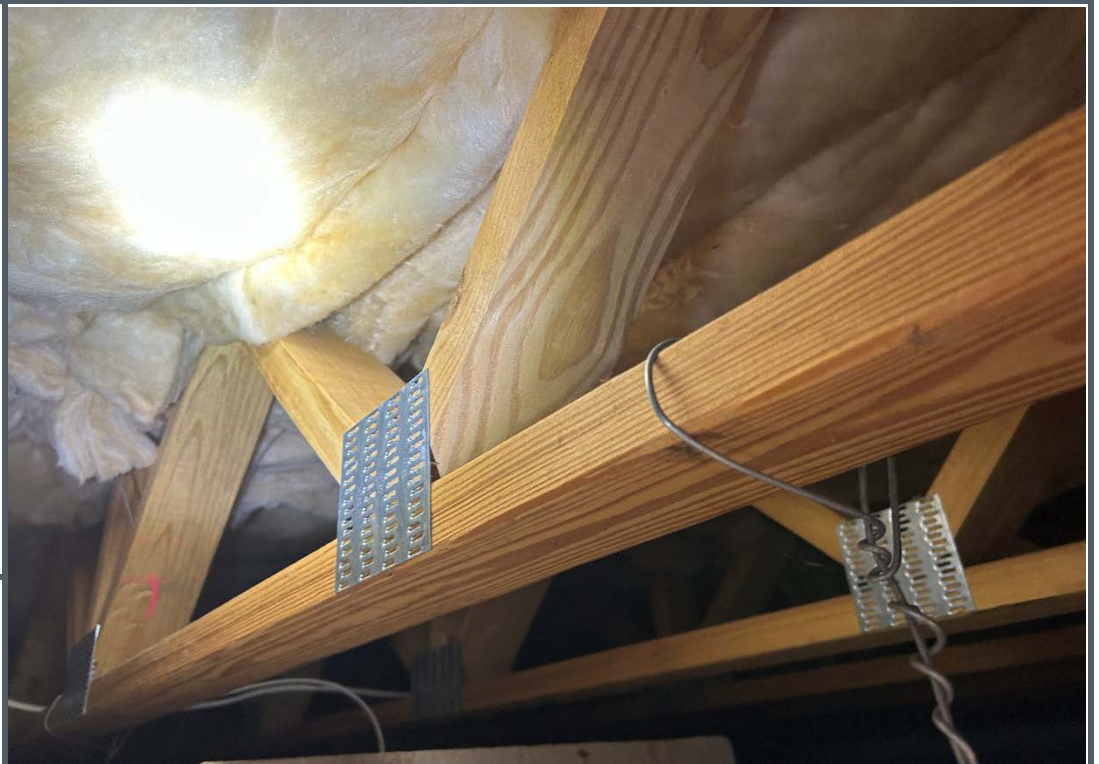
Photo No.  
8

Additional view of the floor trusses.

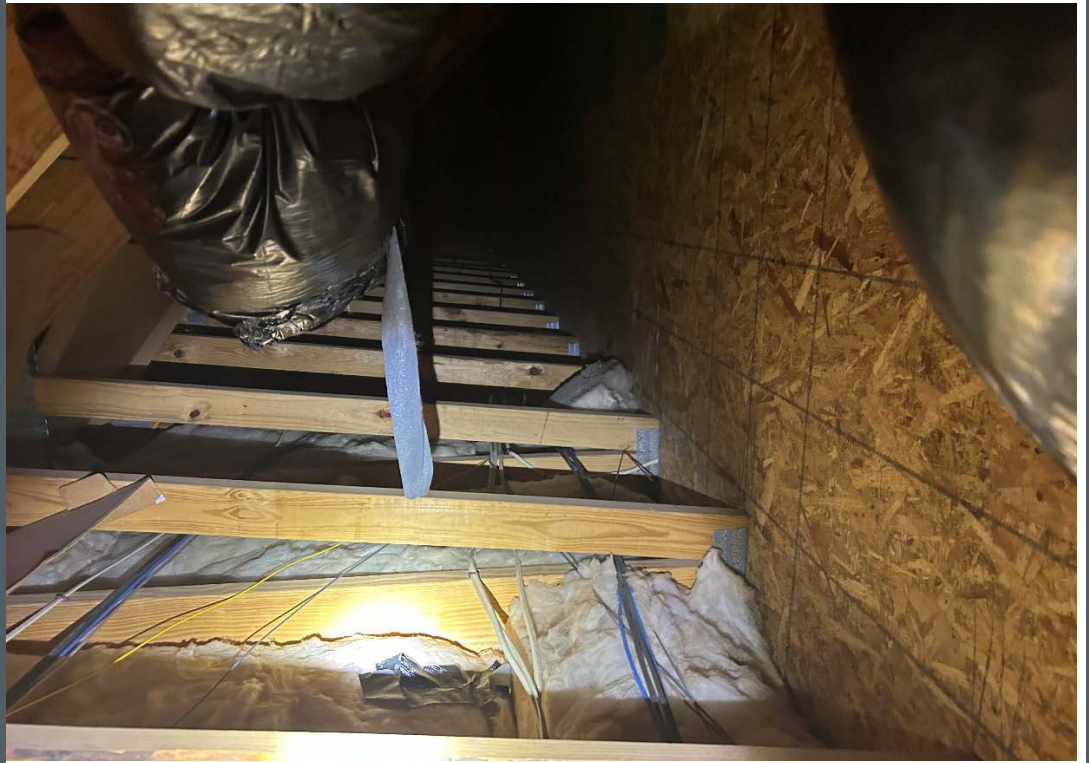
Photo No.  
9

View of the attic roof trusses above.

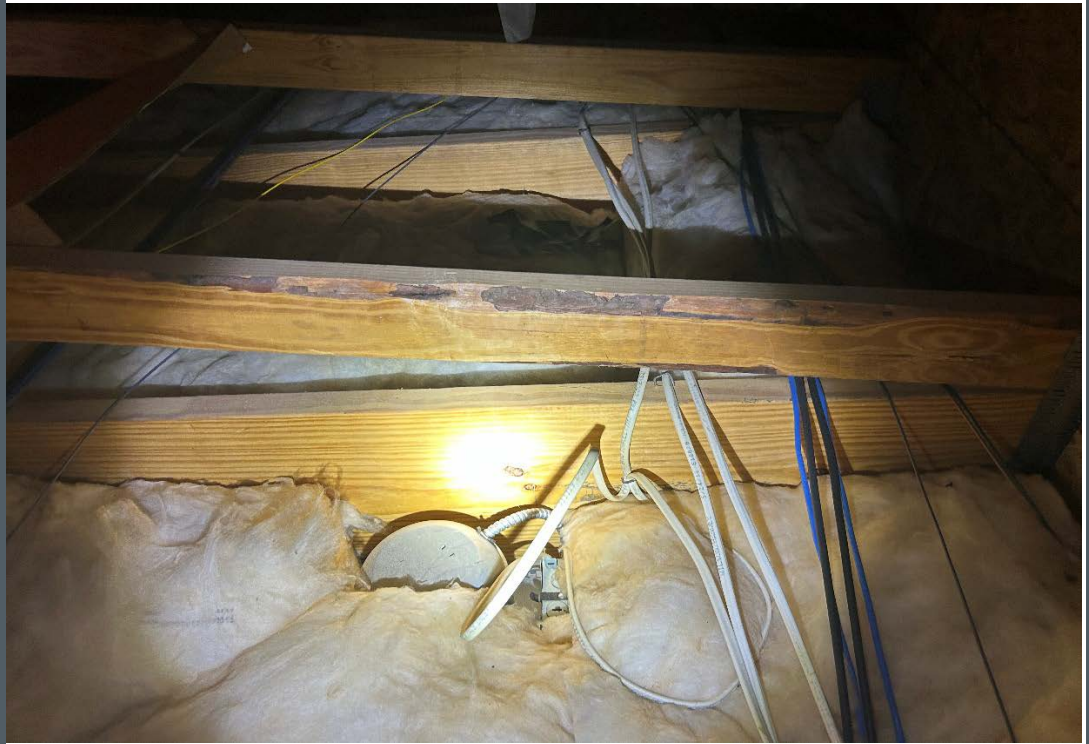
Photo No.  
10

View of the attic roof trusses above.
