Harnett	IP 12/14/09, 1 County		INSPECTION TICKET INSPECTOR: IVR		39 15/09
	. : 233 EIS		SUBDI		
	: BOUCHAF	D JASON CL			
	: 03-9597				
			& ALTER RESIDENTIAL		
DIRECTIO			3:20 PM VBROWN LLINGTON 27546.		
			DIV #9. 27W TO DOCS		
			MICRO TOWER TURN		
	RIGHT,	THEN RIGHT	TURN RIGHT EISLER		
	DRIVE.				
			ECTOR EVERTHING IS		
			X20 ADDITION TO		
		ECK******	, 16X28 DET GAR,		
	IVAIZ L	)ECK××××××××	* *		
	10X12 L				
	RE: 000 000 1	.6X20 ADDIT	16X28 DETGAR, 12X16SHEL, 10X1	2	
FLOOD Z	RE: 000 000 1 ONE :	<b>6X20 ADDIT</b> FLOOD ZONI	16X28 DETGAR, 12X16SHEL, 10X1 X		
FLOOD ZO # BEDROO	RE: 000 000 1 ONE : OMS	<b>6X20 ADDIT</b> FLOOD ZONI	16X28 DETGAR, 12X16SHEL, 10X1 X .00 SEPTIC -	2 EXISTING? : EXISTING	. <b></b>
FLOOD ZO # BEDROO	RE: 000 000 1 ONE : OMS UPPLY	6 <b>X20 ADDIT</b> FLOOD ZONI : : CO	16X28 DETGAR, 12X16SHEL, 10X1 X .00 SEPTIC - UNTY		
FLOOD ZO # BEDROO WATER SI	RE: 000 000 1 ONE : OMS UPPLY	.6X20 ADDIT, FLOOD ZONI : : CO	16X28 DETGAR, 12X16SHEL, 10X1 X .00 SEPTIC - UNTY

Reference: Engineering Services 233 Eiser Rd. Lillington, NC Project No.: 09GAR-F540

## HARNETT COUNTY

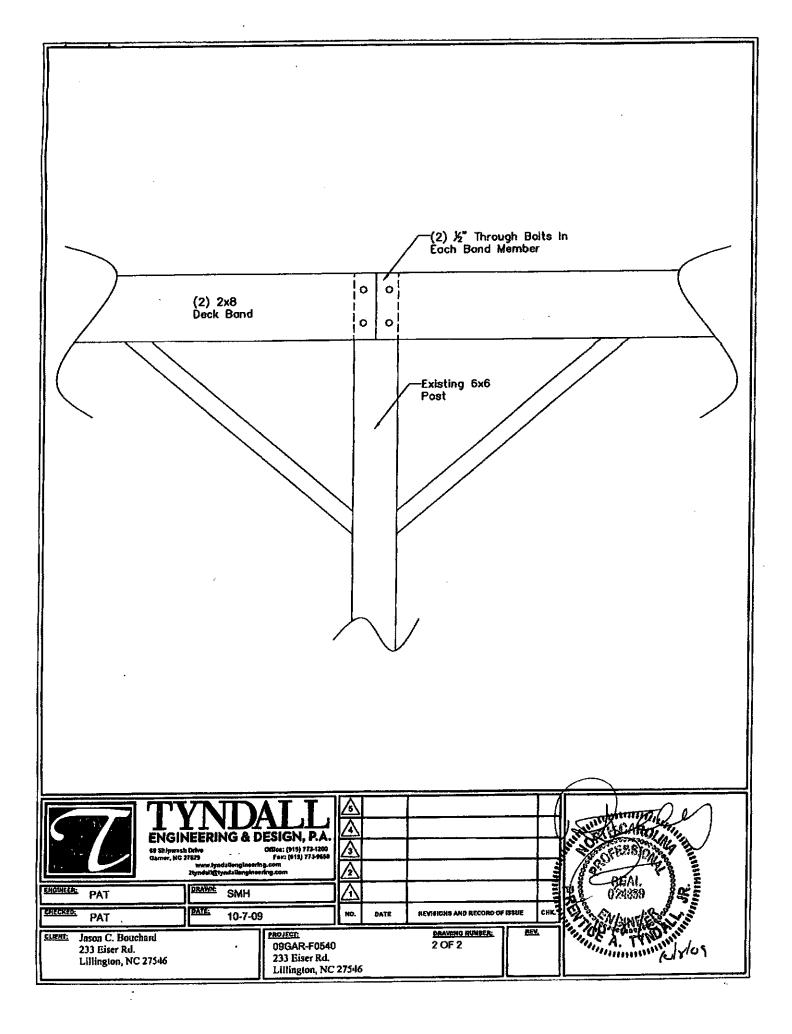
- Based on our observations and analysis, the existing framing is adequate as constructed to support the anticipated loading conditions. However, the existing (2)2x8 header should be secured to the existing 6x6 posts with (2) 1/2" through bolts per connection. The reader is referred to the attached diagram for details. Additionally, a Simpson H2.5 clip should be added to each rafter at the (2) 2x8 header connection.

- 3) Based on our observations and analysis, the existing framing is adequate as constructed to support the anticipated loading conditions. However the existing (2)2x8 band should be secured to the existing 6x6 posts with (2) 1/2" through bolts per connection. The reader is referred to the attached diagram for details.
