Reference: Soil Investigation and Septic Consulting

Recombination Map for Donald Mangum and Olivia Mangum

Soil Investigation and Septic Consulting Recombination Map for Donald Mangum and Olivia Mangum 3 November 2017

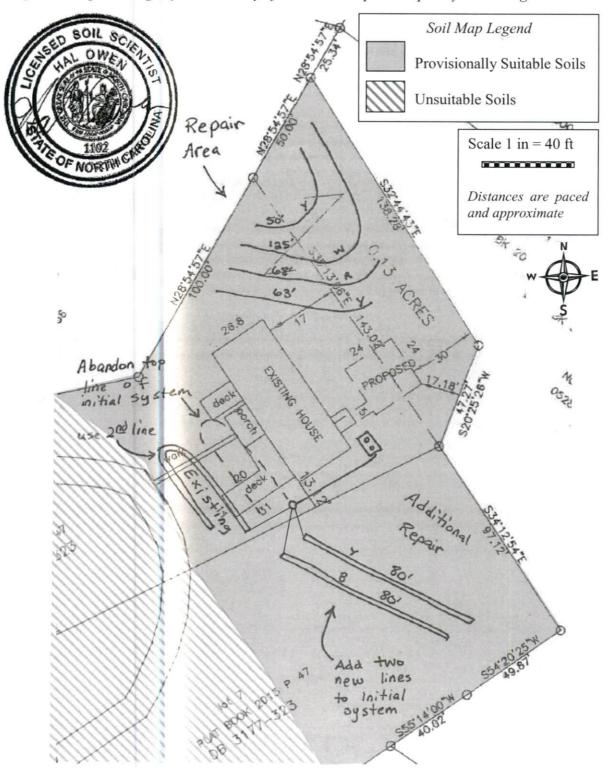
Figure 1. Map showing Septic Suitability of Soils and Proposed Septic System Design

Hal Owen & Associates Inc. reviewed the septic permit issued by the Harnett County Department of Environmental Services (Permit # 27765) and identified the existing septic system at the site. The home does not have a foundation drain, and it utilizes the public water supply. The existing septic system utilizes a 1000 gallon septic tank from which effluent flows to a distribution box to two 100-foot long accepted status (EZ-flow) drainlines. It appears that additions to the home have covered most of the top existing drainline, and only about 80 feet of the bottom drainline still meets regulatory requirements.

It appears the initial septic system can be modified to support the septic needs of a four bedroom home. The storage capacity of the existing septic tank is adequate, and it will not need to be modified. The existing distribution box can be used if it will accommodate three lines, otherwise a new distribution box should be set. The first (top) drainline should be plugged or disconnected from the distribution box, and the second drainline should be left in place. Two new 80-foot EZ-flow drainlines will need to be added in the right side-yard beside the existing home. The new drainlines should be installed on contour with trench bottom depths at 18 to 24 inches below surface. The modified system will utilize gravity distribution to three 80-foot accepted status drainlines and have a corresponding long term application rate of 0.5 gal/day/ft².

The repair septic system is proposed as a pump to a pressure manifold or serial distribution to 300 feet of accepted status drainlines utilizing a long term acceptance rate of 0.4 gal/day/ft<sup>2</sup>. The drainlines should be installed on contour with trench depths at 18 to 24 inches below surface.
