ADDRESS : 238 CHESAPEAKE RD SUBDIV: RICHMOND PARK PH2
CONTRACTOR : KUSZMAUL, GLENN CRAIG PHONE : (919) 302-4988
OWNER : MADONNA DOMINIQUE & CORY H PHONE :
PARCEL : 09-9565-03- -0282- -14-
APPL NUMBER: 17-50043000 CP ADD & ALTER RESIDENTIAL
DIRECTIONS : T/S: 12/28/2017 12:08 PM LLUCAS ----
RICHMOND PARK #436

STRUCTURE: 000 000 FIRE RESTORATION

PERMIT: CPBP 00 CP BUILDING PERMIT

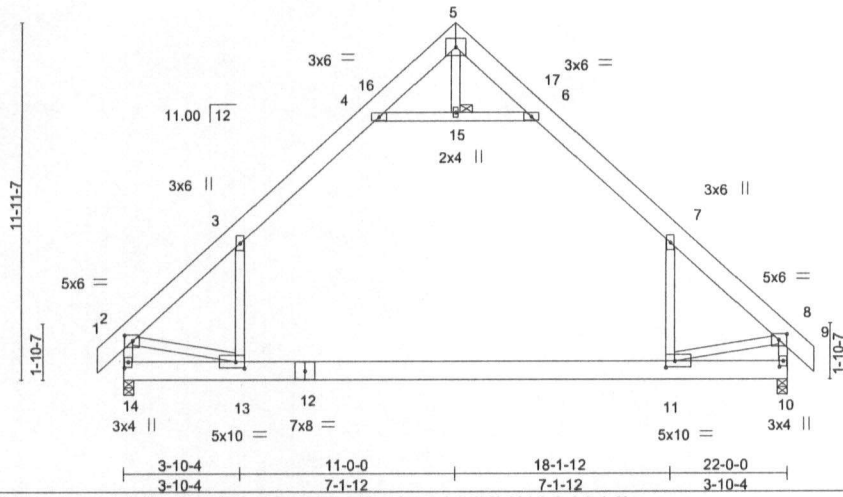
Job JJO180110	Truss T2	Truss Type Attic	Qty 1	Ply 2	cameron	E11887892
------------------	-------------	---------------------	----------	----------	---------	-----------

- NOTE: DUE TO THE OVERALL LENGTH TO DEPTH RATIO OF THE ROOM, THE FLOOR MAY EXHIBIT OBJECTIONABLE VIBRATION AND OR BOUNCE. BUILDING DESIGNER TO CONSIDER PROVIDING MEANS TO DAMPEN THESE EFFECTS. TRUSS DESIGN SHALL BE REVIEWED AND APPROVED PRIOR TO MANUFACTURING.
