HAL JWEN & ASSOCIATE, INC.

Reference: Existing System Investigation
Estate of William Russell Lamm
NC PIN 1601-82-5786

Soil and Existing System Investigation for Jay Lamm (NC PIN 1601-82-5786)

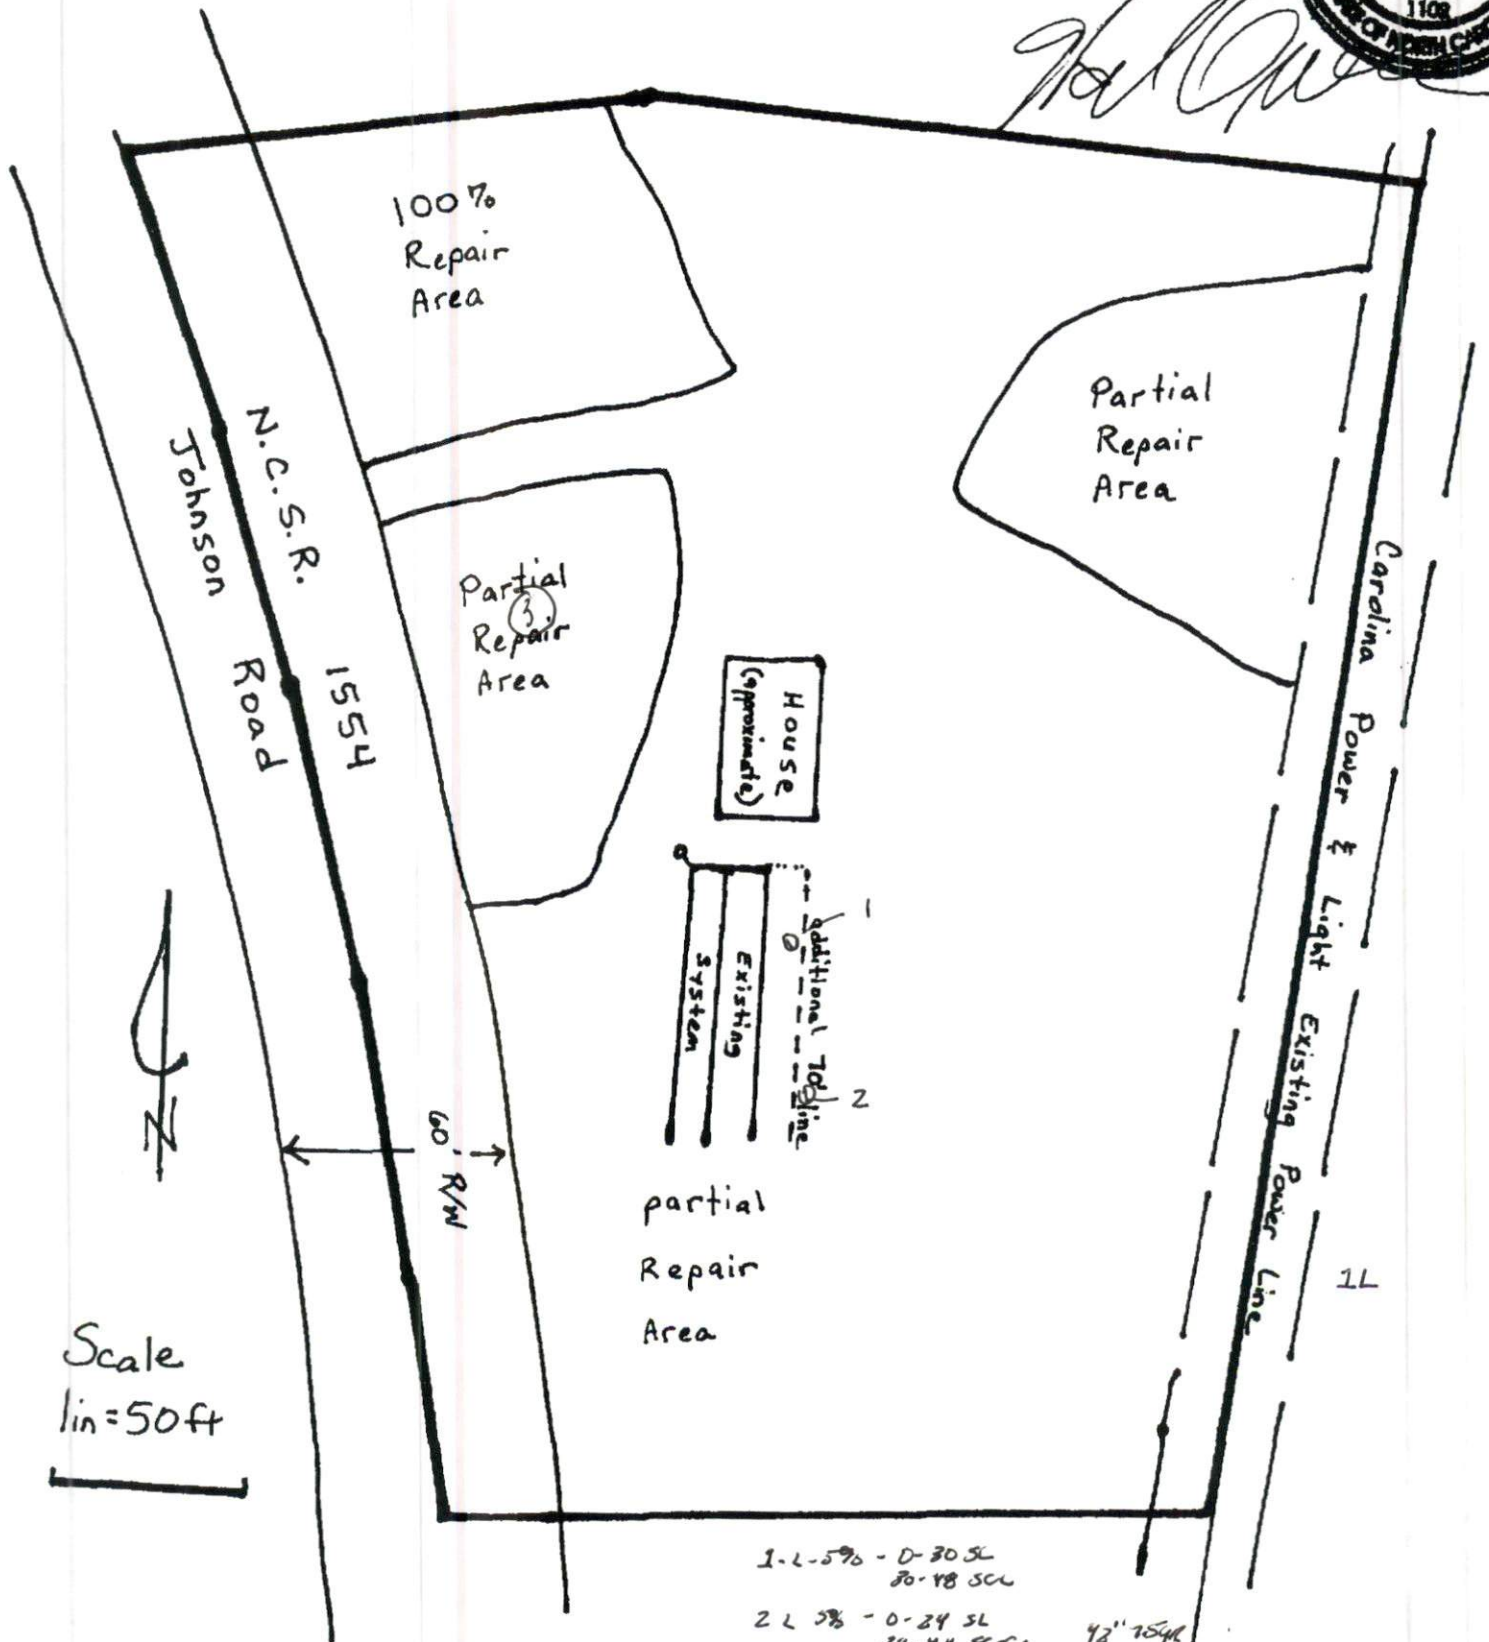
The area in front of the home (see map) appears adequate to support about 200 feet of conventional drainline installed 12 to 18 inches below surface. The soils are not as good here so this represents only about half of one system. The front yard typically has little competition for other uses and can easily be designated to serve as the repair area for the septic system.

- 1. L-5% - 0-30 SL
30-48 SCL
- 2 L 5% - 0-24 SL
24-44 SCL 42" 154L
4/2
- 3 L 5% - 0-24 SL
24-42 SCL 36-38"
