**SOIL/SITE EVALUATION  
for ON-SITE WASTEWATER SYSTEM**

Bryan DT + Jim E Go TO SITE TO check reported FAILURE (Repair App.)

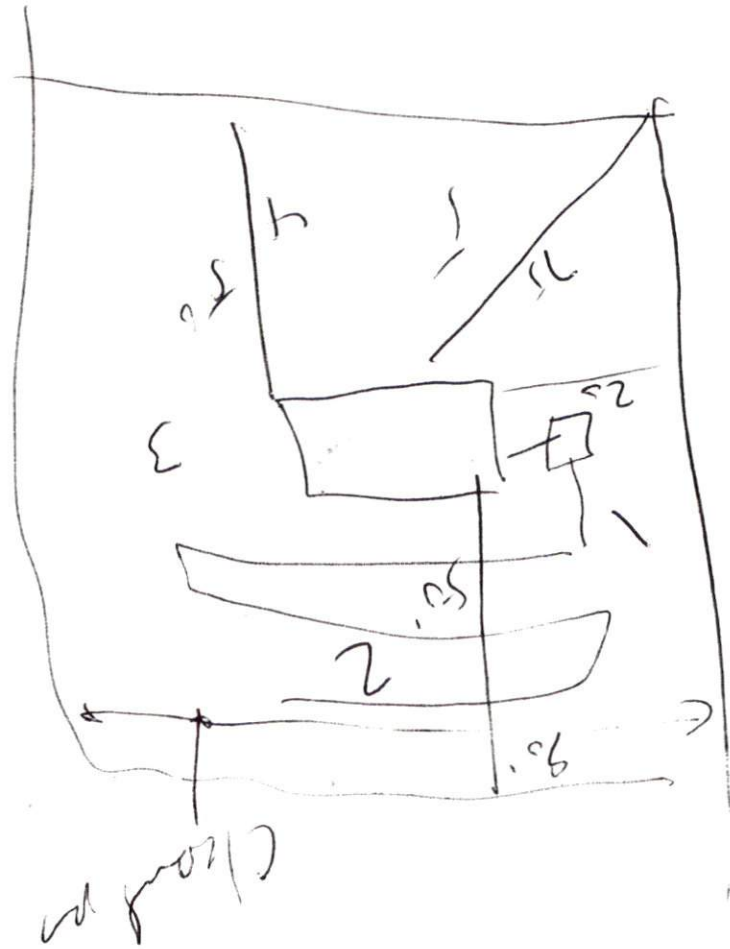
ON ARRIVAL WALK OUT TO DRAINFIELD + TANK AREA AND SEE NO FAILURE AT THAT TIME. SPOTS LOOKED AS IF THERE WAS FAILURE AT ONE TIME (MAYBE A WEEK OR 2 OLD). OWNER ARRIVES AND EMPLOYEED TO USA HE HAD A FAILURE, BUT REPLACED (PUMP AT ONE TIME) ALSO HAD WATER Softener - Attached to <sup>WATER</sup> SYSTEM. SAID WHEN MR HOLLAND WENT THERE TO CHECK IT OUT TANKS WERE BACKLASH UP. OWNER RAN PUMP AND DISCONNECTED Softener. SYSTEM BEGAN TO OPERATE PROPERLY AND NO FAILURE OBSERVED AT TIME. TOLD OWNER TO GIVE FEEDING OF PREVIOUS HAND. AND CHECK PIPE GOING TO ELECTRIC BOX FOR FURTER BLOCKAGE.
