ADDRESS . : 74 ROBERT BRANCH CIR

STRUCTURAL INSPECTION REPORT

LOT 23 MILL BRANCH SUBDIVISON 2300-sf± RESIDENCE

KIPLING, HARNETT COUNTY, NORTH CAROLINA

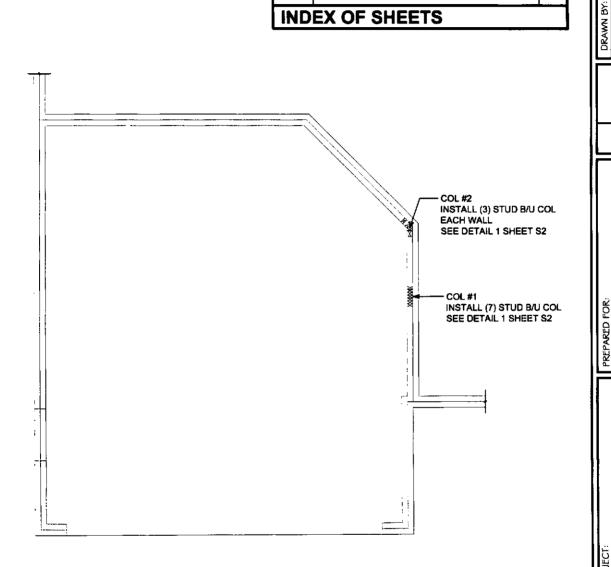
PLAN AT GARAGE

Observations and Notes Photograph Item 1 Observation: The floor framing beneath the 7-stud built-up column at the right-side wall in the garage overhangs the foundation wall by 5 inches. Recommendation: Install a built-up column beneath floor framing at column. Refer to drawings in appendix for more details. Item 2 Observation: The floor framing beneath the built-up column at the right-rear corner of the garage overhangs the foundation wall by 6 inches. Recommendation: Install built-up column beneath the floor framing at column. Refer to drawings in appendix for more details.

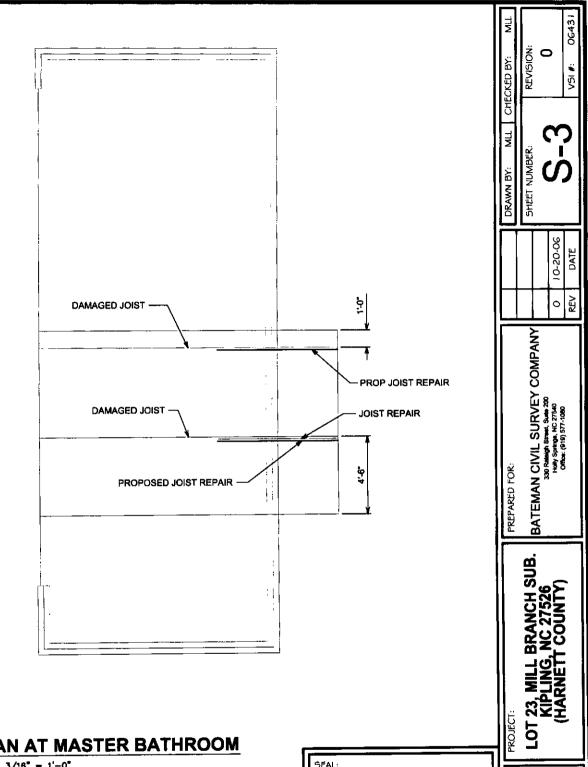
PLAN AT MASTER BATHROOM

Photograph **Observations and Notes** Item 3 Observation: A joist repair was observed beneath the cantilevered portion of the floor framing at the master bathroom, 2'-6" from the front wall. This repair conceals damage to original joist. Recommendation: Install a 2x10 joist beside repair. Refer to drawings in appendix for more details. Item 4 Observation: A damaged joist was observed beneath the cantilevered portion of the floor framing at the master bathroom, 1'-0" from the rear wall. Recommendation: Install a 2x10 joist beside damaged joist. Refer to drawings in appendix for more details.
