PREPARED 8/21/06, 13:59:38  
Harnett County

INSPECTION TICKET  
INSPECTOR: IVR

-----  
ADDRESS . : NEIGHBORS RD SUBDIV:  
CONTRACTOR : PHONE :  
OWNER . . : POPE BRYON MARIS & REBECCA A PHONE : (910) 892-2353  
PARCEL . . : 02-1528- - -0071- - -  
APPL NUMBER: 06-50015272 CP NEW RESIDENTIAL (SFD)  
DIRECTIONS : HWY 301 SOUTH FROM DUNN, TOWARDS BENSON  
TURN LEFT ON NEIGHBORS RD AT CARLIE C'S  
MCLAMBS OPERATIONS CENTER 3/4 MILE ON  
RIGHT DJOHNSON  
-----

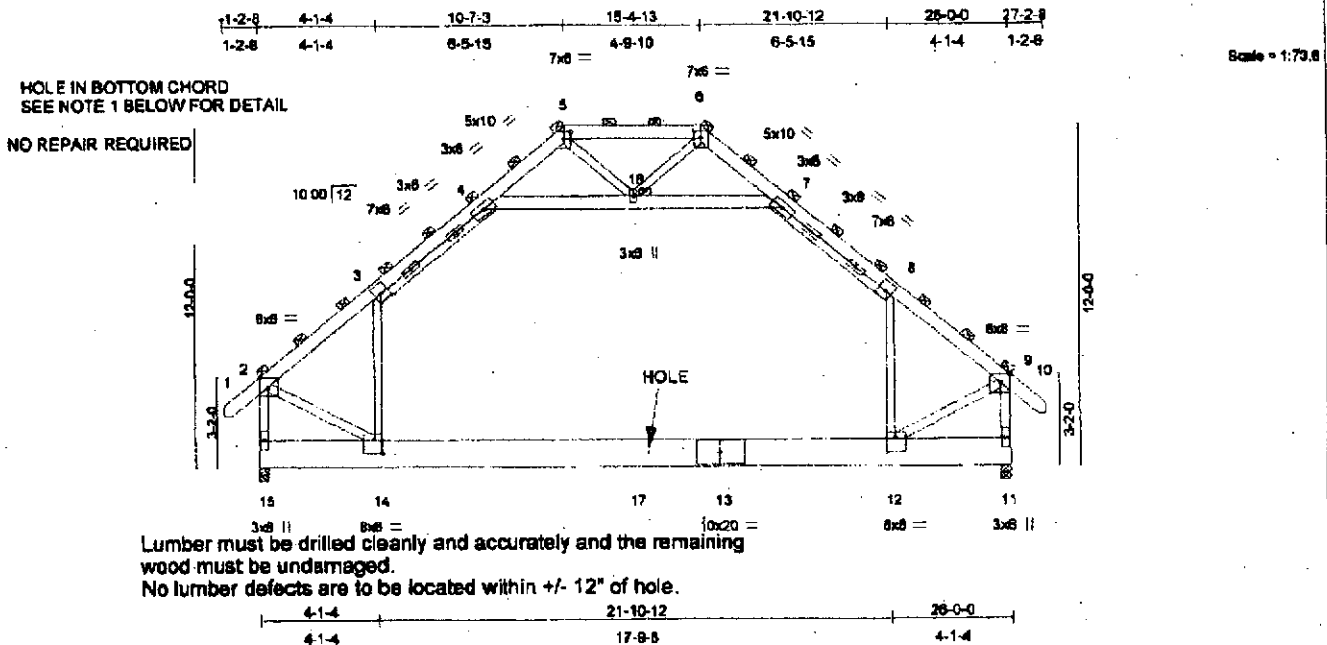
| 13308 | HGR01 | PIGGYBACK ATTIC | 2 | 3 | Job Reference (optional) | | |

| TYP/SQ | REQUESTED<br>COMPLETED | INSP<br>RESULT | DESCRIPTION<br>RESULTS/COMMENTS |
|---|---|---|---|
| R425 01 | 9/21/06<br>9/21/06 | KS<br>DP | FOUR TRADE ROUGH IN VRU #: 001276452<br>1. Girder trusses not nailed per drawing--HGR01 2. HGR01 drilled by electrician--need truss engineers evaluation and recommended repair 3. Triple girder attached to HGR01 at center point with parallel floor joists intersecting girder. This puts point load in center of girder. Should have ladder framed to spread load. Provide engineers repair. 4. H03 trusses cut at ends over garage windows. Need truss engineers repair 5. Truss pracing micing on webs for H01 6. H10 simpson connector installed at wrong location on H02 7. Fir down to 9 1/4 inches for bonus room dormer 8. No mid story guides on plumbing pipes.9. need water test on waterlines, not air.10. washing machine horizontal branch drain shall be 3 inch. Do not insulate \$50 reinspection |

- 1) Repair Condition: 0-0-12 dia. hole located 0-5-10 from the bottom edge to the center of hole in bottom chord 2-8-4 to the left of joint 13.
- 2) N/A

- 3) 3-ply truss to be connected together with 10d (0.146"x3") nails as follows:  
 Top chords connected as follows: 2 X 6 - 2 rows at 0-9-0 oc, 2 X 4 - 1 row at 0-9-0 oc.  
 Bottom chords connected as follows: 2 X 12 - 2 rows at 0-9-0 oc.  
 Webs connected as follows: 2 X 4 - 1 row at 0-9-0 oc, 2 X 6 - 2 rows at 0-9-0 oc.
