-----  
ADDRESS . . : 44 WILLIAM BETHUNE CT  
CONTRACTOR : WILLIAM P JACKSON  
OWNER . . . : BFT BUILDERS INC #18  
PARCEL . . . : 01-0544- - -0012- -18-  
APPL NUMBER: 08-50019596 CP NEW RESIDENTIAL (SFD)  
DIRECTIONS : CAROLINA OAKS #18-401S RT ON ELLIOTT  
BRIDGE RD RT ON WILL LUCAS RD S/D ON RT  
ON CAROLINA OAKS CIRCLE RT ON WILLIAM  
BETHUNE CIRCLE LOT ON RT.JD  
-----

-----  
**STRUCTURE: 000 000 44X50 3BR W/GARAGE (02)**

-----  
**PERMIT: CPSF 00 CP \* SFD**

Harnett County

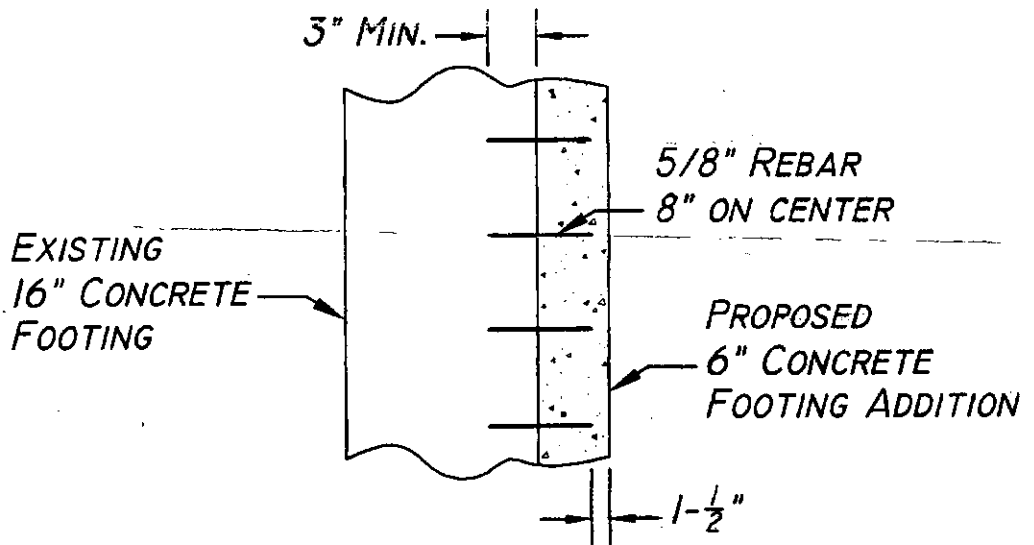
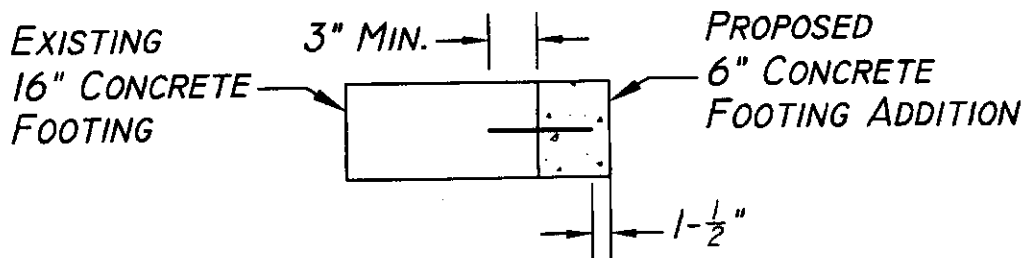
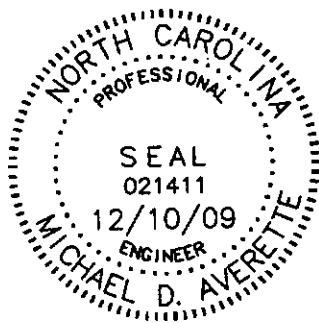
**FOOTER DESIGN**

1. Top of footer still not clear of mortar and debris. Unable to verify piers are in center third of footers, and projection in areas highlighted on plans. Clean of footers and have engineer repairs where needed.  
 \$50.00 re-inspection fee.  
 T/S: 11/30/2009  
 09:28 AM DETAYLOR -----

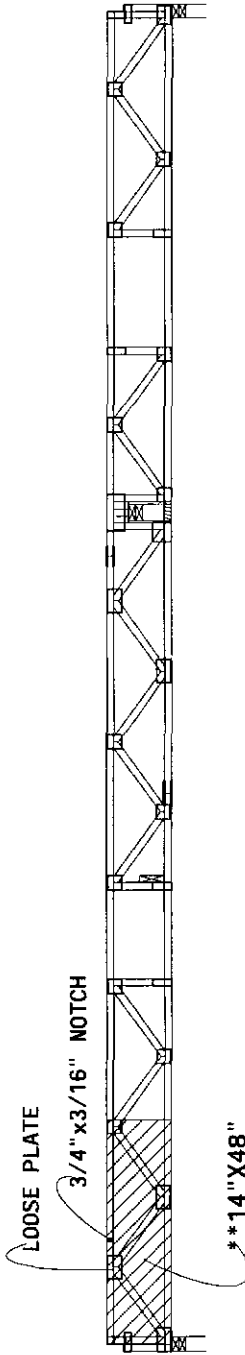
TRUSS REPAIR

This truss is repaired for a loose plate and a 3/4"x3/16" notch cut in the top chord a 3" right of the loose plate as shown.

Shore Truss and any supported spans in proper position as repair is being made.

\*\* (2) NEW 3/4"X(SIZE SHOWN) C-D EXT APA 48/24 STRUCTURAL SHEATHING (PLYWOOD OR OSB). ATTACH BOTH GUSSETS TO ONE FACE OF THE TRUSS WITH SIMPSONS 1/4"X4.5" SDS SCREWS SPACED 4" OC. THROUGHOUT THE TOP CHORD AND WEB AND AT 12" OC IN THE BOTTOM CHORD, WITHOUT SPLITTING THE LUMBER.
