ADDRESS . . : 389 CAROLINA OAKS CIR
CONTRACTOR : WILLIAM P JACKSON
OWNER . . . : BFT BUILDERS INC #55
PARCEL . . . : 01-0544- - -0012- -55-
APPL NUMBER: 08-50019600 CP NEW RESIDENTIAL (SFD)
DIRECTIONS : CAROLINA OAKS #55-401S RT ON ELLIOTT
BRIDGE RD RT ON WILL LUCAS RD S/D ON RT
ON CAROLINA OAKS CIRCLE RT ON
CAROLINA OAKS CIRCLE LOT ON LEFT AROUND
CIRCLE.JD

STRUCTURE: 000 000 46X54 3BR W/GARAGE (02)

PERMIT: CPSF 00 CP * SFD

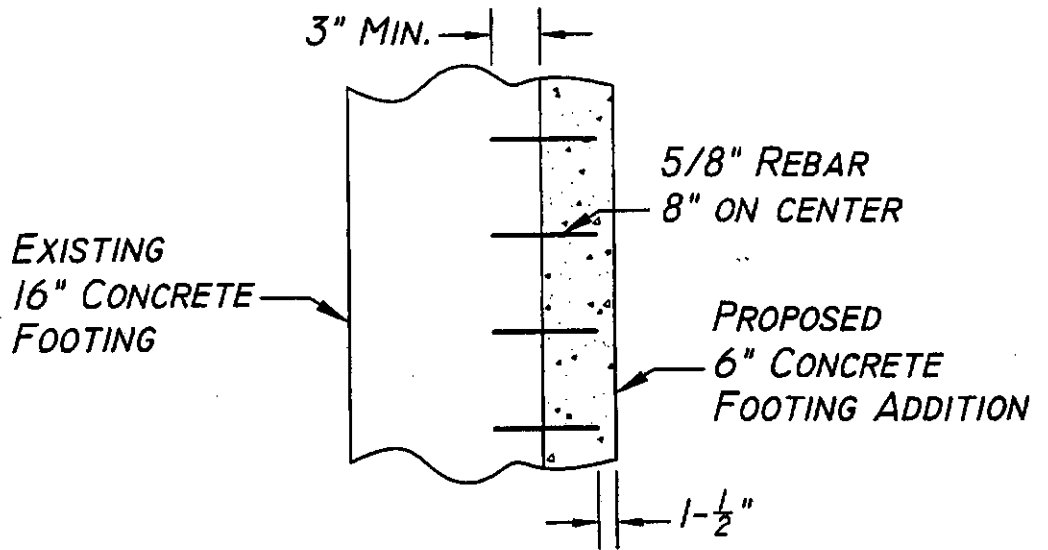
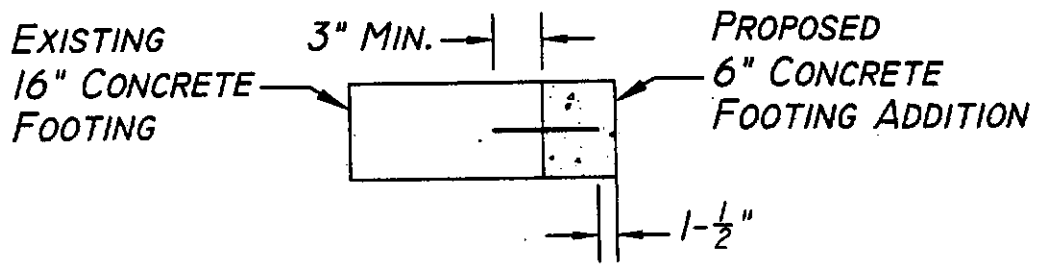
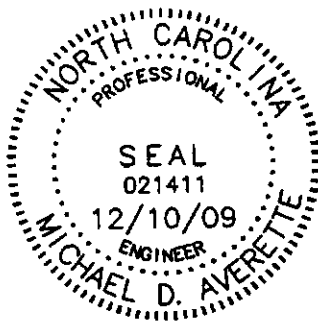
FOOTER DESIGN

1. Top of footer still not clear of mortar and debris.
 Cleanoff top of footer, and have engineer repair where
 projection is not met.
 \$50.00 re-inspection fee.
 T/S: 11/30/2009 09:25 AM DETAYLOR

Projection not met at front of garage walls. Have engineer repair and call for re-inspection.
